Analysis of the TEPCO Fukushima Daiichi NPS Accident

Interim Report
(Provisional Translation)

October 2014

Nuclear Regulation Authority, Japan

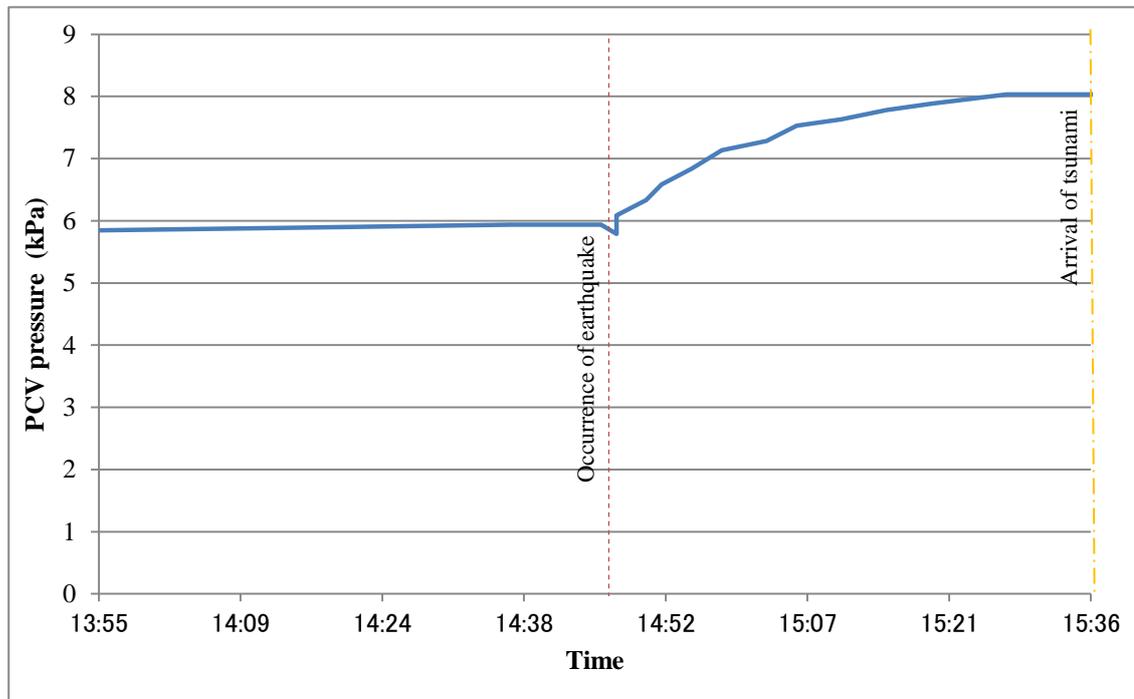
Figure 1.4 Behavior of PCV Pressure

The measured PCV pressure had increased about 2.0 kPa from the earthquake occurrence to the tsunami arrival (Fig. 1.4). In addition, the "High PCV pressure (13.7 kPa)" alarm was not generated.⁶

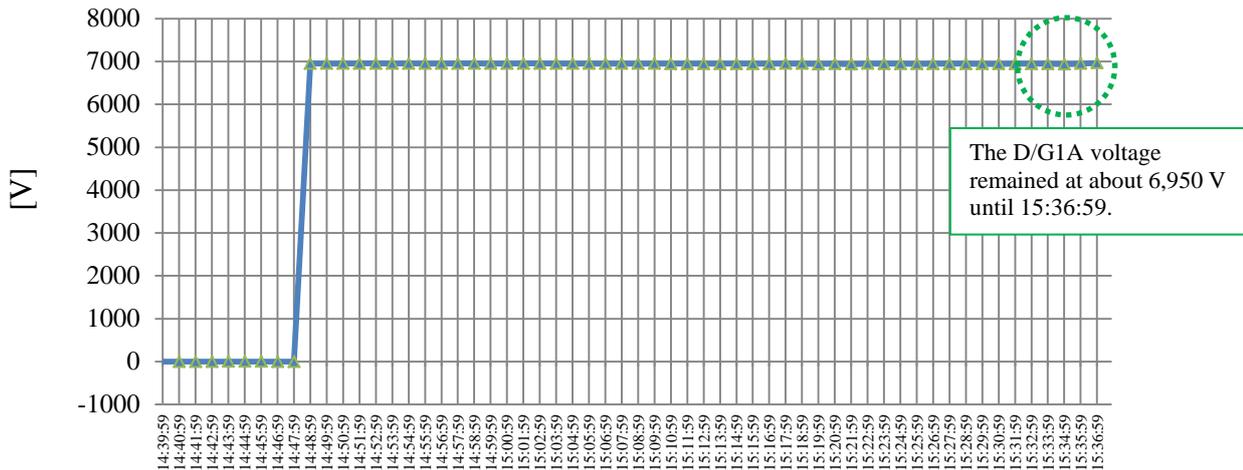
Figure 2.4 Behavior of D/G1A Voltage Value

With the aide of the newly provided data of the transient phenomena recorder, the NRA found that D/G1A remained at about 6,950 V until 15:36:59 (data collecting time just before data measurement stopped) (Fig. 2.4). Conversely, M/C1C connected to D/G1A dropped its voltage to almost 0 V between 15:35:59 and 15:36:59, and was subsequently disabled to supply power (Fig. 2.5).

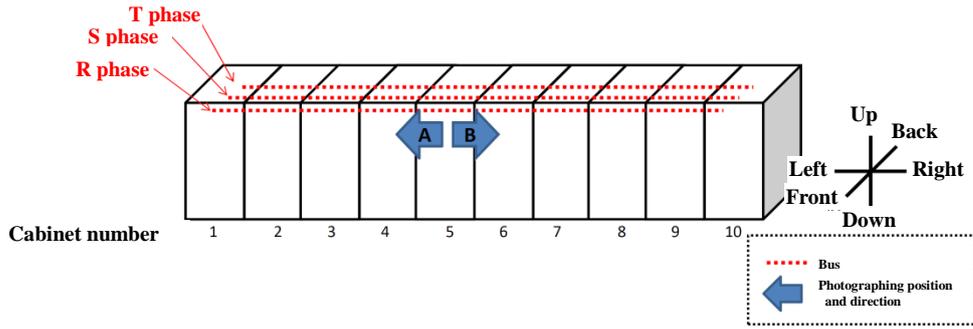
Figure 2.8 Buses and Bus-supporting Insulators inside M/C1C

The NRA therefore estimated that M/C1C did not cause such outages due to the effects of the earthquake, as was pointed out in the National Diet Investigation Commission report.

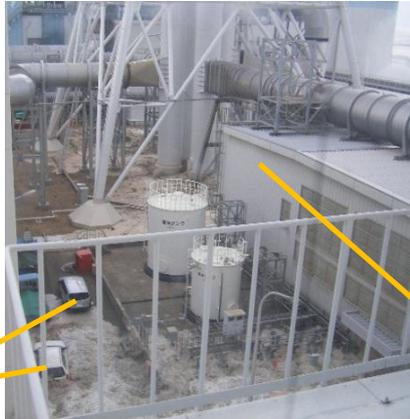
Photo 3 (Tsunami 2-2 caused large-scale flooding on the premises (height: O.P.+ 10 m).)

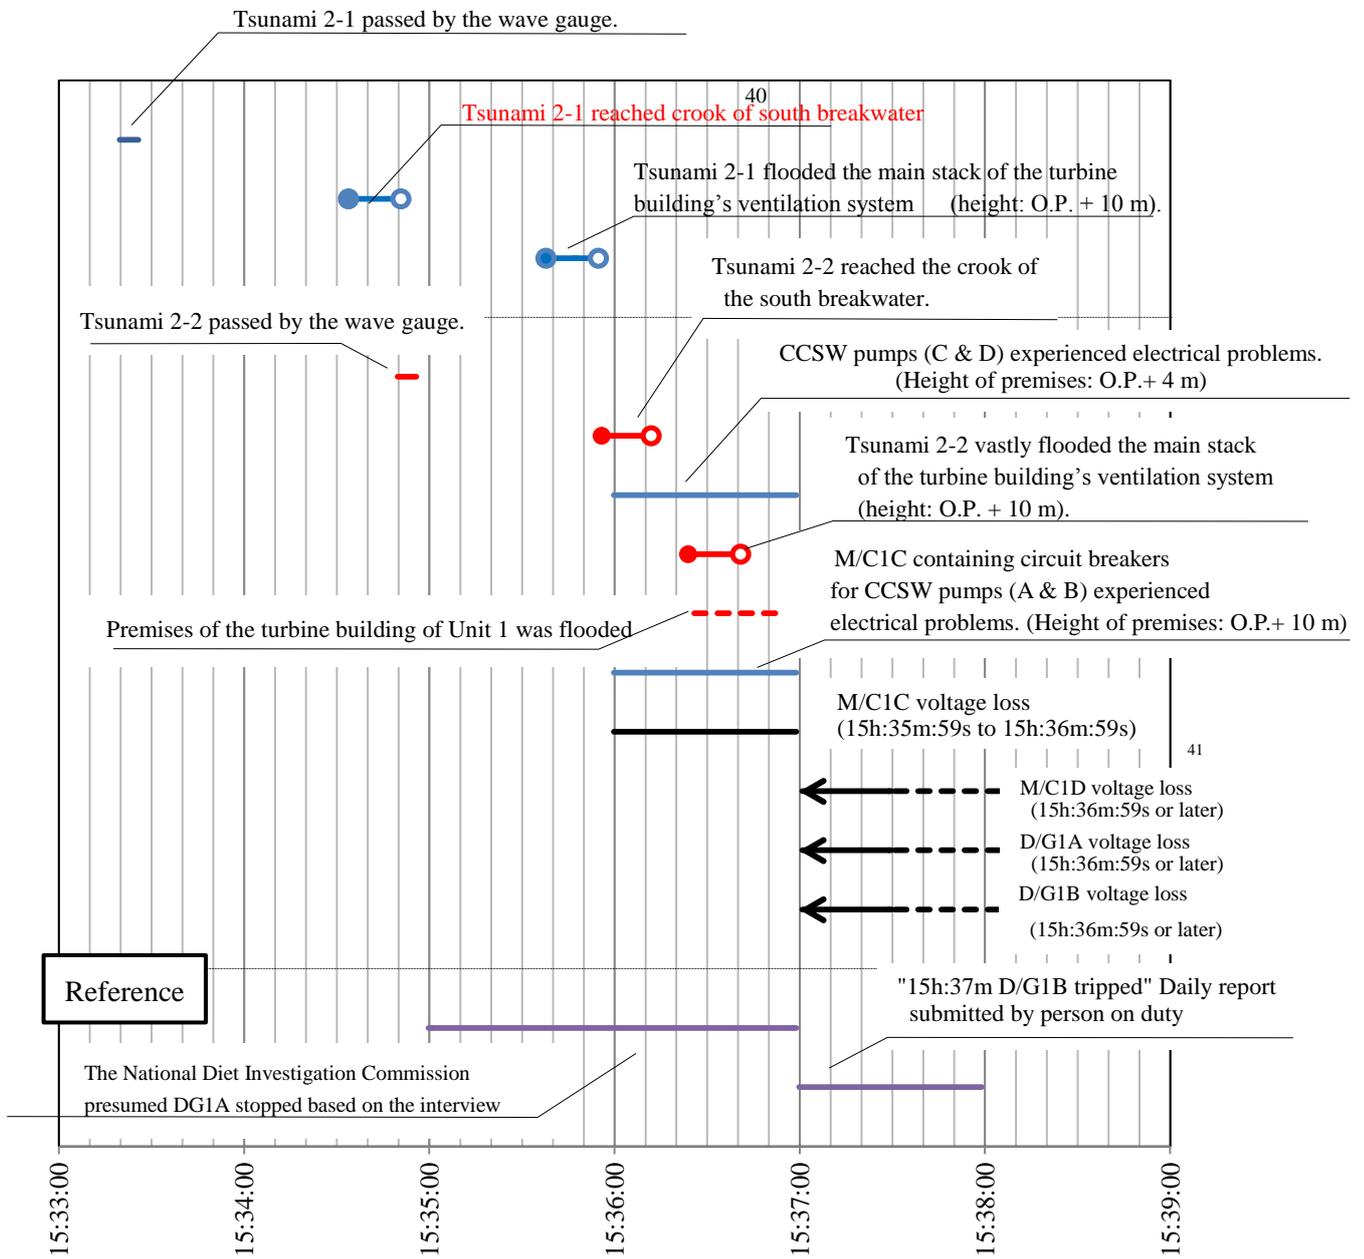
Figure 2.25 Time-series Arrangement of Wave Gauge Record Data, Photos, and Transient Phenomena Recorder Data (Unit 1)

Judging from Fig. 2.25, the NRA estimated that M/C1C, M/C1D, D/G1A and D/G1B lost their voltages after the premises of the turbine building of Unit 1 (containing this equipment) were assumed to be flooded and also that this situation is roughly correspond to the tsunami inundation.

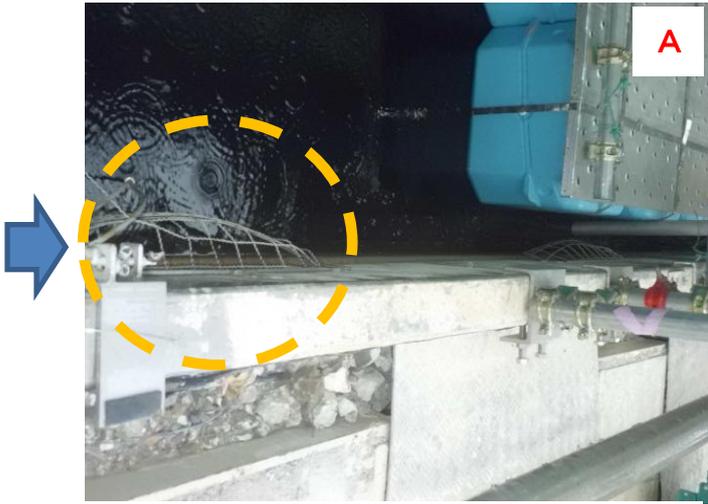
Deformation of the exhaust port net of the exhaust duct above the SFP on the 5th floor (deformed outward)
(photographed by TEPCO on November 8, 2011)

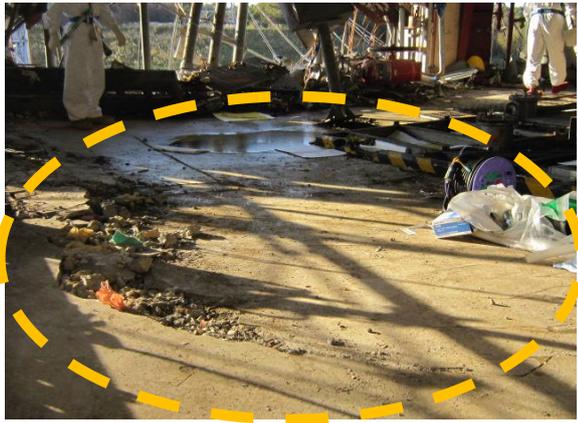
Photographed by TEPCO on November 8, 2011
Floor damage in the southwest area of the 4th floor

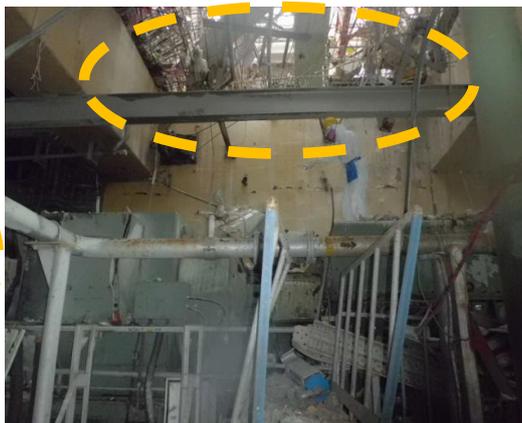
Photographed by TEPCO on November 8, 2011
Ceiling damage in the southwest area of the 4th floor

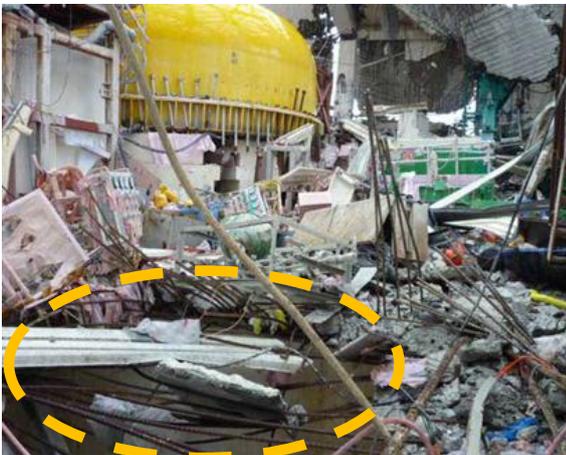
Photographed by TEPCO on October 5, 2011
Floor damage in the southwest area of the 5th floor

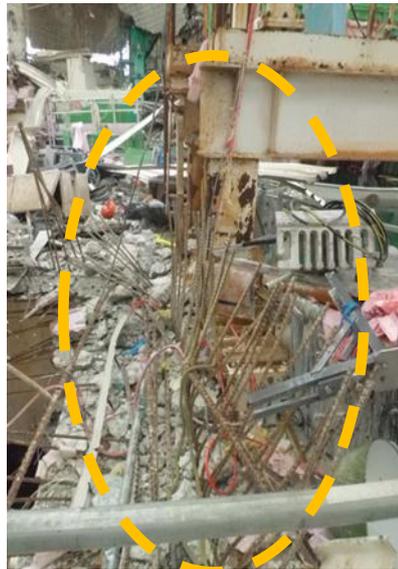
Photographed by TEPCO on October 5, 2011
Floor damage in the southwest area of the 5th floor (upward-vent reinforcing bars)

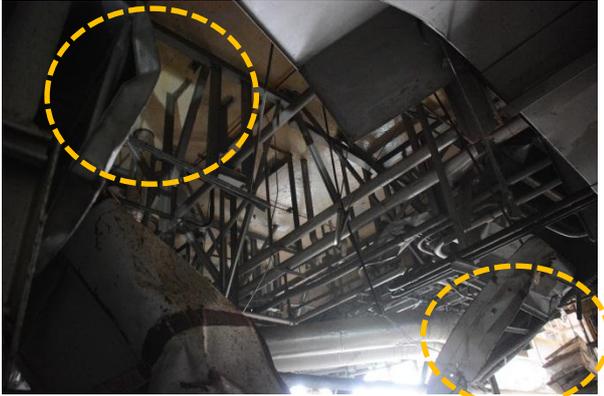
Photographed by the NRA on July 12, 2013
Ceiling damage in the northwest area of the 3rd floor (duct damage)

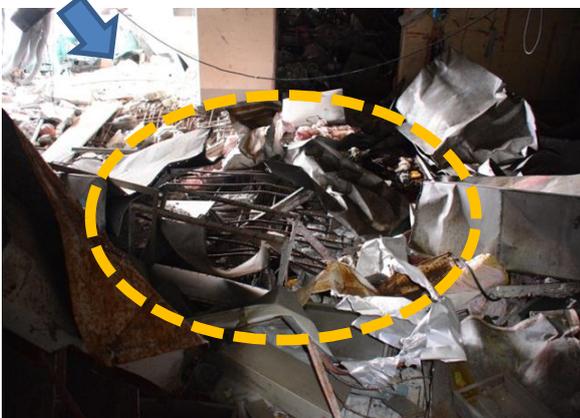
Photographed by the NRA on July 12, 2013
Floor damage in the northwest area of the 3rd floor

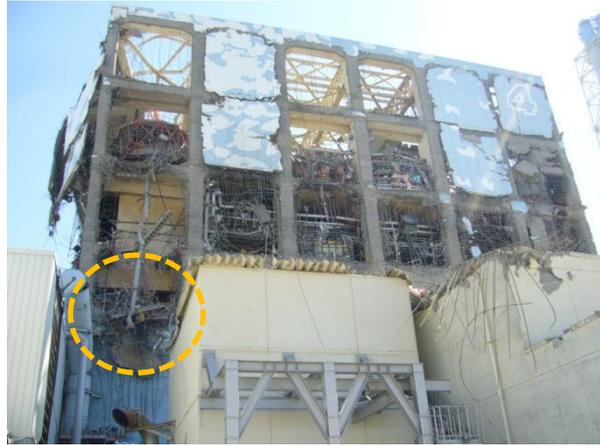
Photographed by TEPCO on March 18, 2011
Complete destruction of the wall west of the staircase in the northwest area of the 3rd floor

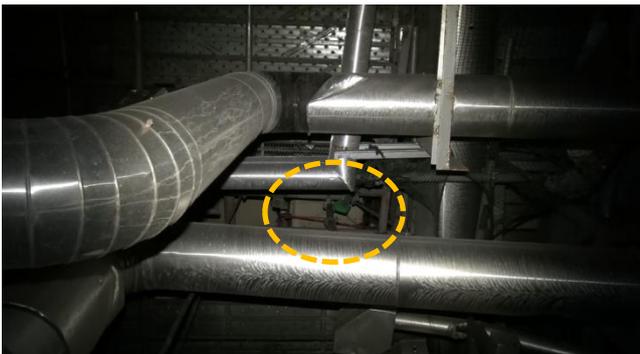
Photographed by the NRA on February 6, 2014
 Ceiling penetration
Ceiling damage in the northwest area of the 2nd floor (directly under the damaged floor in the northwest area of the 3rd floor)

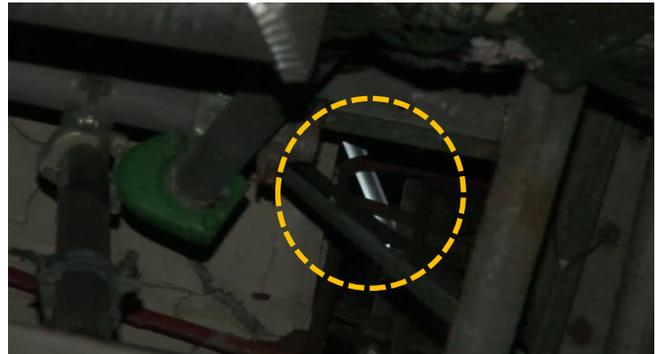
Photographed by the NRA on February 6, 2014
 Magnified penetration view (of materials on the 3rd floor that the NRA visually recognized)

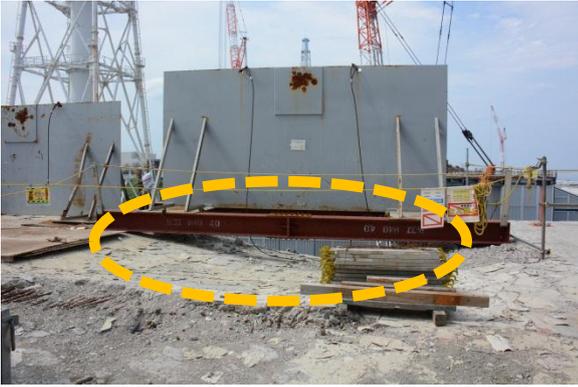
Photographed by the NRA on July 11, 2013
Downward deformation in the north area of the 5th floor
