Evaluation of the report by Tokyo Electric Power Company regarding the leakage from piping transferring water treated at the Multi-nuclide Removal System (ALPS) at the Fukushima Daiichi Nuclear Power Station

Nuclear Regulation Authority
15 July 2015

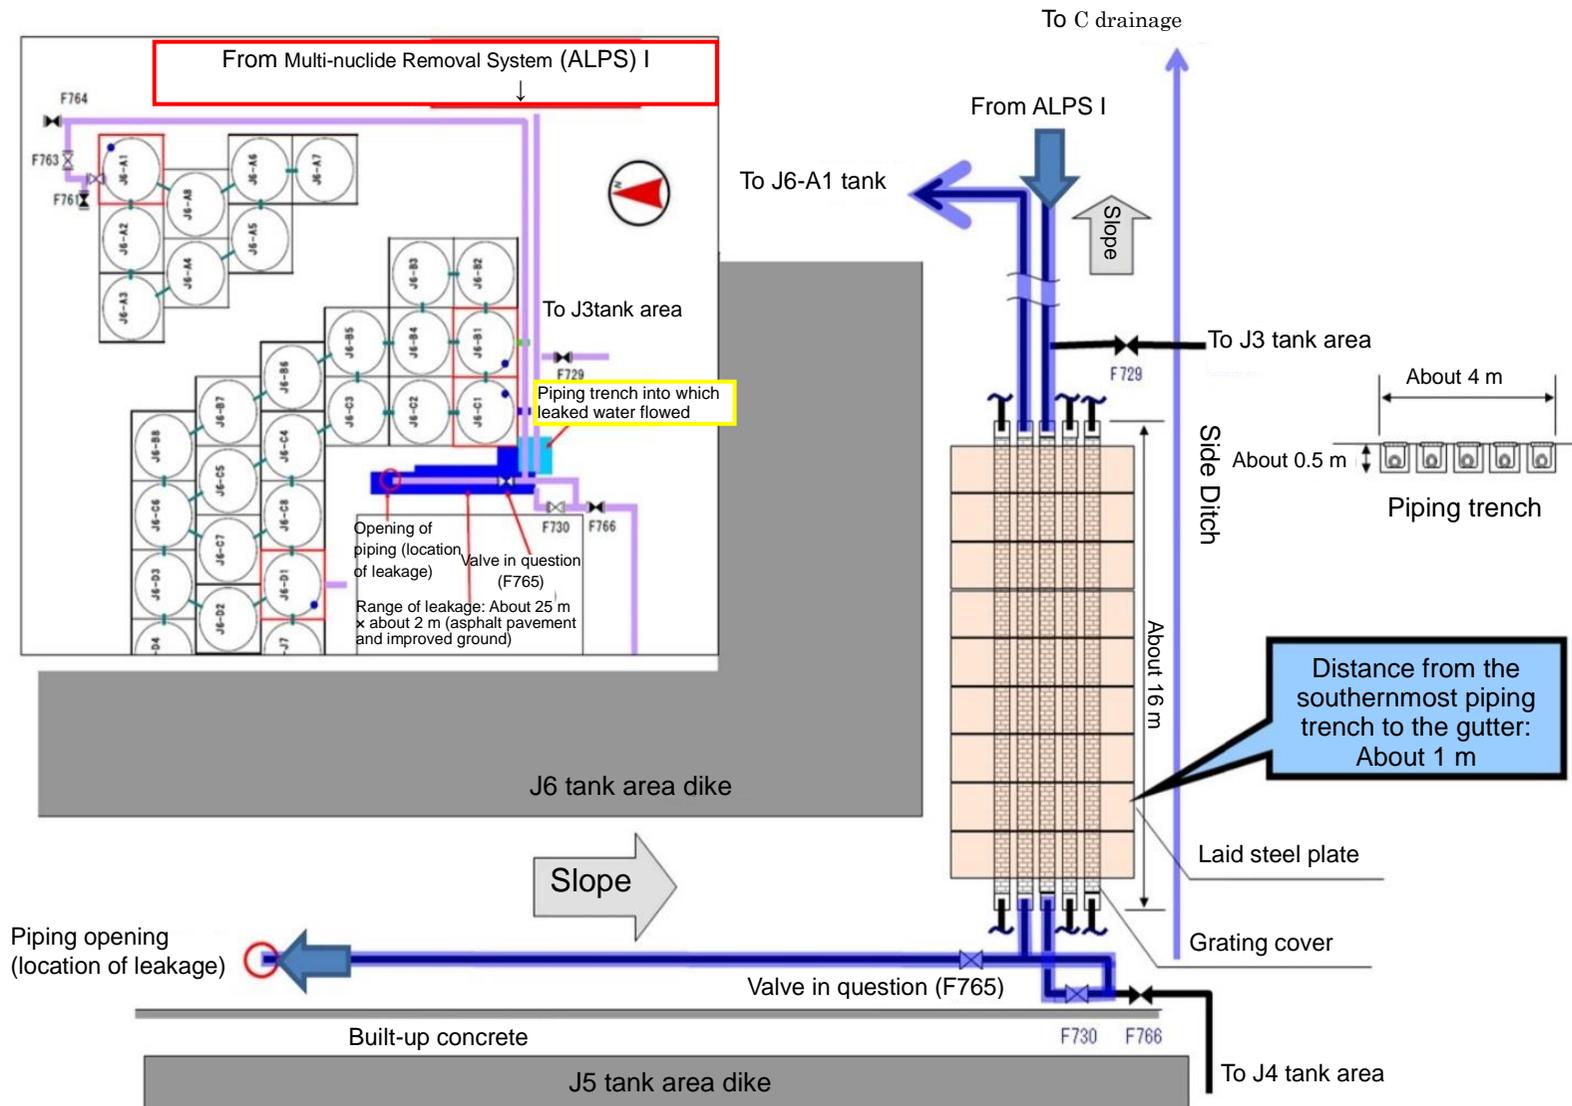
Figure 2. Schematic view of treated-water transfer piping*4

The leaked water flowed onto the road, contaminated part of location where crushed stones and mound were laid (see Figure 3) and flowed into the piping trench, where it accumulated (see Figure 2). The water inside the piping trench and water accumulated on the ground (about 9 m³) as well as earth and sand (about 5.7 m³) contaminated by the leaked water were collected (see Figure 4).

- Upon checking the site after the leakage occurred, the Equipment Management Division learned that the transfer piping connecting the sample tank to the tank in question branched in front of the valve F765, the valve F765 was located on the transfer piping under construction, the transfer piping beyond the valve F765 was under construction, thus in unconnected condition, and the end of the transfer piping was in an open state.

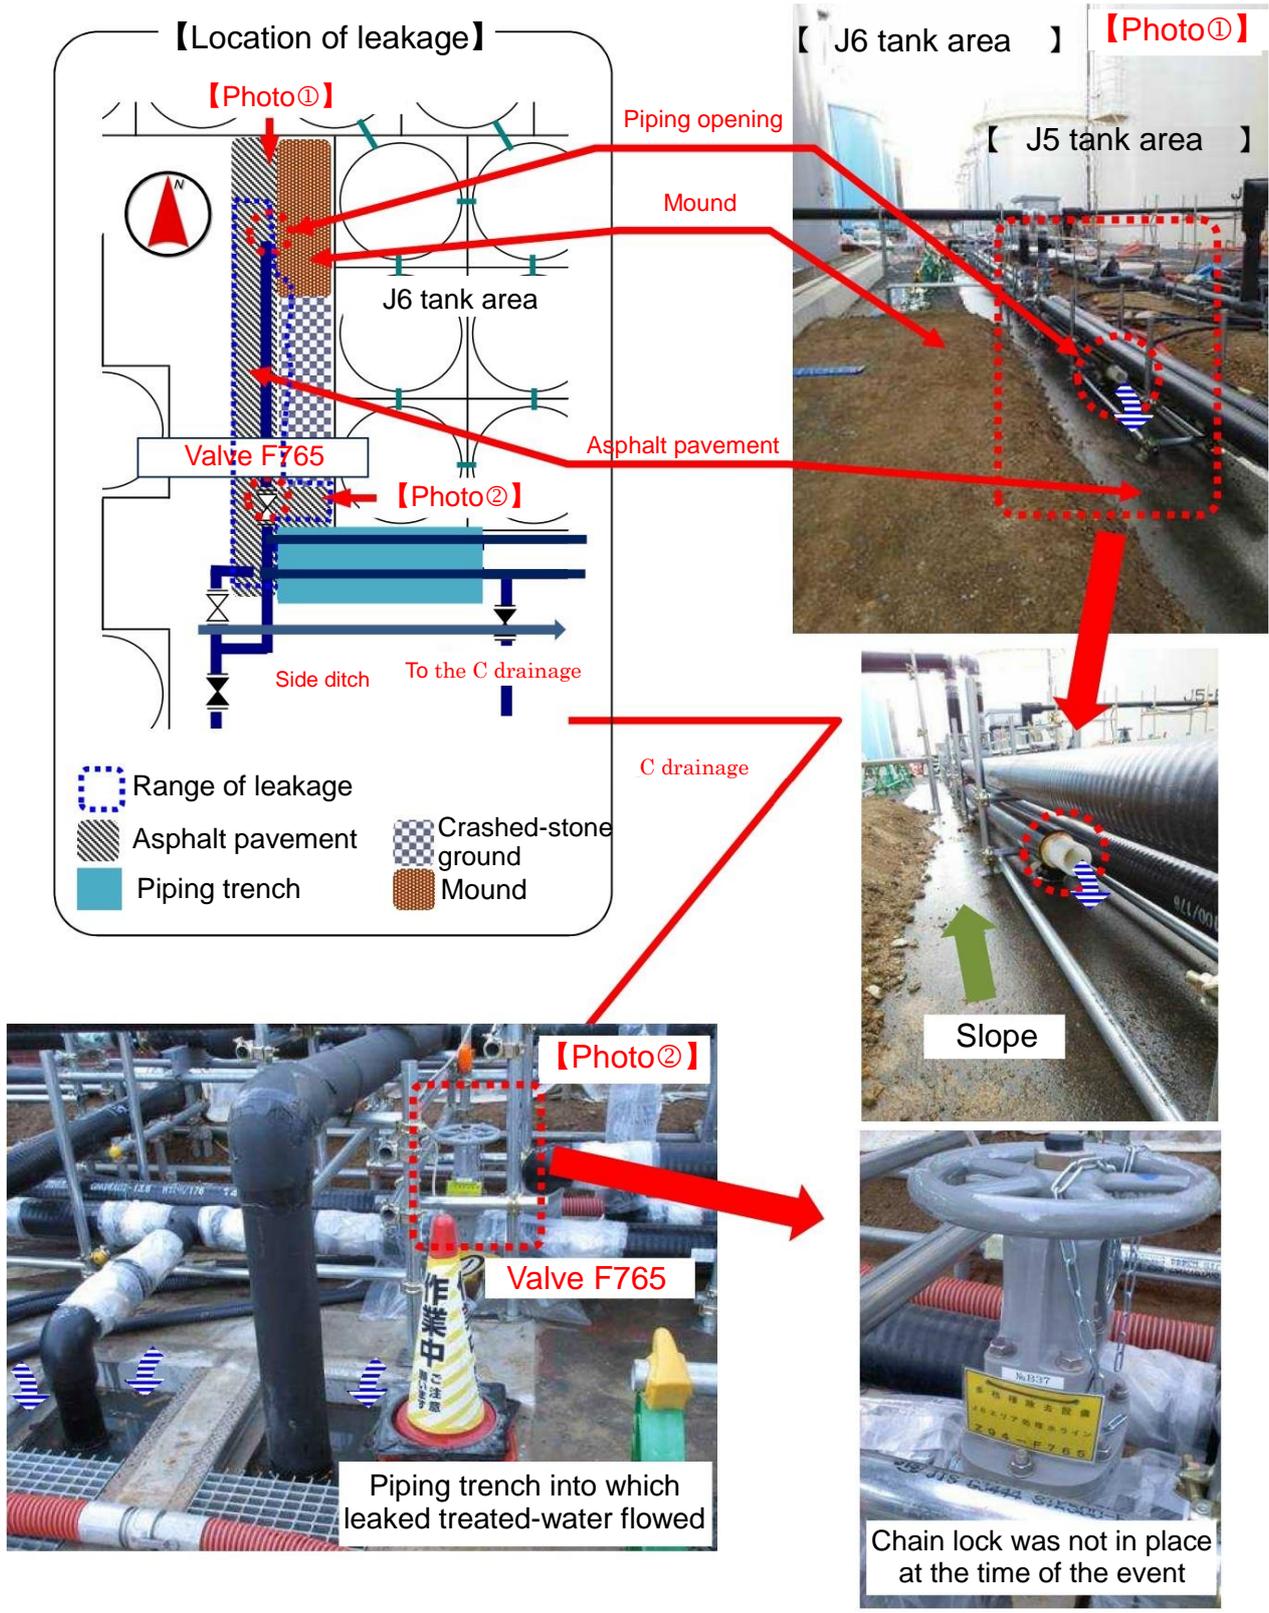
Figure 3. Situation of leakage on site*⁵

Effective dose due to γ ray and equivalent dose to skin were checked for workers who had patrolled the J6 tank area (see Figure 3). As a result, the NRA has concluded that their radiation exposure was improbable.

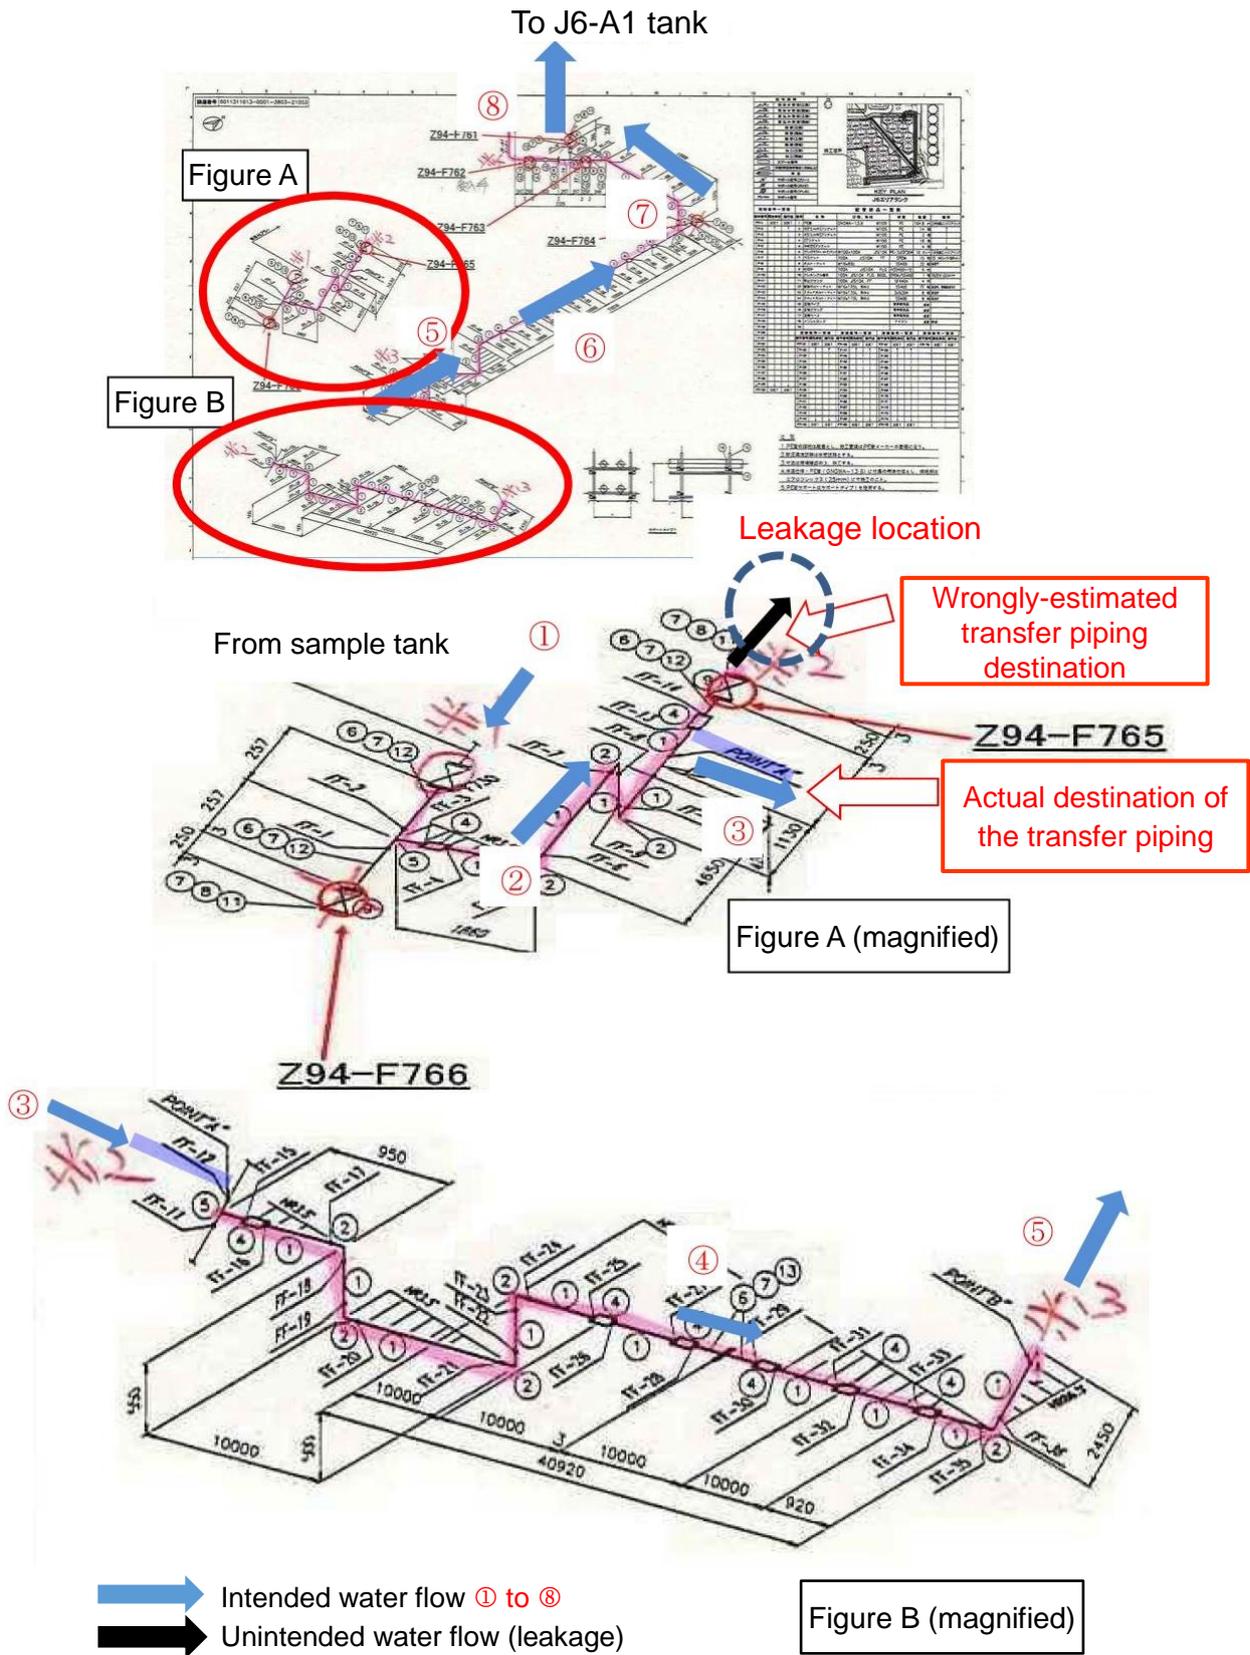
Figure 5. Treated-water transfer route map used during the preparation of the treated-water transfer manual*⁷

- In the piping construction drawings, however, piping connections were divided, which made it difficult to grasp piping routes. Therefore, the Equipment Management Division, with advice from the Construction Division, prepared piping construction drawings in which transfer routes were clearly indicated using highlighters (hereinafter referred to as the "transfer route drawings") (see Figure 5). In so doing, however, the Equipment Management Division mistakenly judged that valve F765 was on a transfer route and prepared a transfer manual that required switchover of the valve F765 from "close" to "open." In fact, the valve F765 was located on a transfer route under construction and thus the procedure requiring the "open" operation of the valve F765 was wrong.

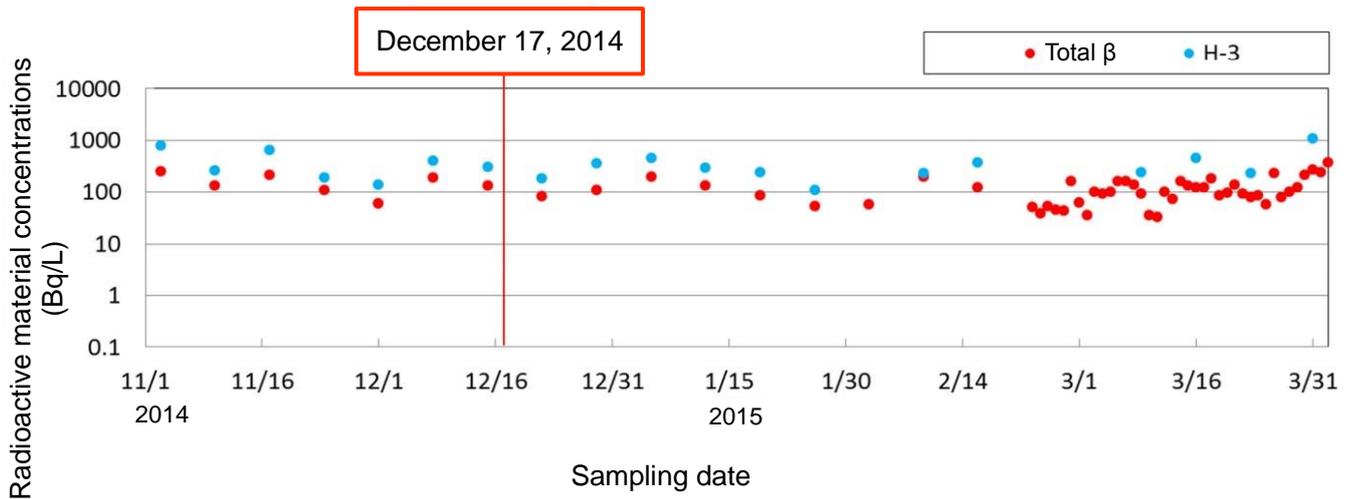
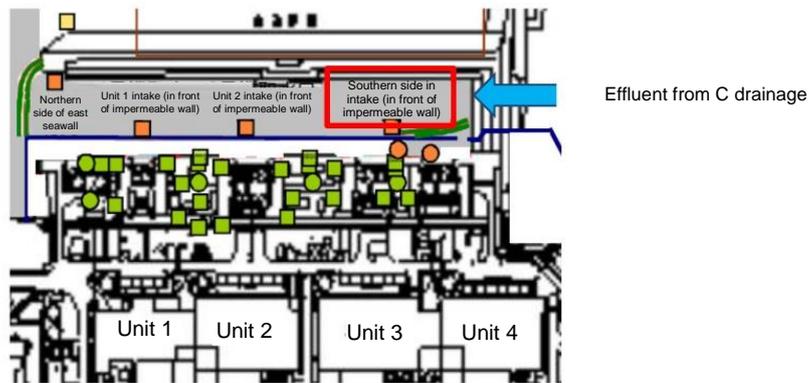
Figure 7. Concentrations of radioactive material in seawater after the leakage from the ALPS treated-water transfer piping

No inflow of the leaked water to drainage channel was observed. The leaked water inside the piping trench was collected entirely. The earth and sand contaminated by the leaked water were also collected. No rainfall was observed during the period from the occurrence of the leakage until the collection of the contaminated earth and sand and workers in charge of monitoring checked the range of water expansion and the depth of wet earth and sand during the collection. No significant variation was observed regarding radioactive material concentrations in C drainage and the harbor in the vicinity of its discharge point after the leakage occurred (see Figures 7 and 8). Judging from the above, the NRA has concluded that the leaked water has not impacted drainage channels or the ocean.
