Evaluation of the Tokyo Electric Power Company's Report Regarding Leakage from Contaminated-Water Transfer Hose at the Fukushima Daiichi Nuclear Power Station

Nuclear Regulation Authority (NRA)

January 20, 2016

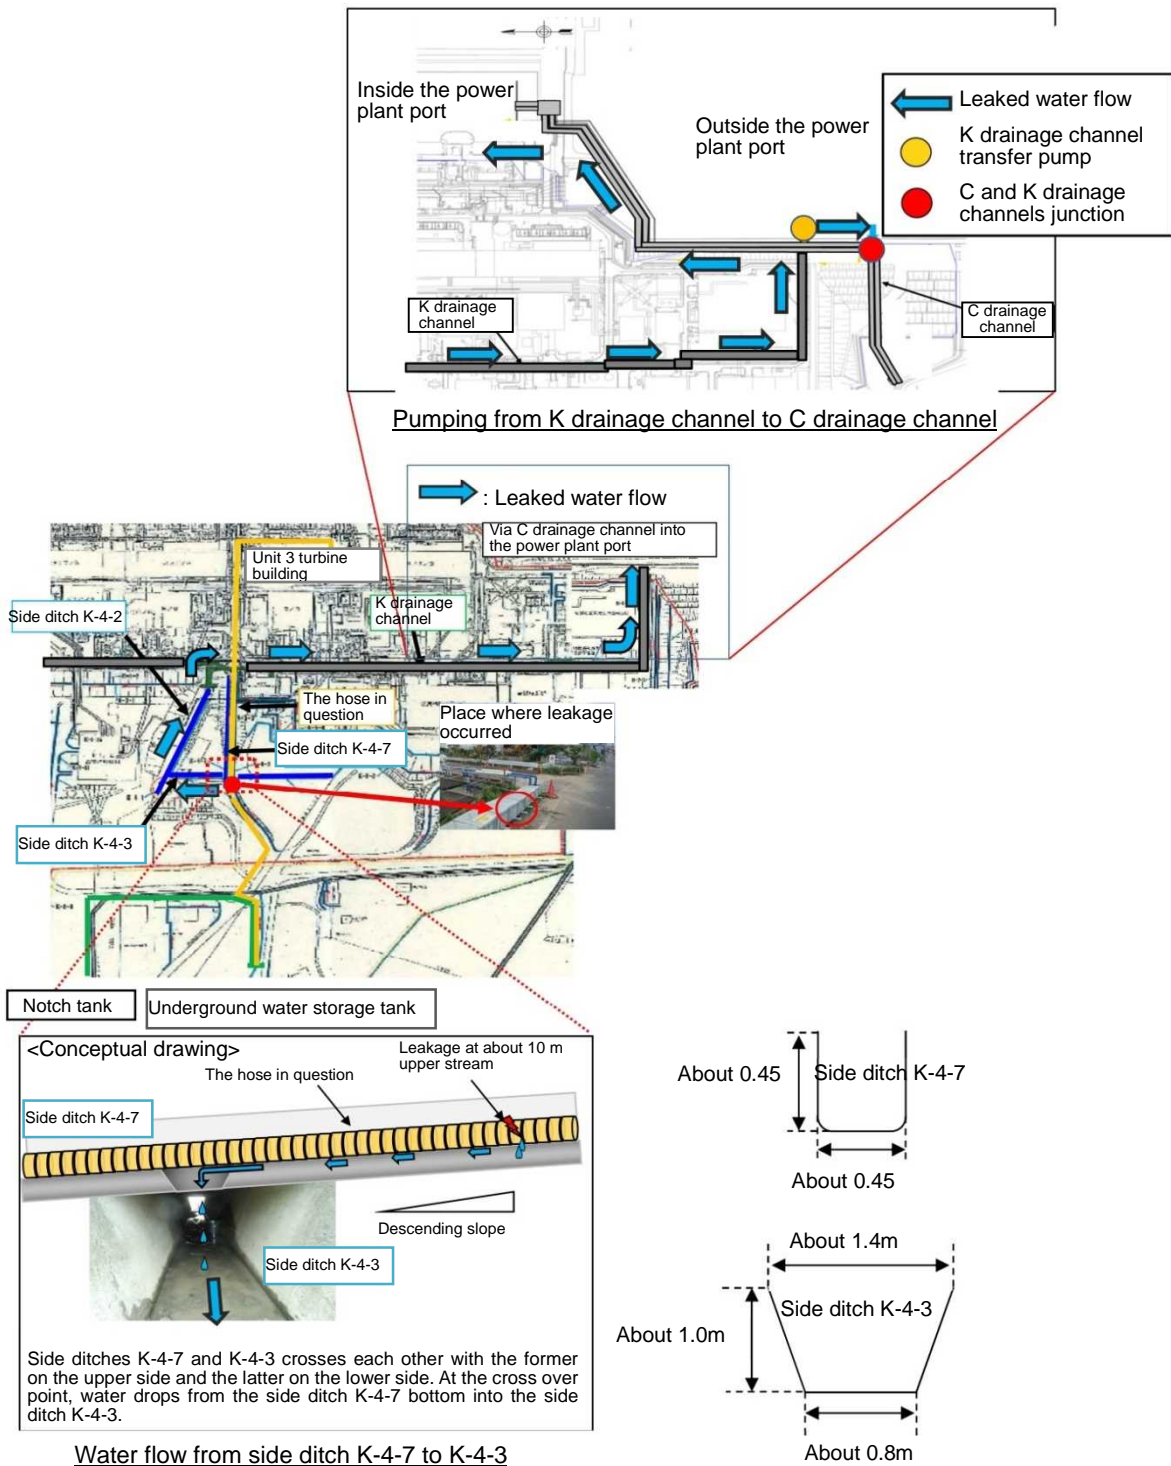
**Figure 1. Situation at the time of the leakage
(Excerpt from the TEPCO report, with partial revision)**

At around 10:08, May 29, 2015, during the operation of pumping and transferring the water stored in the notch tanks (total capacity: 1,000-ton) to the Unit 3 turbine building, a subcontractor worker found that the water was leaking from the polyvinyl chloride (PVC) pressure hose (hereinafter referred to as “the hose in question”) (see Figure 1). The leaking water outflowed into side ditch K-4-7 (where the hose in question was in place), and via downstream side-ditches K-4-2 and K-4-2, flowed into drainage channel K. Water in drainage channel K was pumped and transferred to drainage channel C and flowed into the port of the power plant. At 10:26, responding to the subcontractor worker's notification, the transfer pump from the notch tanks was stopped.

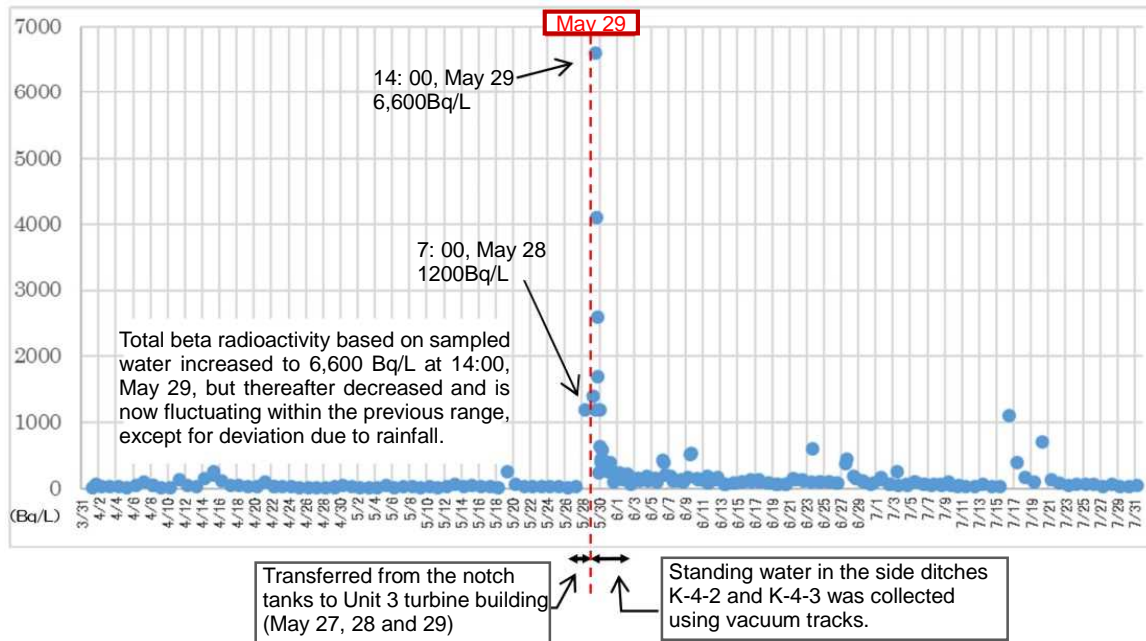
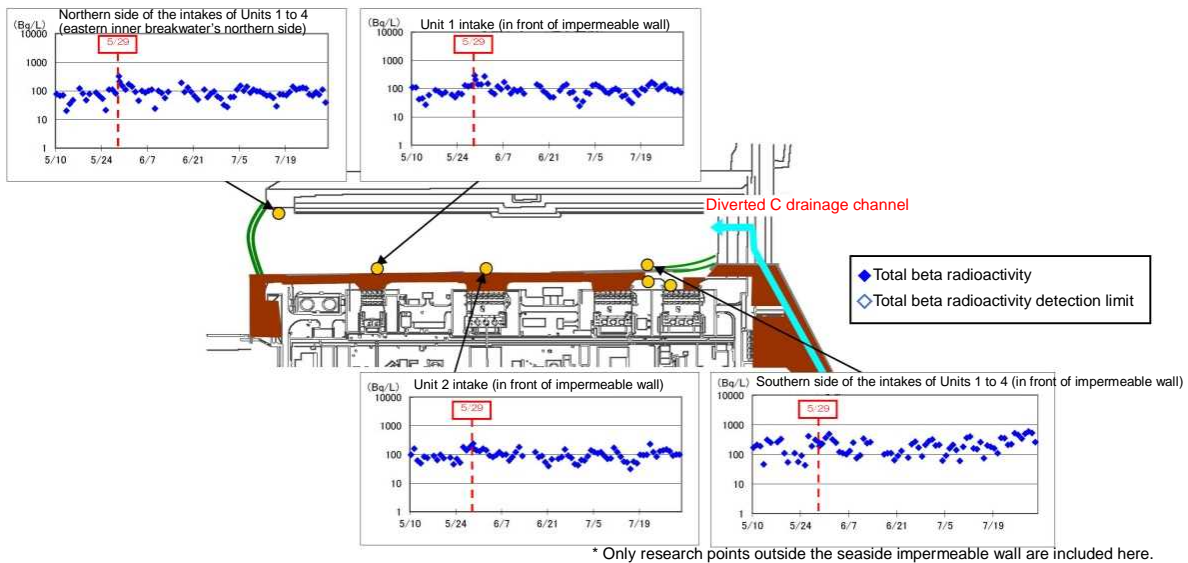
Figure 2. Results of monitoring at the K drainage channel outlets and Units 1 to 4 intakes (Excerpt from the TEPCO report, with partial revision)

Upon the leakage notification, total beta radioactive concentration at the drainage channel K outlet was checked by sampling, which revealed total beta radioactive concentration of about 29 Bq/L at 7:00, May 27. On May 28, however, the concentration of sample water increased to about 1,200 Bq/L (see Figure 2). On the assumption that the leakage event occurred during from when the water transfer started at 9:00, May 27 until the transfer was stopped on May 29, the maximum volume of water leaked was assessed to be about 15 m³ on the basis of the size of the leakage section opening.

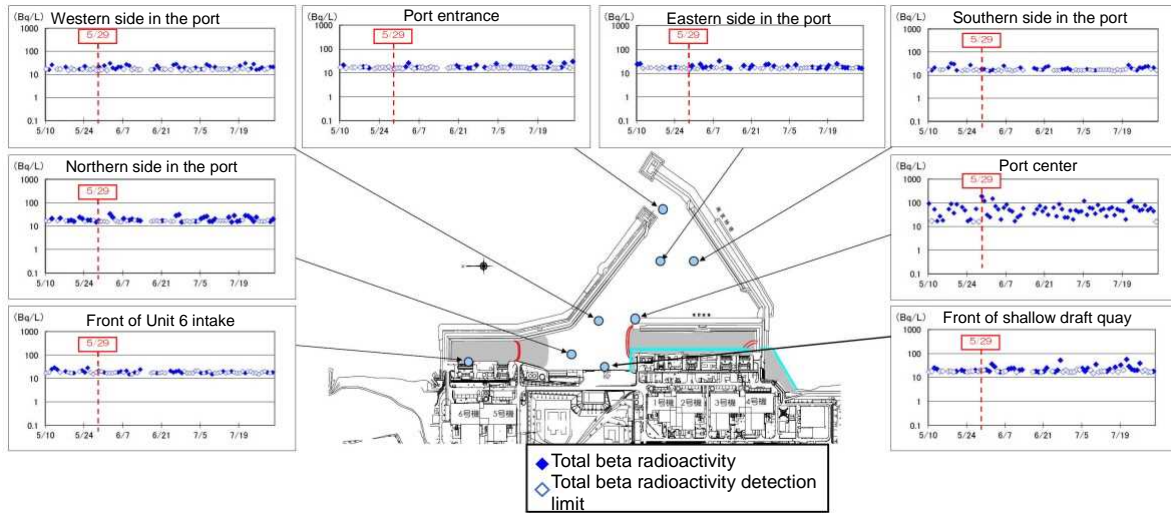
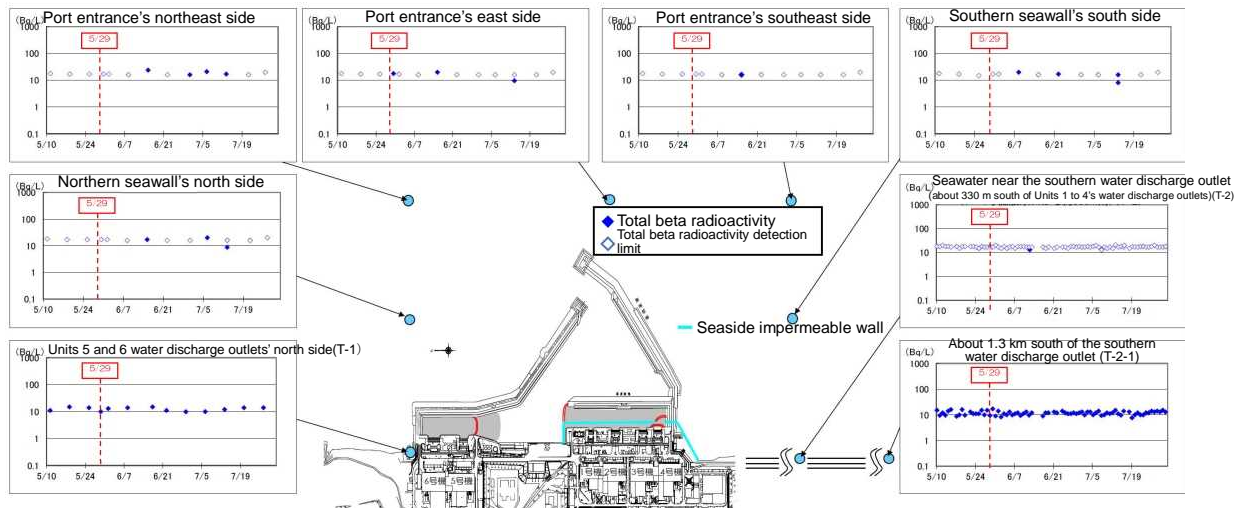
Figure 3. Monitoring results inside and outside the plant port
(Excerpt from the TEPCO report, with partial revision)

Any of the total beta radioactive concentrations periodically sampled at the port entrance were below detection limit from May 26 (before the occurrence of the leakage) to June 1 (after the occurrence of the leakage) (see Figure 3). Also continuous monitoring results did not show significant variation during this period (see Figure 4).

With regard to the plant vicinity (outside the port), an ad hoc analysis on May 30 based on samples from the port entrance's east side indicated a total beta nuclide radioactive concentration of 18 Bq/L, which is comparable to the detection limit of past analysis results. No significant variation was found also thereafter (see Figure 3).

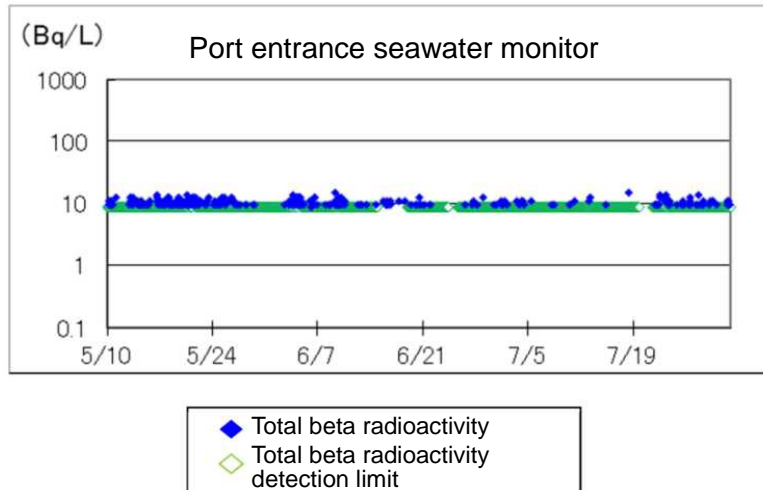
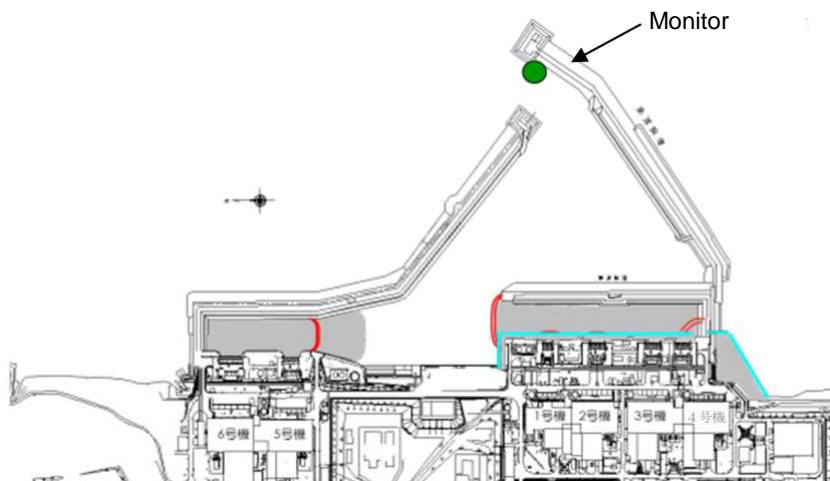
**Figure 4. Results of monitoring port entrance seawater
(Excerpt from the TEPCO report)**

Analysis results of the radioactivity of water samples taken from the port entrance and port entrance seawater monitoring did not suggest a significant variation from before and after the leak was found. No total beta radioactivity suggesting that the leaked water flowed outside the port was detected (see Figures 3 and 4). Therefore, it is estimated that no sea contamination occurred that would pose a threat to human health or the environment.

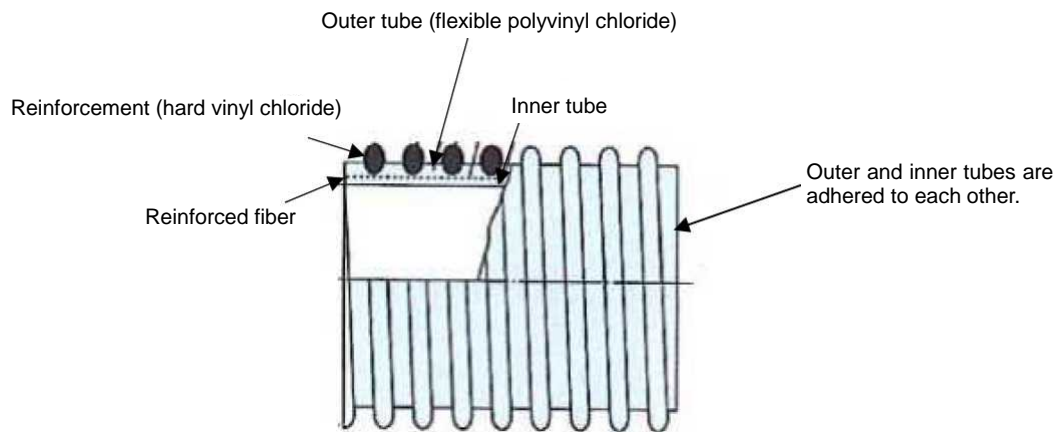
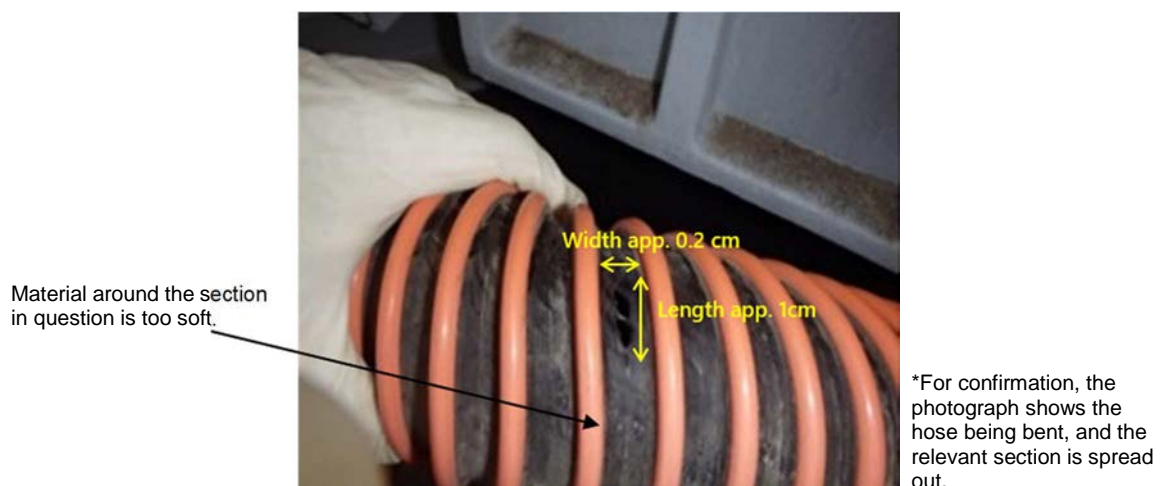
Figure 5. Specifications, structure and inspection results of the hose in question (Excerpt from the TEPCO report)

The hose in question was laid in the side ditch in October 2013 as a transfer line from the notch tanks to the Unit 3 turbine building. The hose was installed without being anchored and with sufficient slack. The hose was repeatedly used for water transfer over an extended period, during which water flow and internal fluid dead weight caused a bend with a smaller radius than regulations allowed, resulting in the separation of the inner tube and the outer tube. Under such conditions, the pressure during water transfer caused the hose to crack (see Figure 5).

- The section in question was checked visually, which showed an oval hole approximately 1 cm long and 0.2 cm wide.
- The section in question was the outer side of a bend. Around the section, the reinforcing ring interval was greater than normal and the hose was softer than usual.

- ① Replacement of the hose in question with a PE pipe

Replacement of the hose in question with a PE pipe was completed on June 20, 2015 (see Figure 6). Similar sections were investigated and improvements were made, such as keeping the bending radius within tolerance and isolation from the side ditch (completed at the end of October 2015) (see Table 1). Pressure hoses outside buildings and the dike will be replaced with PE pipes (completion scheduled for March 2017).

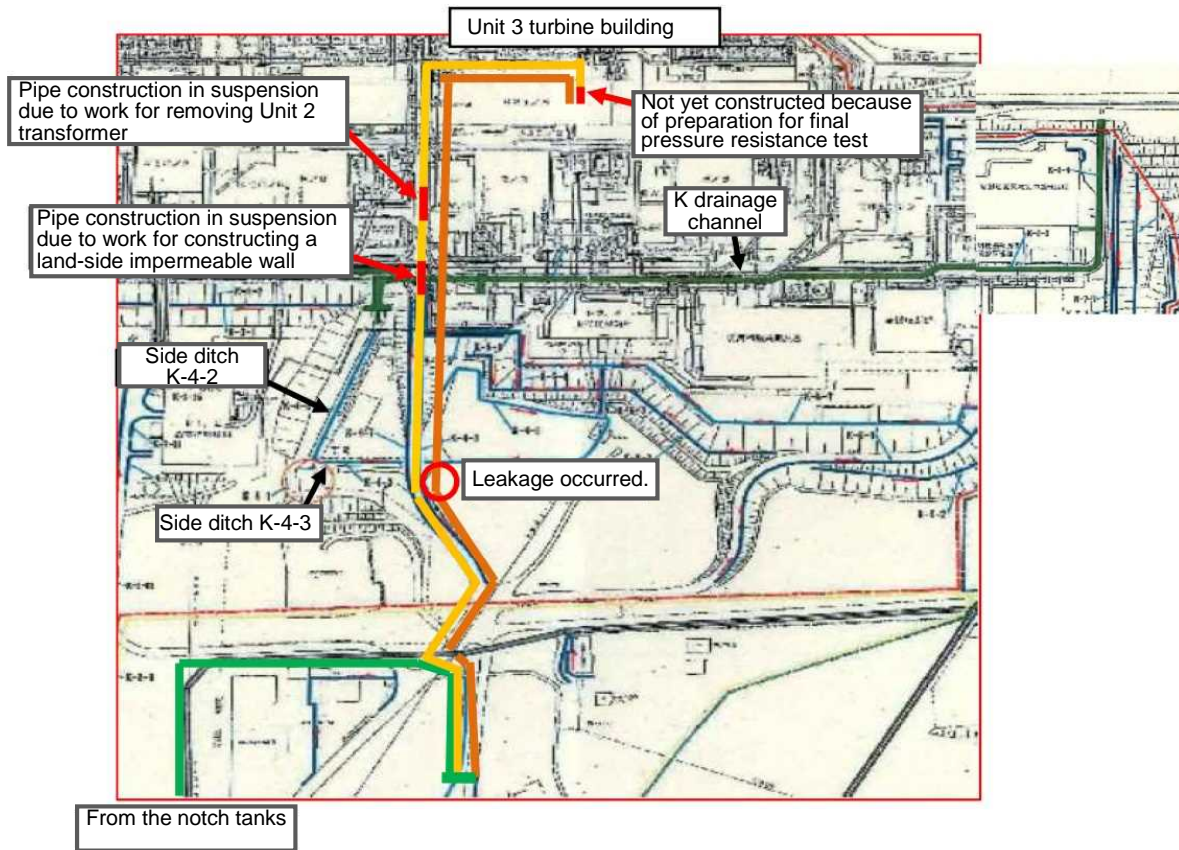
**Figure 6. Situation of constructing PE pipes as of May 2015
(Excerpt from the TEPCO report, with partial revision)**

In March 2014, work to replace the hose with a PE pipe started. However, because the hose work interfered with land-side impermeable wall installation work and Unit 2 transformer removal work, the hose laying work was suspended in October 2014. As the pipe installation work was not expected to be restarted, an acceptance inspection was carried out only on the already installed hose. Although the above-mentioned interference with other work was resolved in March 2015 and the hose replacement work was able to continue in April 2015, the replacement work

remained suspended (see Figure 6).

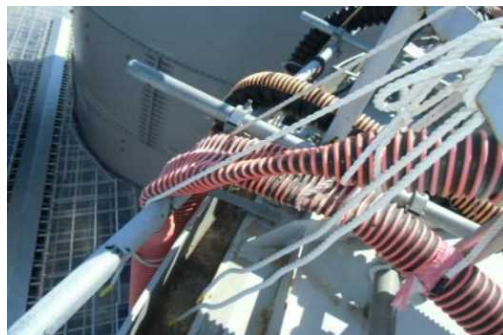
* 1. Bends in the hose at the upper part of tank were significantly deformed due to weight.

Inspection results of hoses for transferring high-concentration contaminated water outside of buildings and dikes found two unusable lines which were removed on July 21.

* 1. A bend section deformed due to weight
