Investigation and analysis of TEPCO's Fukushima Daiichi NPS Accidents (1/9)

NRA investigation and analysis of TEPCO's Fukushima Daiichi NPS accidents

Background to investigation and analysis of TEPCO's Fukushima Daiichi NPS accidents

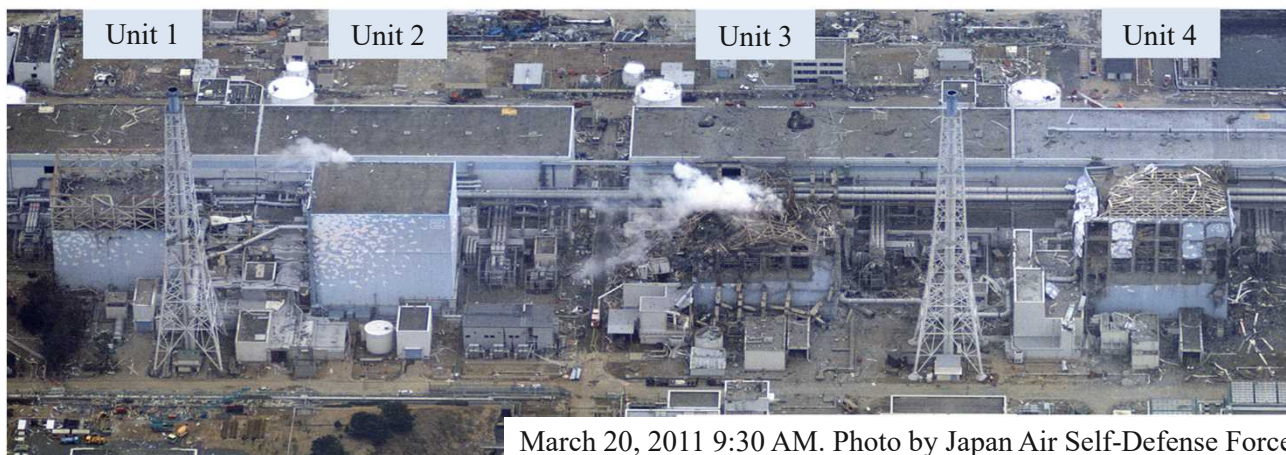
March 20, 2011 9:30 AM. Photo by Japan Air Self-Defense Force

- Units 1, 3, and 4: Hydrogen explosion damaged the reactor building and the top floor collapsed
- Units 1, 2, and 3 suffered damage to the reactor core and reactor pressure vessel, resulting in leakage from the primary containment vessel (PCV).

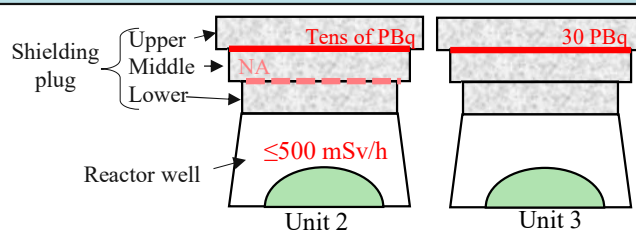
Figure 1. Estimation of contamination in the shielding plug in Unit 2 and Unit 3

The results of dose rate measurements on the operating floor and reactor well indicated that a radiation source existed in the gap between the shielding plugs. Based on the TEPCO's measurement results, the investigation team concluded that there were tens of PBq of Cs-137 in Unit 2 and about 30 PBq of Cs-137 in Unit 3 between the upper shielding plug and middle shielding plug.

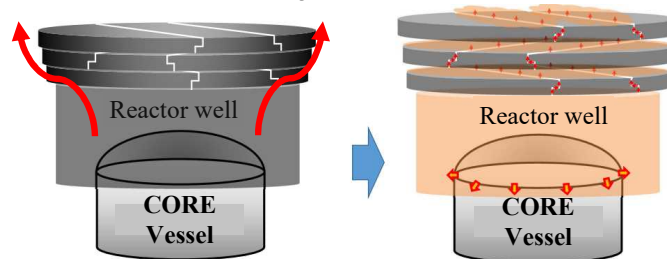
Figure 2: Cs-137 leakage routes

The results of the dose rate measurement on the top surface of the Unit 2 shielding plug confirmed that high doses at the joints of the shielding plug, which is divided into three parts, and at the intersection of the joints, suggesting that the joints of the shielding plug (rather than the outer edge of the shielding plug as previously thought) are likely to be the main leakage routes of Cs-137.

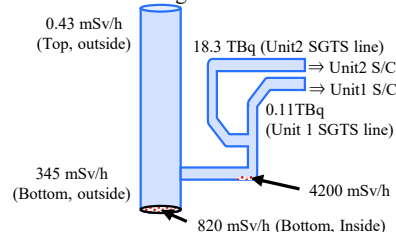
Figure 3. Contamination situation of No. 1, No. 2 shared-stacks and SGTS

The results of the SGTS pipeline dose rate measurements revealed the following situation:

- High levels of contamination at the bottom of the shared-stack.
- Unit 2 is more contaminated than Unit 1 SGTS pipeline, which was successfully vented.

The analysis of vapor flow reproduction using the RELAP code also suggested that Cs-137 migrates with vapor flow and that contamination accumulates when the vapor condenses.

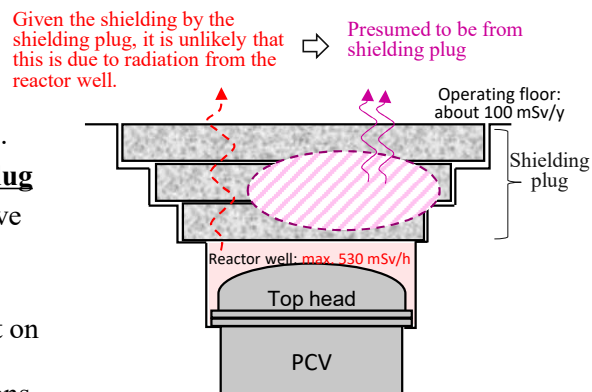
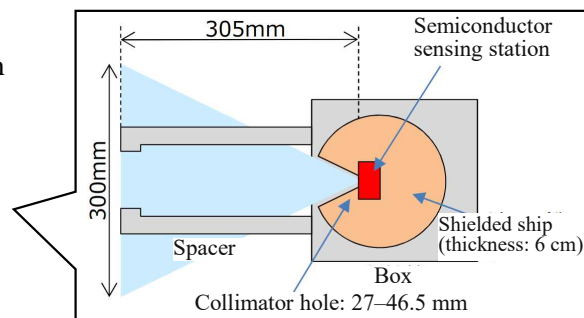
- Even after the decontamination of the operating floor, the air dose rate above the shielding plug did not decrease and remained higher than that on the surrounding floor (about 100 mSv/h).
- The maximum air dose rate in the reactor well was 530 mSv/h.
- The surface contamination density on the shielding plug was similar to that on the surrounding floor.

Therefore, it is presumed that there is a very strong dose at one of the locations inside the shielding plug.

- In November 2018, TEPCO measured the air dose rate at a height of 1.5 m from the floor (*2) and found it to be 79-148 mSv/h on the shielding plug. Based on the values, an evaluation was conducted using the gamma-ray calculation code (*3), and it was estimated that approximately 70 PBq of Cs-137 was present in the gap between the upper shielding plug and the middle shielding plug.
- Additionally, it was estimated to be more than 20-40 PBq based on the results of measurement by TEPCO using a detector with lead shielding at a height of 30.5 cm from the floor (right figure).

Based on the above, it is considered that tens of PBq of Cs-137 exists in the gap between the upper shielding plug and middle shielding plug.

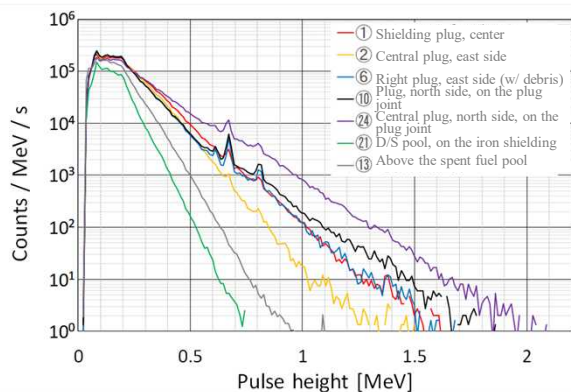
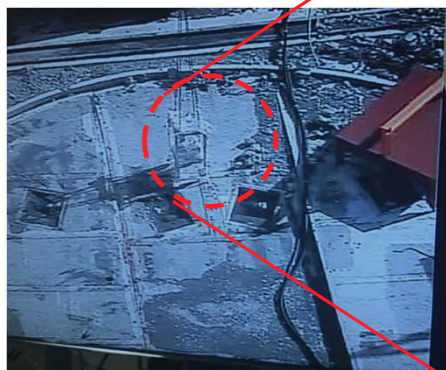
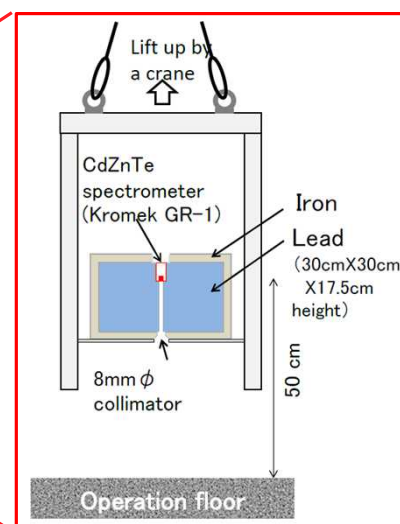
Measured on Unit 3 shielding plug by spectrometer with lead collimator hung by crane

The surface of the shielding plug of Unit 3 was eliminated by about 5 mm thick, and hence surface contamination is unlikely. Consequently, it seems that the total absorption peaks observed in this measurement with a sufficient collimator represent transmission lines from the lower part of the shielding plug. Based on this assumption, the contamination density of Cs-137 on the underside of the shielding plug was estimated to be 2.7×10^{10} Bq/cm² on average (equivalent to 31 PBq assuming a simple uniform distribution over the entire surface).

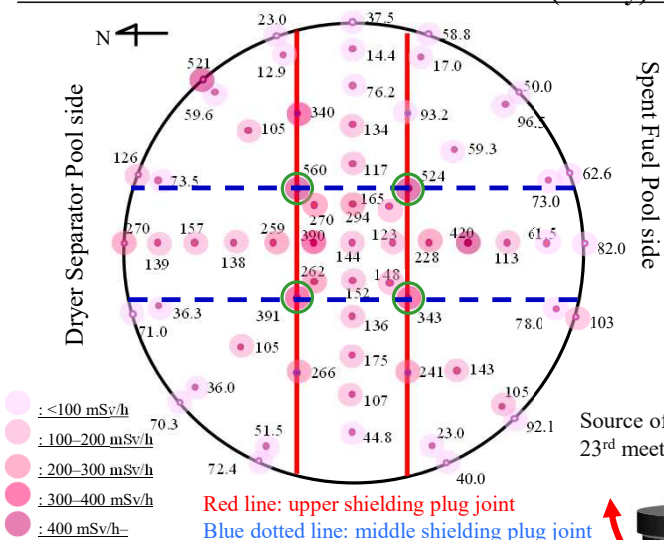
Measurement results of ambient dose rate (mSv/y) at 64 points

- The dose rates on the dividing line of the shielding plug (red line) and at the intersection of the dividing lines (green circle) are higher than those at the circumference, suggesting that the leakage routes of Cs-137 are not at the outer circumference of the shielding plug as previously assumed, but at the shielding plug joints.

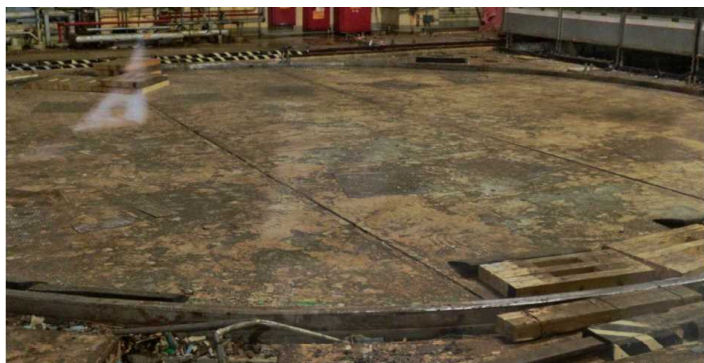
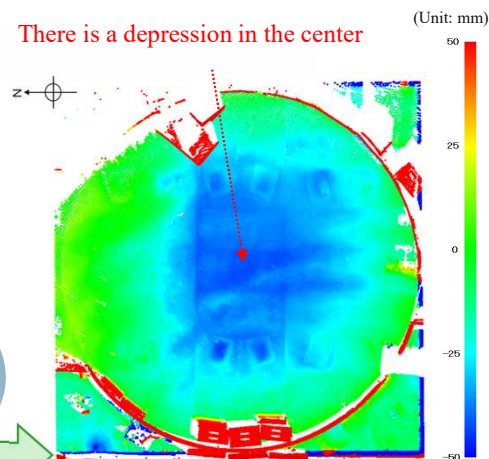
Unit 2 shielding plug

In December 2021, the NRA measured the shielding plug geometry using a 3D laser scanner in order to investigate the leakage routes and it turned out that the center of the shielding plug was dropped by 6cm in the most.

There is a depression in the center

- This deformation indicates that the dividing line of the shielding plug may be a Cs leakage route.

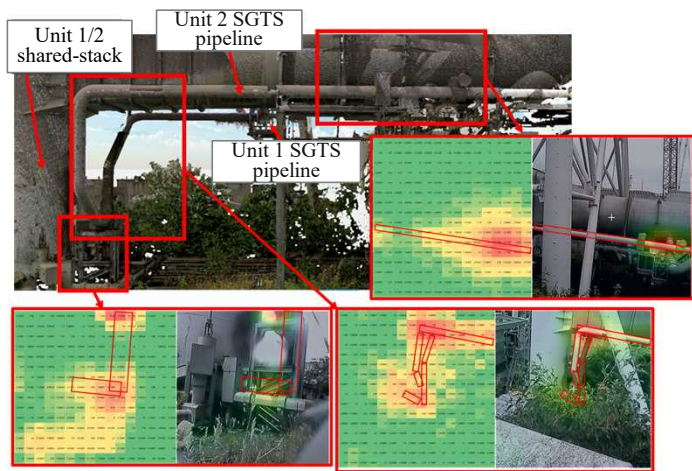
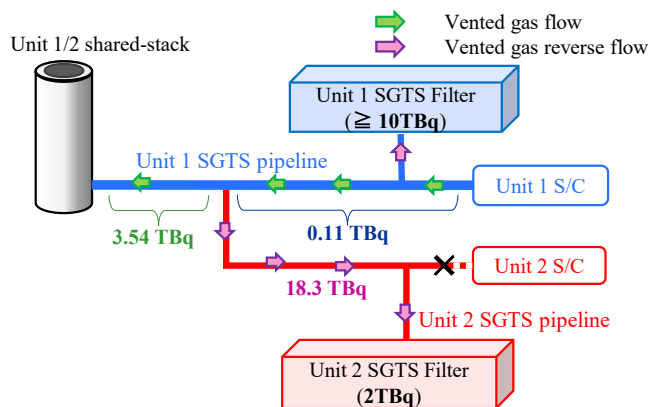
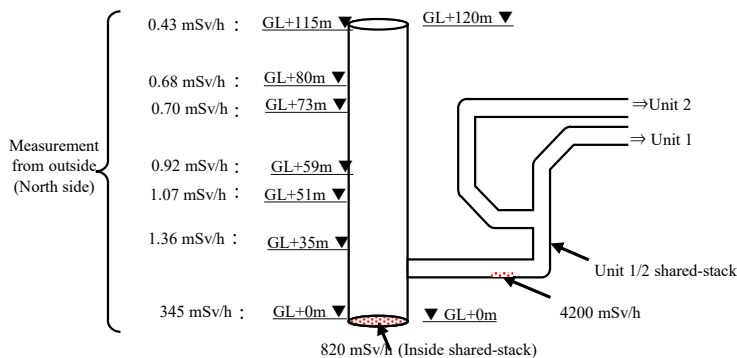
- ① The Unit 2 SGTS pipeline without successful PCV venting is more contaminated than the Unit 1 SGTS pipeline with successful PCV venting.
- ② The Unit 1 SGTS filter train is more contaminated than the Unit 2 SGTS filter train.
- ③ The contamination of the Unit 1/2 shared-stack is more severe at the bottom of the exhaust stacks.

Connecting portion to Unit 1/2 shared-stack
Data collected from the Secretariat of the Nuclear Regulation Authority on July 9, 2020

USGTS pipeline joint portion

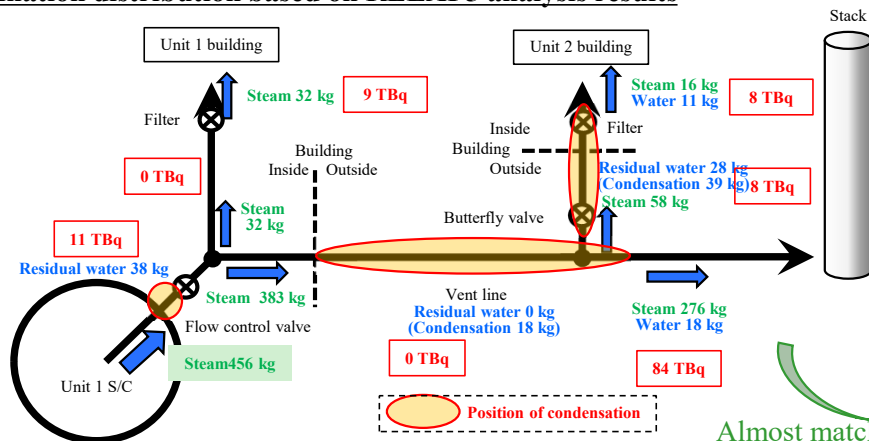
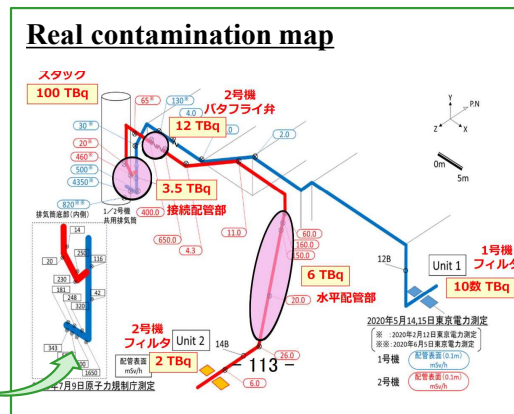
Contamination distribution based on RELAP5 analysis results

Almost match

- Backflow occurred at the gravity damper in the Unit 1 & 2 SGTS pipeline system, and Unit 1 PCV vent gas flowed back into each reactor building.
- Vapor condensation in the pipelines was suggested to be the primary cause of the contamination.
 - The residual location of the condensate coincided with the highly contaminated area (identified in the on-site investigation).

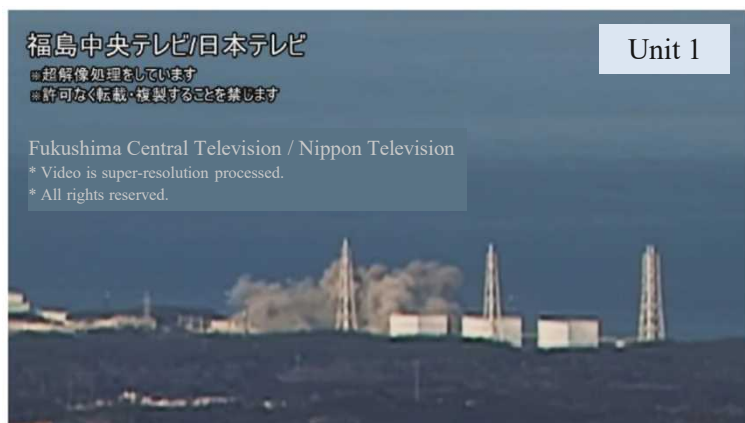
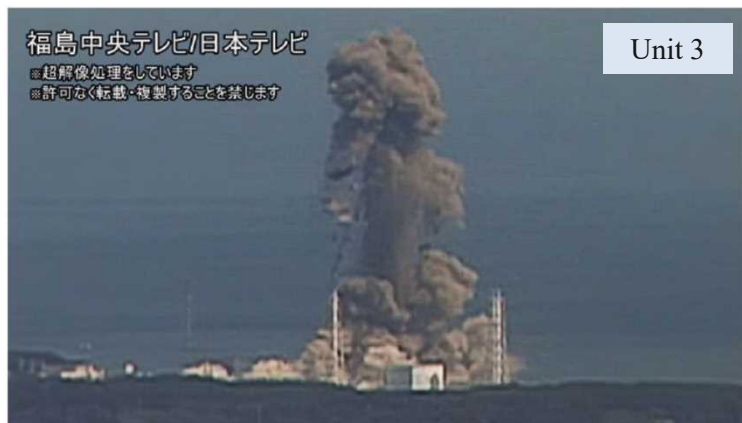
(1) Comparison of the videos of hydrogen explosion of Unit 1 & Unit 3

Analysis of (1) shows that in case of Unit 3, it is observed that fragments from Unit 3 building are lifted up with black plume not like in case of Unit 1.

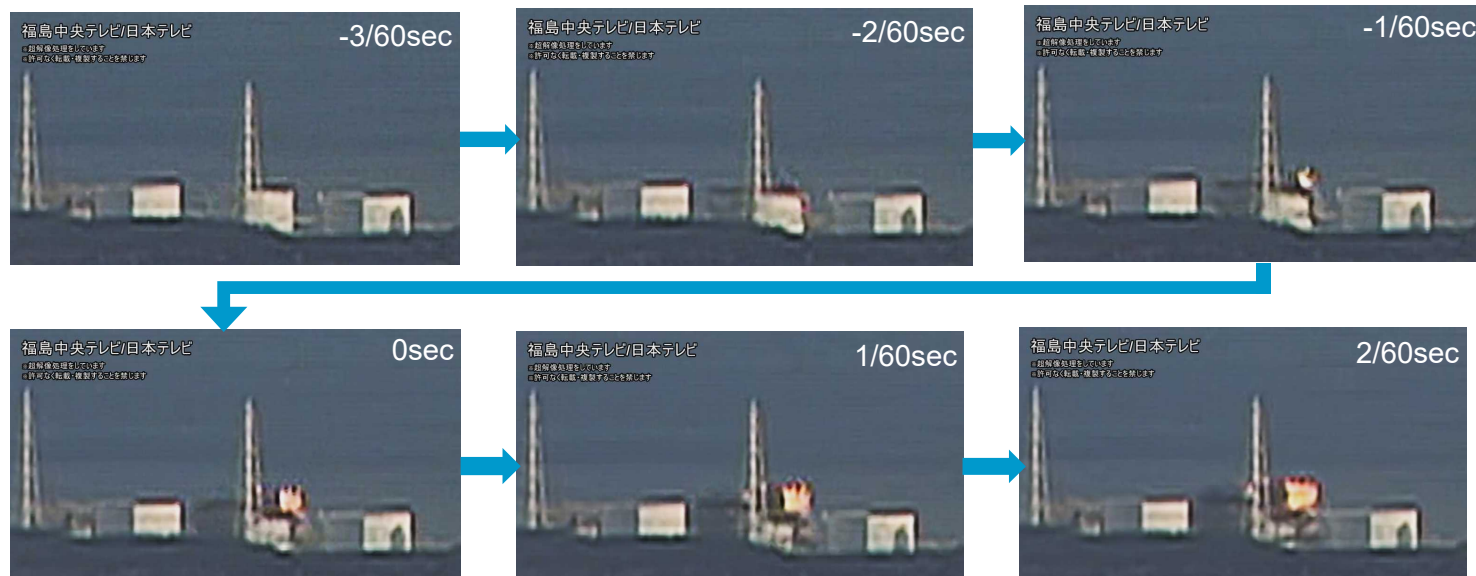
(2) Analysis of the video of hydrogen explosion of Unit 3 flame by flame

Analysis of (2) shows that the combustion of Unit 3 continued relatively long. Therefore, it is unlikely that the fragments is lifted up only by first explosion energy because such large explosion will extinguish the fire.

The series of fire in the picture (2) is orange, so it is possible that there are organic compounds in the gases reacted.

The rising black smoke in the Unit 3 reactor building may not have been caused by the impact of the explosion but by the rising air currents caused by the combustion of flammable gases.

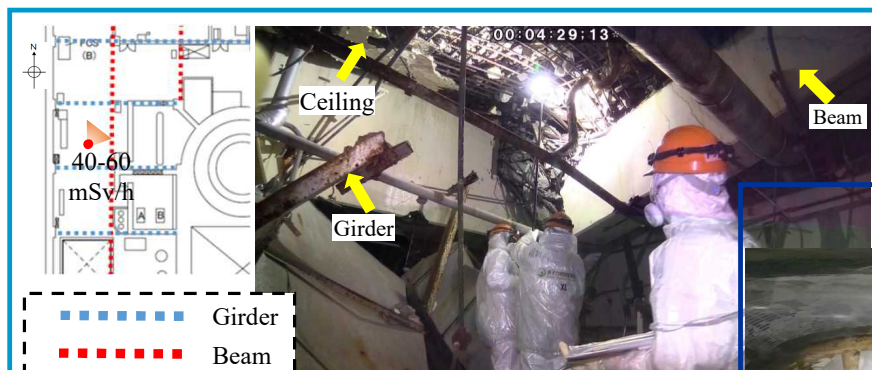
- The investigation team confirmed that some of the ceiling beams on the third floor of the Unit 3 reactor building were damaged. This suggests that the explosion occurred not only on operating floor (5th floor of the reactor building) but also on the 4th floor.
- The explosion at the time of the accident was not necessarily a detonation. However, even if it was a deflagration, it had enough energy to damage the reactor building.

Damage to ceiling beam on third floor of Unit 3 reactor building

The NRA decided to add hydrogen protection of the reactor building as an objective of PCV venting.
(At 38th FY2022 NRA, September 14, 2022)

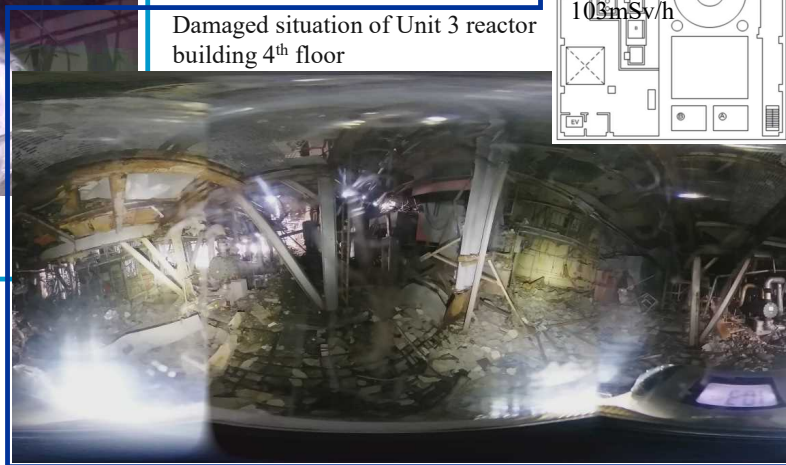
Damaged situation of Unit 3 reactor building 4th floor

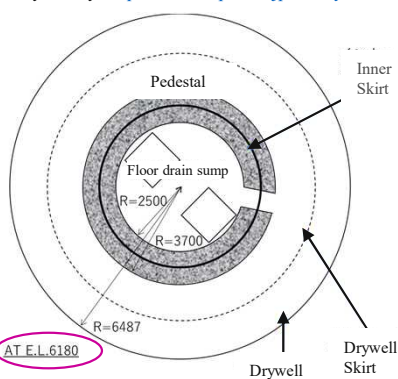
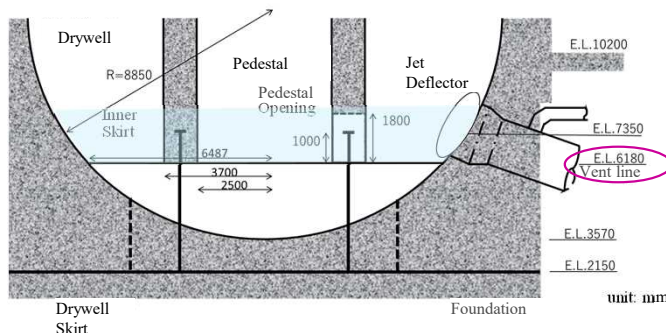
Damaged concrete of pedestal

1. Debris mound seems to exist near the pedestal opening. (not clear)
2. Loss of concrete at both sides of the opening. Rebars seems to be intact.
3. Concrete is lost only below the crust.
4. Lead net shield melted at a specific height.
5. Miscellaneous pipes are not affected severely.

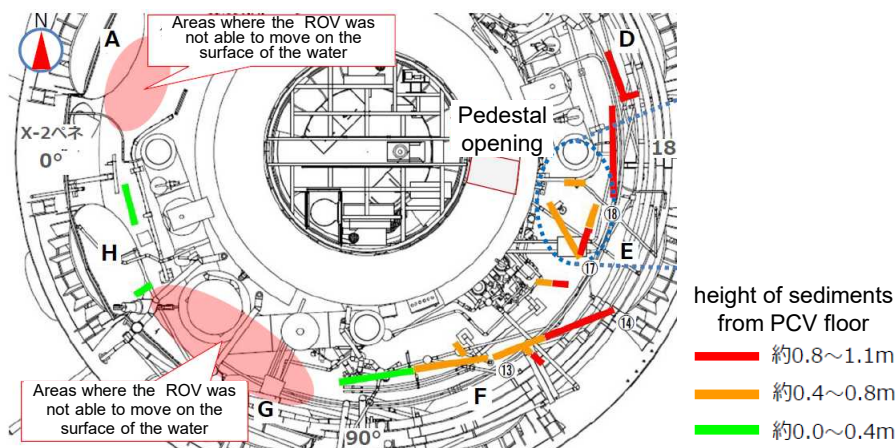
Crust (table-like sediments)

6. "Crust" exists from the area of opening to the other side.
7. "Crust" is the highest near the opening (~1.2m) and lowest at the other side (~0.3m).
8. "Crust" includes small bubbles. Its thickness is calculated around 3cm at a place.
9. Underside of the "Crust" seems to be smooth.
