Analysis of the TEPCO Fukushima Daiichi NPS Accident

Interim Report
(Provisional Translation)

October 2014

Nuclear Regulation Authority, Japan

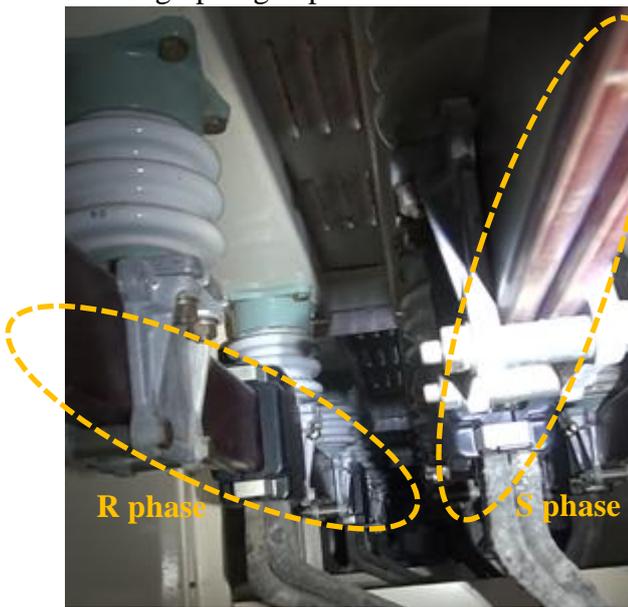
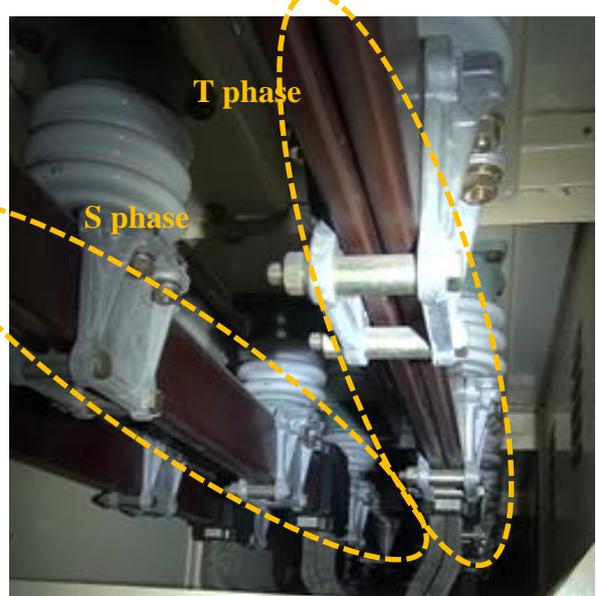
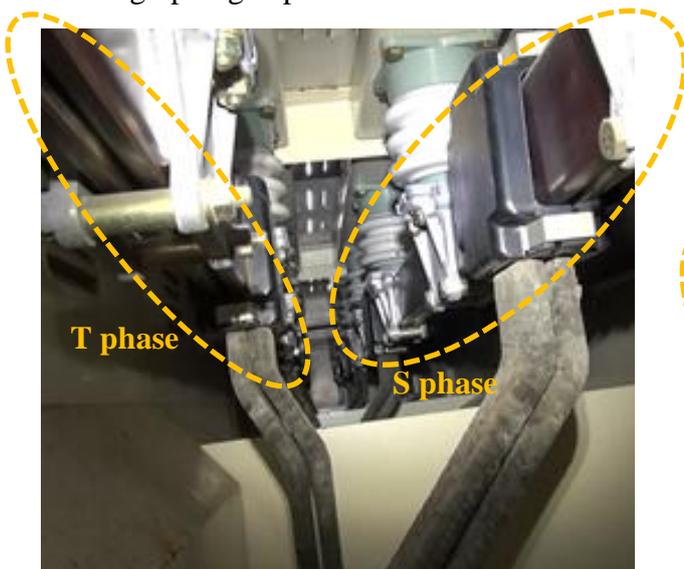
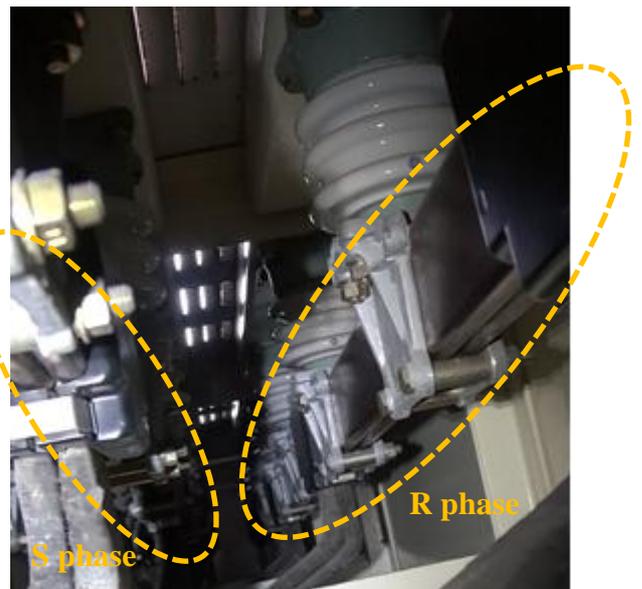
Figure 2.8 Buses and Bus-supporting Insulators inside M/C1C

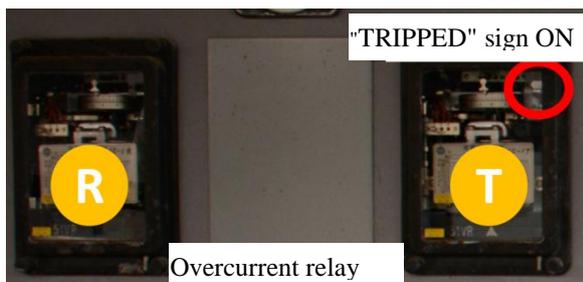
For Condition (g), overcurrent relays for the R and T phases (i.e. apparatus for detecting excessive current) were located near D/G1A side of the D/G1A power receiving circuit breaker ("1" in Fig. 2.11). In the site investigation, the NRA found no "TRIPPED" sign (indicating the relay had been tripped) on the R-phase overcurrent relay, but found one on the T-phase overcurrent relay (Fig. 2.12). However, the NRA estimated that the overcurrent relay did not actually trip, because this sign fell down and was improperly activated by the effects of the earthquake because M/C1C was not consequently damaged and with no short-circuiting or ground fault, based on the results of the analyses below (see 2)).²²

Figure 2.12 "TRIPPED" Sign of M/C1C Overcurrent Relay (Cabinet 1)

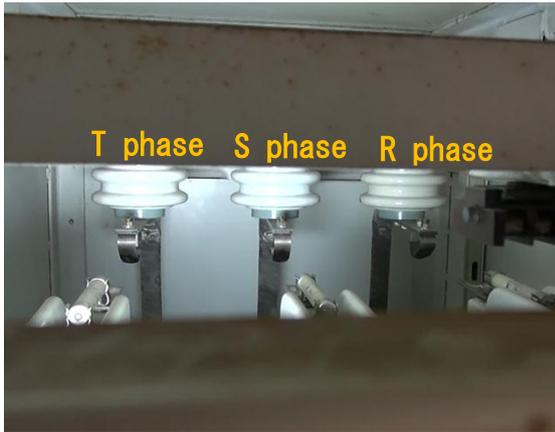
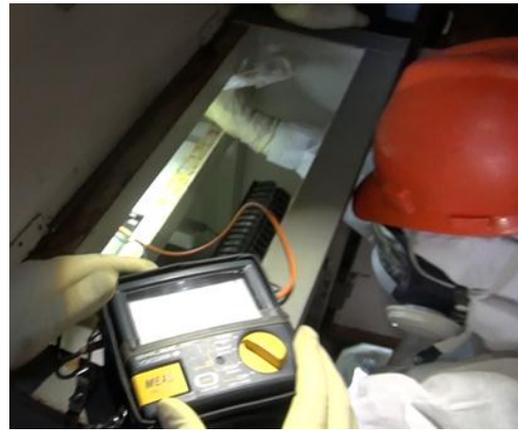
In the site investigation, the NRA measured the interphase insulating resistances of the R, S, and T phases of the buses to examine whether the bus in M/C1C was short-circuited or grounded by the effects of the earthquake.²³ The measured interphase insulating resistances were 2.8 MΩ between the R and S phases, 1.9 MΩ between the S and T phases, and 2.7 MΩ between the T and R phases²⁴ (Figs. 2.14 and 2.15). The NRA staff opened the M/C1C cabinet and visually investigated the condition of the bus. The NRA could not find any thermal or physical damage of buses and bus supporting insulators (Fig. 2.8). Judging from the above, the NRA estimated that the R, S, and T phases of the bus were completely insulated from each other without any electrical contact, and that

Insulating resistance measuring points on top of Cabinet 5

Figure 2.14 Insulating Resistance Measuring Points

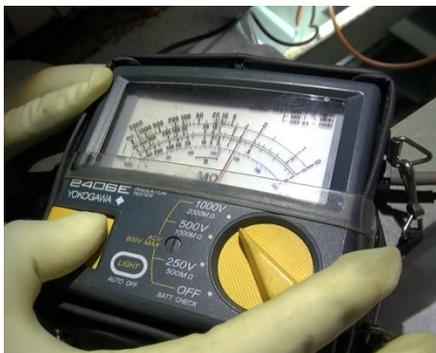
2.8 MΩ between R and S phases

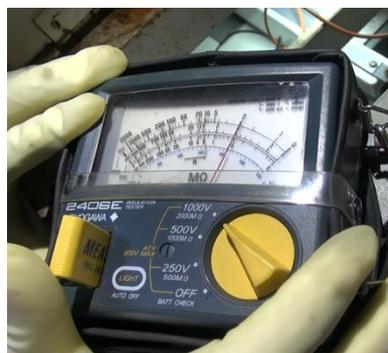
1.9 MΩ between S and T phases

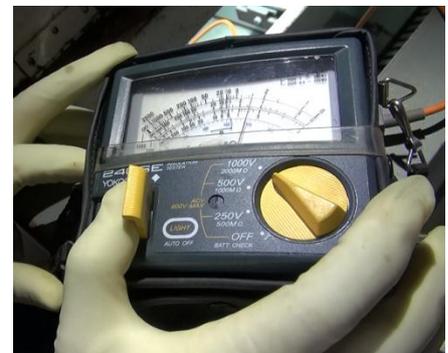
2.7 MΩ between T and R phases

Figure 2.15 Measured Interphase Insulating Resistances

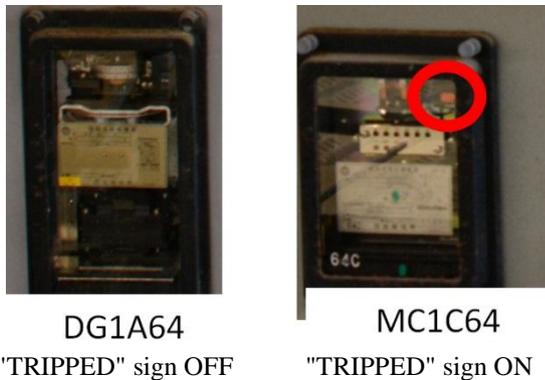
lost power supply to the bus and did not have ground fault overvoltage. Therefore, the NRA could not presume that only MC1C64 tripped. Judging from these findings, the NRA estimated that MC1C64 did not actually trip, and that the "TRIPPED" sign was turned on after being dropped due to the earthquake. Therefore, the NRA estimated that ground fault did not occur in M/C1C.

Figure 2.17 "TRIPPED" Sign of M/C1C Overvoltage Relay

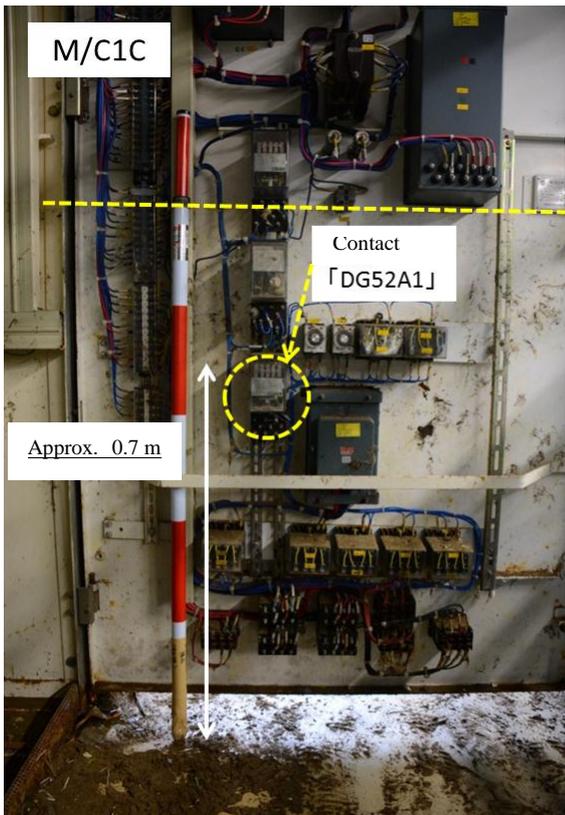
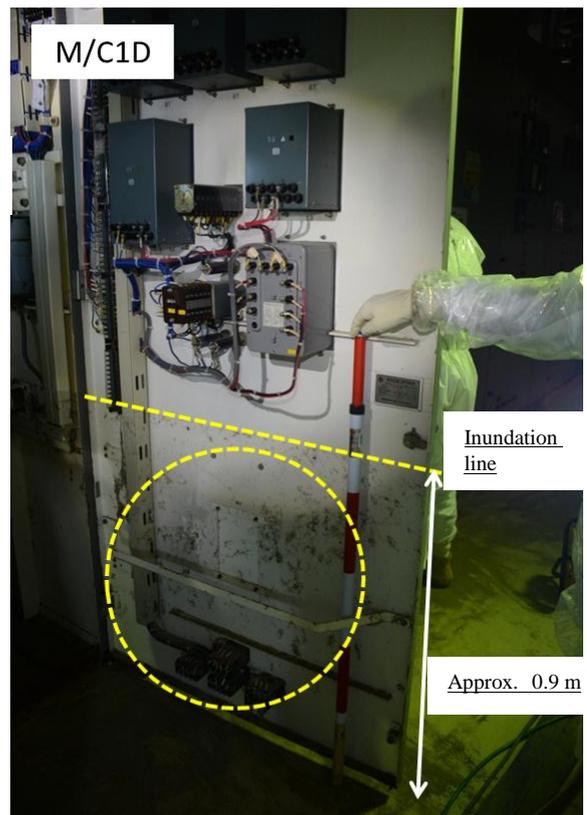
The contact "DG52A1" (1) is usually opened and no current flows, but when this contact is flooded by seawater, this contact is assumed to pass current through the seawater. In the site investigation, the NRA checked its location and the possibility of flooding. The contact of M/C1C was located at a height of about 0.7 meter behind the front door of M/C1C. The height of flooding relative to M/C1C was about 1.0 meter. Accordingly, the NRA estimated that the contact was completely submerged in seawater by tsunami (Fig. 2.19).

Figure 2.19 Location of Control Circuit in the D/G Power Receiving Circuit Breaker, and Inundation Height

heights of inundation differed to open their D/G power receiving circuit breakers. M/C1C had contacts located at a height of about 0.7 m behind the cabinet's front door, and lost its voltage when the contacts were flooded and the D/G1A power receiving circuit breaker opened (see (2) 3)). Conversely, M/C1D had similar contacts on the upper part of the cabinet (at 1.0 m or higher) (Fig. 2.19). Therefore, M/C1D did not trigger the D/G1B power receiving circuit breaker until the water level reached a height of about 0.9 m and submerged the bus of the closed circuit breaker.

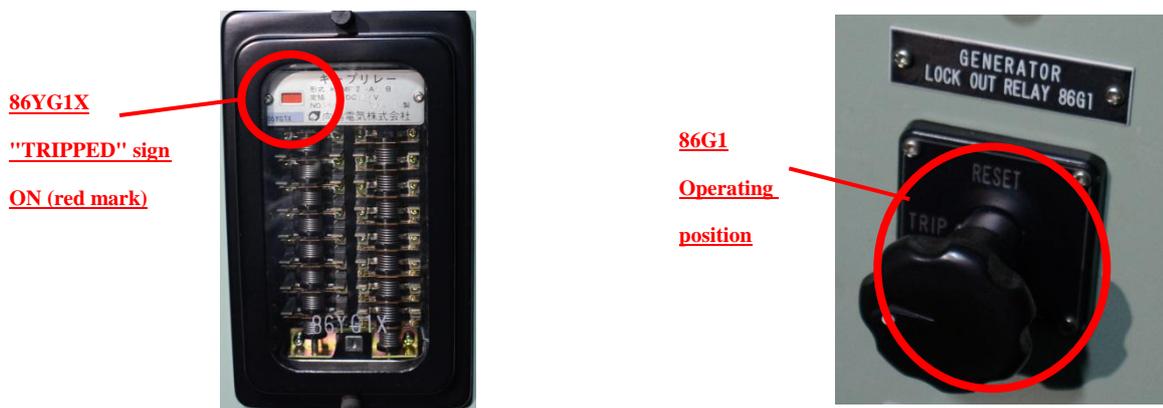
The contact "86YG1X" (2) was closed and passed current when a turbine trip signal was output in connection mode and activated the main generator lockout relay "86G1."^{26,27} In the site investigation for confirming the these relay' operational condition, the NRA confirmed this relay was activated and the contact indicated its "ON" sign (Fig. 2.20).

Figure 2.20 Main Generator Lockout Relay

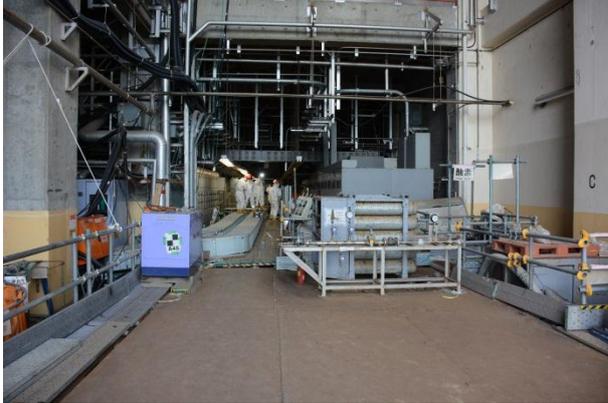
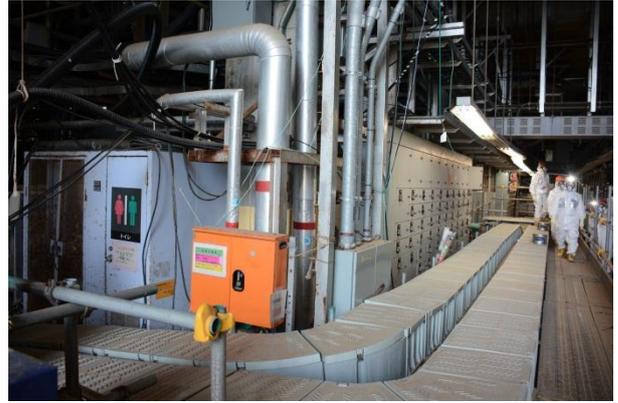
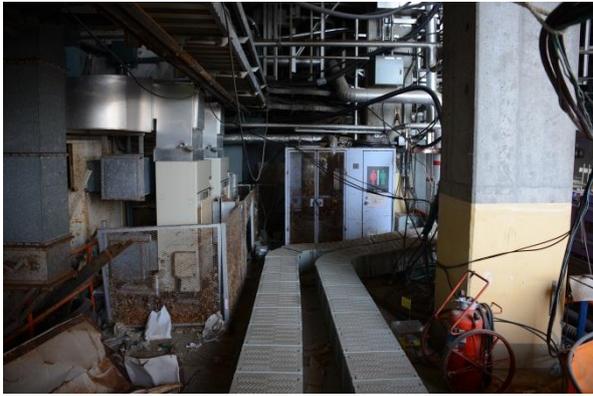
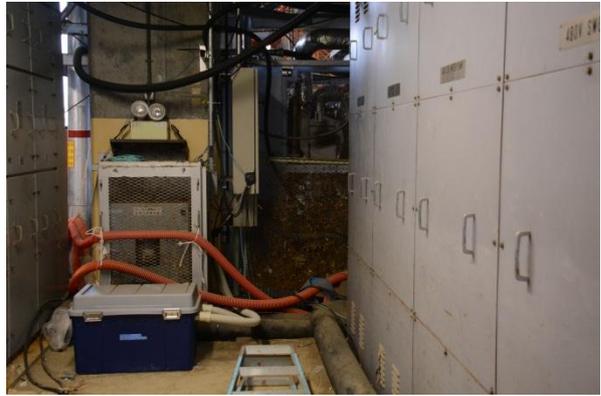
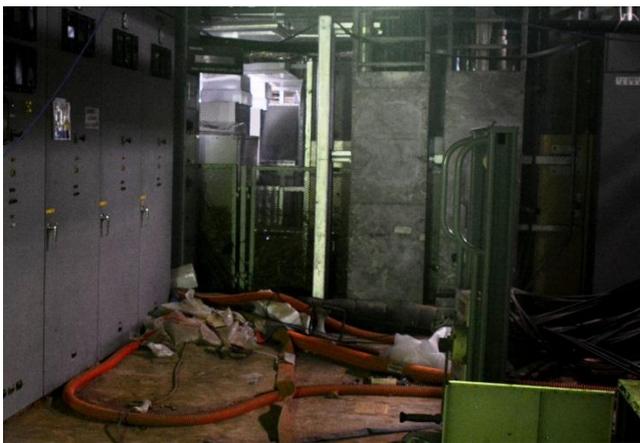
In the site investigation regarding the above, the NRA found that the cabinet referred to as M/C1D in the National Diet Investigation Commission Report was actually the normal-use MCC, and M/C1D was located behind this normal-use MCC (on its south side). M/C1D was located away from the large equipment service entrance through which the tsunami wave came in comparison with the M/C1C (Fig. 2.21). In addition, M/C1D was protected on its east side by certain structures (e.g., lavatory) and equipment against direct flooding coming through the large equipment service entrance (photos 1 to 5). And in the site investigation, the NRA also checked the heights of inundation. The inundation height of M/C1C and M/C1D were approx. 1.0 m and 0.9 m, respectively. From the above findings, the NRA estimated that the tsunami entered through the large equipment service entrance and struck M/C1C first, detoured around the normal-use MCC, and then reached M/C1D.

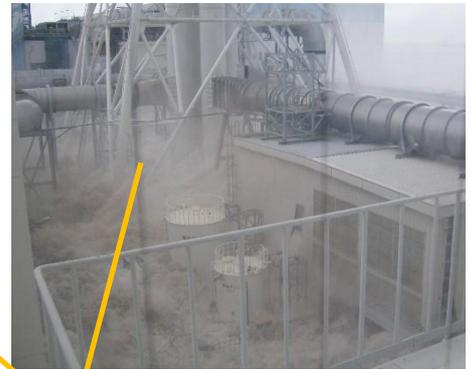
Photo 3 (Tsunami 2-2 caused large-scale flooding on the premises (height: O.P.+ 10 m).)

tsunami struck the coastal area near the site at roughly at the same time (without much time lag). Accordingly, the NRA estimated that the height of the Unit 1 turbine building (O.P. + 10 m) was as high as the main stack of the turbine building's ventilation system, with the premises also being flooded at about the same time when Photo 3 was taken (15:36:24 to 15:36:41)³⁹

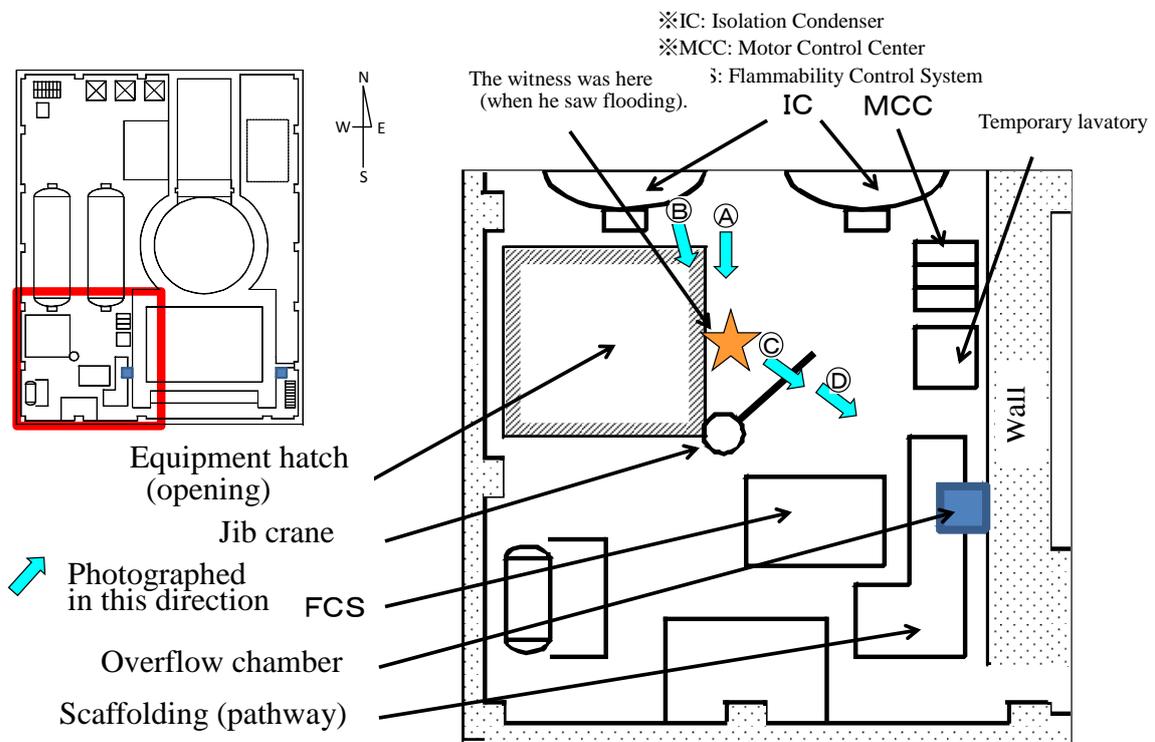
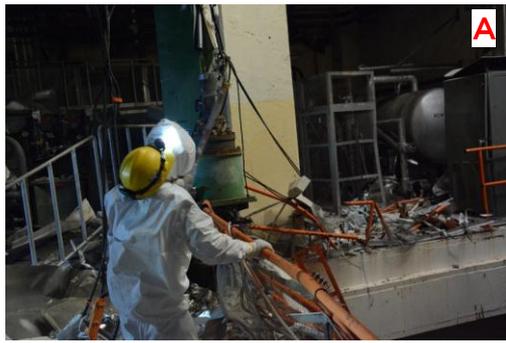
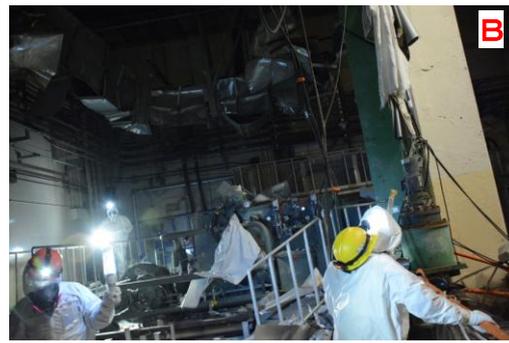
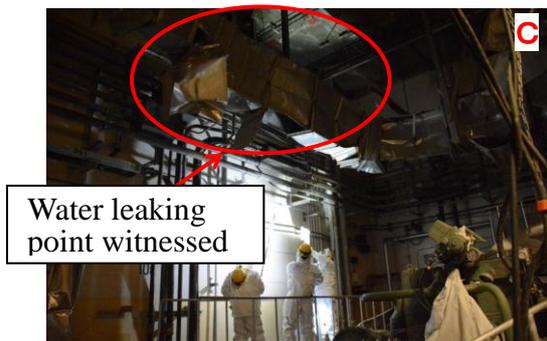
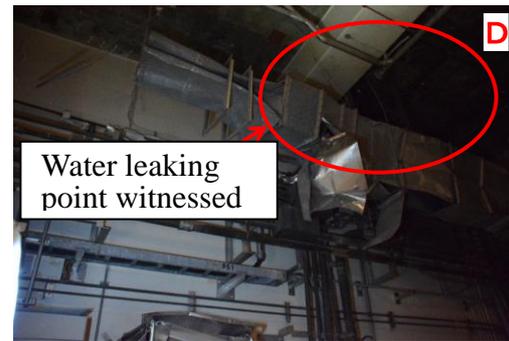
Figure 3.2 Standing Position of Witness when Water Leak came out

As for Issue 1) above, based on the interview, the NRA confirmed the position of the witnesses and the equipment position that could see from the witness's position in the site investigation. As a result, the NRA could identify that witness was standing on the east side (marked "star" in Fig. 3.2) of the equipment hatch (opening) from the positional relationship between the opening, guardrail at the opening and jib crane. Moreover, the NRA estimated that the water leaking point was the vicinity of the overflow chamber above the FCS.

As for the positional relationship between the witness's standing position and the equipment, the NRA confirmed that the actual layout of equipment was almost same the equipment seen by the witness just before and at the time of water leak (i.e. Equipment seen by witnesses just before the water leak: Opening and jib crane; Equipment seen by witnesses at the time of water leak: FCS and pipes above the FCS).

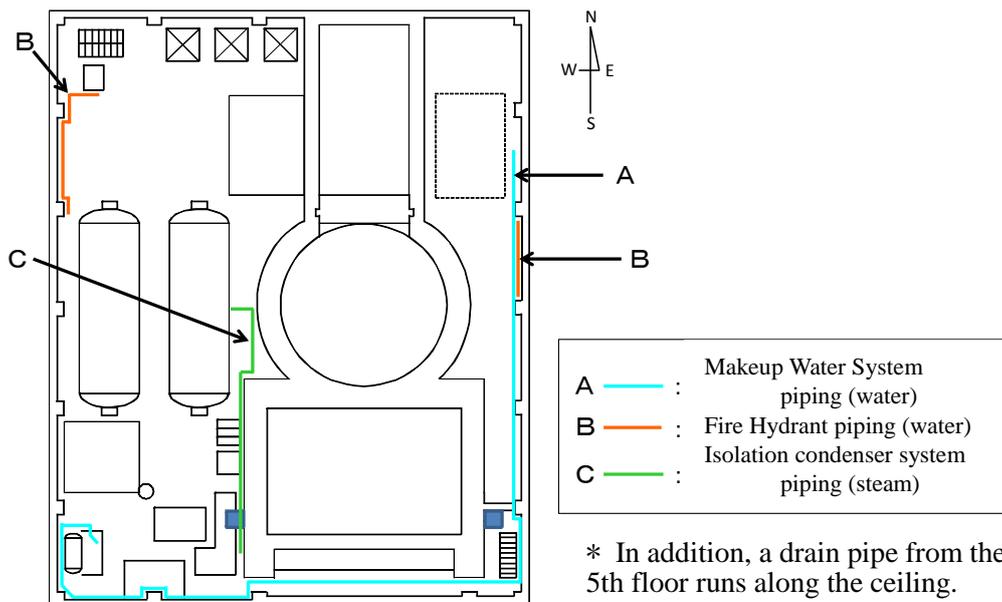
Figure 3.4 Water and Steam Pipes installed on the 4th Floor of the Reactor Building of Unit 1

- Function: Pipe used to feed water to the Standby Liquid Control System (SLC) tank and other equipment
- Location: Running along the south and east walls from the vicinity of the southwest wall (Fig. 3.4)
- Result of assessment: The NRA estimated that this equipment could not be a water leaking point as it is located far from the witnessed water leaking point.

- Function: Pipe used for supplying water to the fire hydrant system
- Location: Located near the northwest wall and east wall (2 places) (Fig. 3.4)
- Result of assessment: The NRA estimated that this equipment could not be a water leaking point as it is located far from the witnessed water leaking point.

- Location: Running from the IC in the west, located near the PCV, and on the west wall of the SFP (Fig. 3.4)
- Result of assessment: The NRA estimated that this equipment could not be a water leaking point although located near the witnessed water leaking point, as this steam discharge pipe never spouts water.

- Location: Running from the floor drain funnel in the cask decontamination area on the 5th floor of the reactor building of Unit 1 to the ceiling near the west wall of the SFP (south of the 4th floor), where water leak was witnessed.

- Result of assessment: TEPCO stated that when the main shock of the earthquake occurred, no decontamination work was done and the floor of the cask decontamination area containing equipment and materials was covered with plastic sheets. However, the NRA estimated that overflowing water due to the sloshing of water in the SFP could possibly flood the 5th floor of the reactor building of Unit 1, and enter the drain pipe through the floor drain funnel. In such case, it is the possibility that the drain pipe from the 5th floor might run the water. The NRA's site investigation found no pipe damage or breaks in this drain pipe. Therefore, the NRA estimated that this drain pipe could not be a water leaking point.

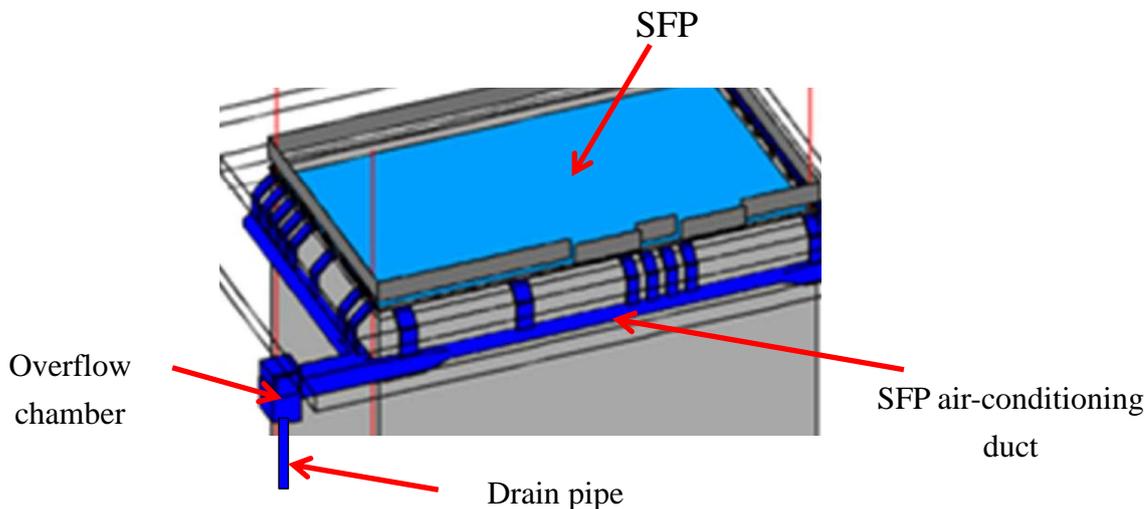
Figure 3.5 Location of the SFP, SFP duct, and Overflow Chamber (image diagram)

- Function: The SFP of Unit 1 was equipped with a ventilation port (air inlet port) 20 cm above the regular SFP water level on a concrete wall. The ventilation port was connected to the ventilation & air-conditioning duct provided near the ceiling of the 4th floor of the reactor building of Unit 1 via an air-conditioning duct (hereinafter, "SFP air-conditioning duct") embedded in the concrete wall to guide steam containing traces of radioactive gas from the SFP to the main stack via the ventilation & air-conditioning system. In addition, the bottom of the overflow chamber was made lower than that of the SFP air-conditioning duct, so as to receive drain water and then discharge it to a drain pipe connected to the lower part of the chamber. (Fig. 3.5)

- Result of assessment: The NRA estimated that water in the SFP possibly overflowed and then flowed into the overflow chamber through a duct inlet provided on the side of the SFP, due to the sloshing caused when the earthquake occurred. This overflowing water apparently caused the water leaking point.

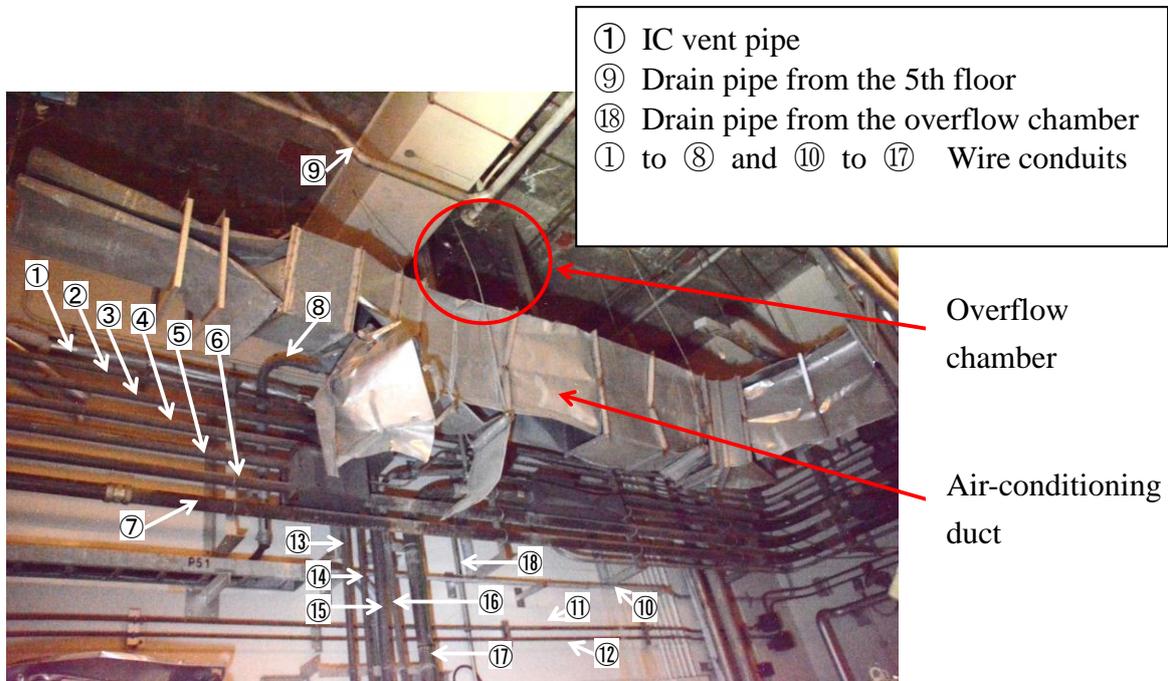
Figure 3.6 Pipe Layout near a Location where Water was seen coming out

chamber were also designed to allow the possible flow of water. However, the NRA estimated that these drain pipes cannot be a water leaking point, as the NRA found no damage or breaks on those pipes in the site investigation.

The NRA therefore estimated that only the "overflow chamber" could have water leaked.

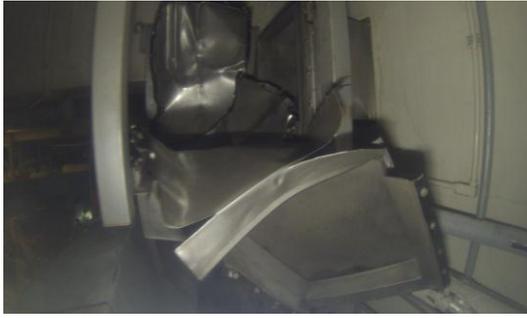
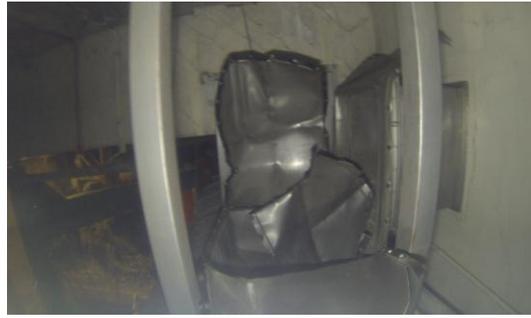
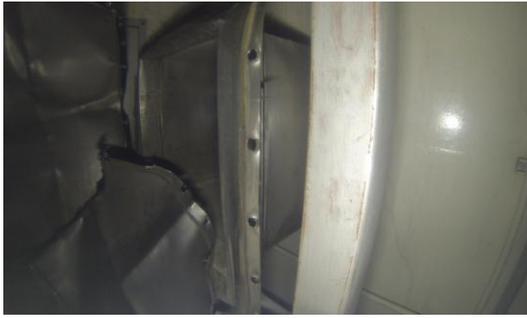
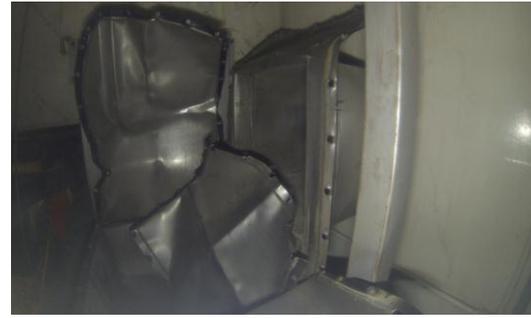
Figure 3.8 Views of Overflow Chamber Surfaces (1)

- The upper portion of the overflow chamber was blown off, as if subject to an internal explosion.
- As far as the site investigation, all bolts of the upper portion were gone. (Nuts and bolts are typically used to couple the overflow chamber to the duct embedded in the concrete wall of the SFP. (Fig. 3.8))

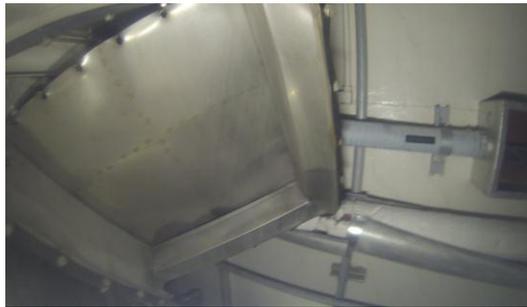
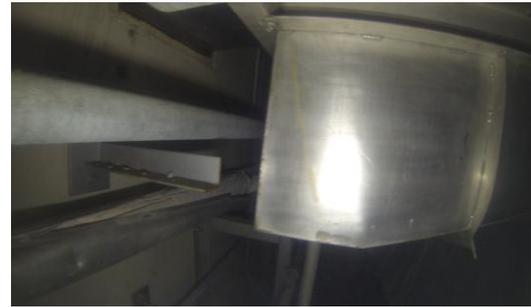
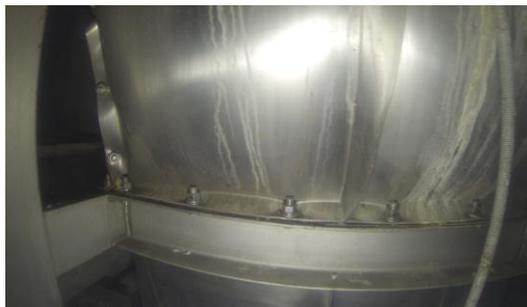
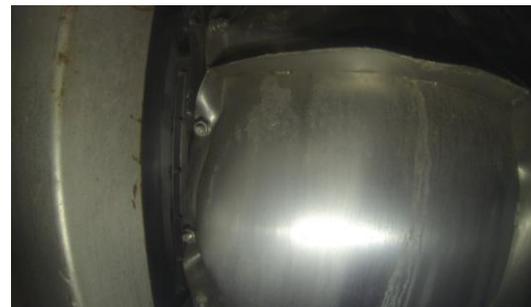
Figure 3.9 Views of Overflow Chamber Surfaces (2)

- The NRA could find no fractured bolts, but found traces of an internal explosion on parts at the side and bottom portions left clinging to the overflow chamber. (Fig. 3.9)

The NRA estimated the gas explosion, not by water pressure, caused the overflow chamber to break (as confirmed in the site investigation), based on the above findings. In other words, the hydrogen explosion that occurred in the reactor building on March 12, 2011 is assumed to be this gas explosion.

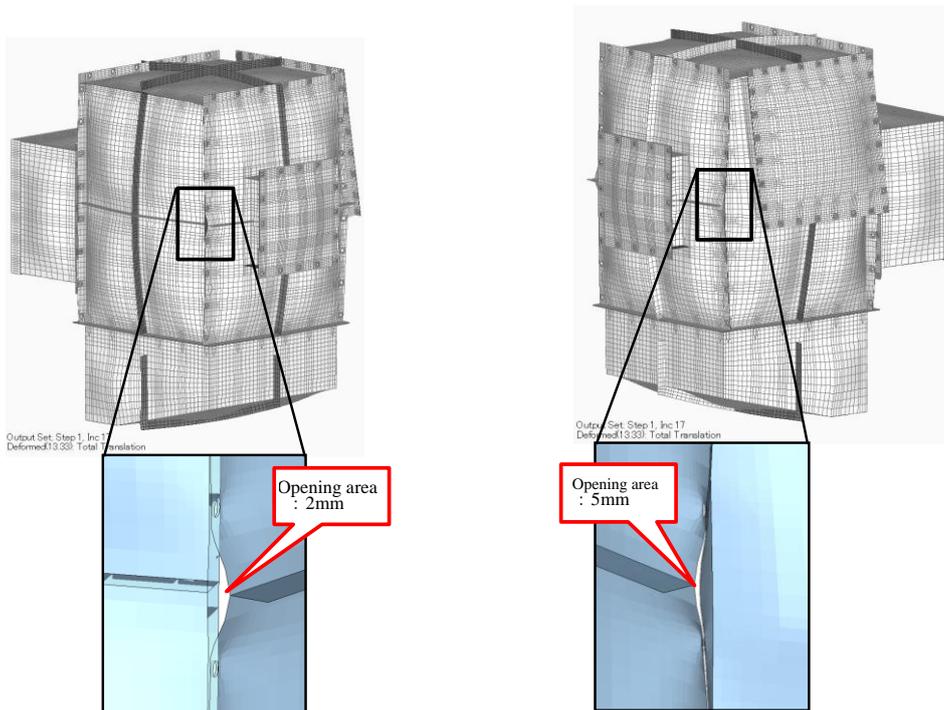
Figure 3.17 Analysis of Overflow Chamber Deformation (example: at 43.2 s (at peak pressure))

The NRA evaluated the overflow chamber deformation caused by the pressure of water ("hydrodynamic pressure" including earthquake force) that flooded from the SFP due to sloshing. From this evaluation, the NRA estimated that some panel joints of the overflow chamber were possibly broken about 40 seconds after the main shock began, followed by water spouting through the gap.

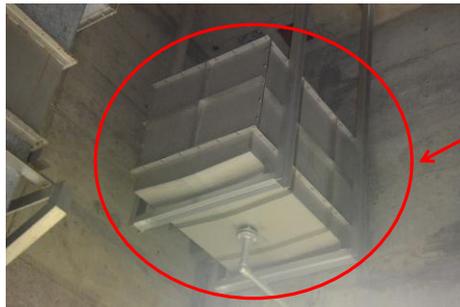
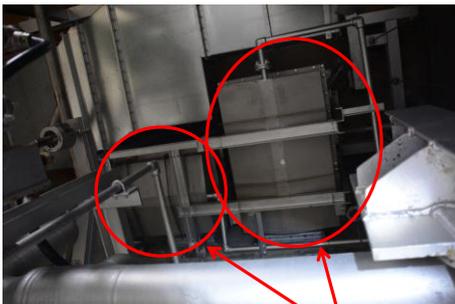
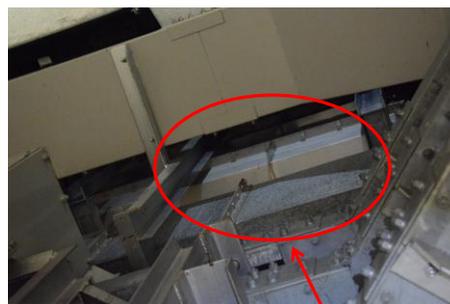
Figure 3.19 Situation of the Overflow Chambers of Unit 6

- As three of the four Unit 6 overflow chambers were located perpendicularly to the longitudinal side of the SFP duct, an earthquake's swaying direction might differ from the direction of water flooding into the chambers. Therefore, if SFP water overflowed due to sloshing, the water pressure applied to overflow chambers in Unit 6 is assumed to be less than that applied to Unit 1's.

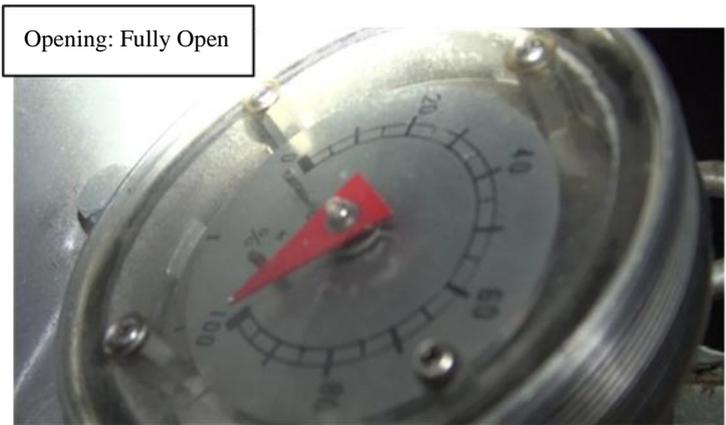
<IC system "A" (2A) opening meter>

Opening: Fully Open

Photographed by the NRA on May 31, 2013.

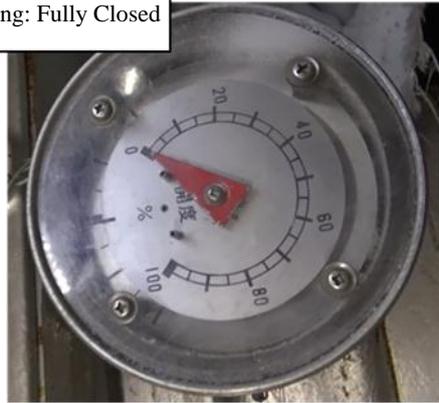
<IC system "B" (2B) opening meter>

The NRA confirmed that the isolation valve (2B) outside the PCV in the IC system “B”, driven by the DC power supply, was "Fully Closed" in the site investigation (see Fig. 5.6).

Opening: Fully Closed

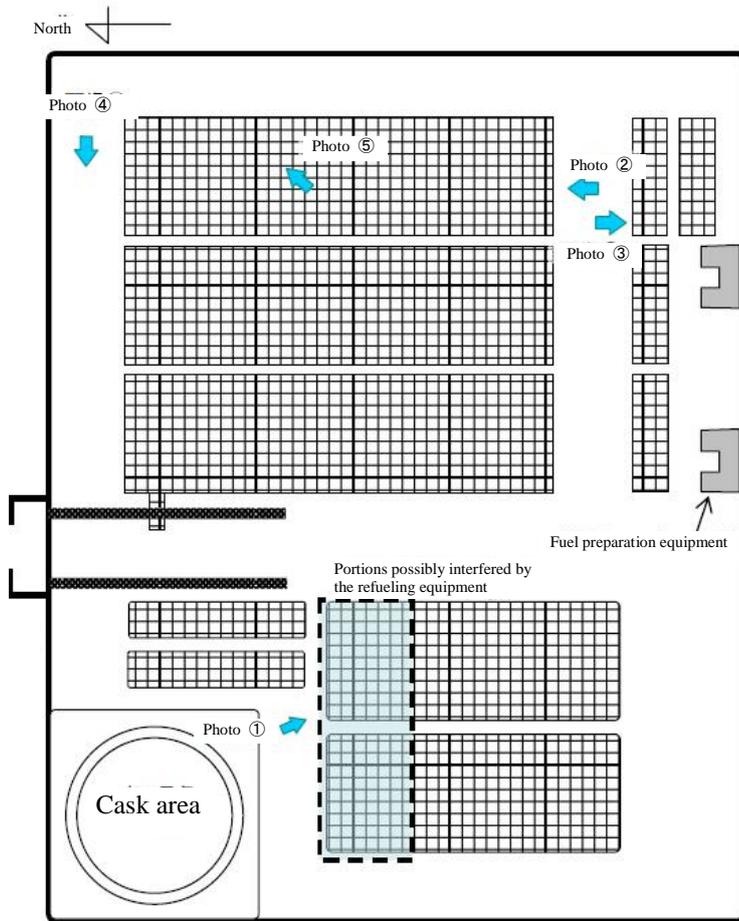
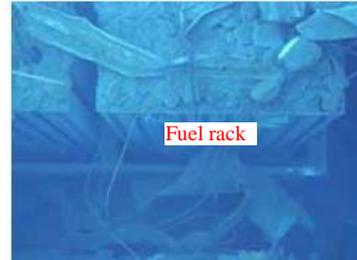
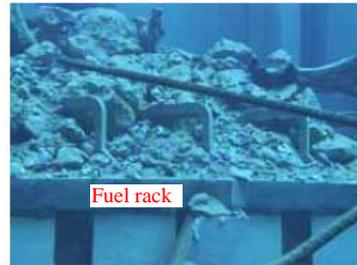
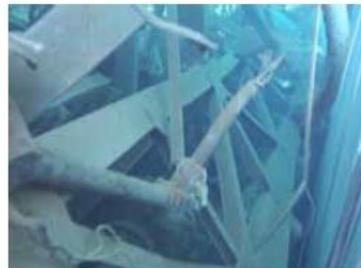
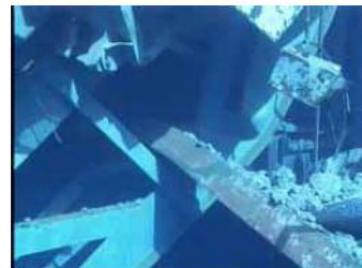
Figure 6.1 Inside Views in the SFP of Unit 3

In the underwater photos taken by TEPCO (in Fig. 6.1) in the SFP of Unit 3 (after the National Diet Investigation Commission report was disclosed), the NRA confirmed concrete, steel frame and other debris, but no significant damage to the fuel storage racks and the peripheries of the fuel assemblies. And in the underwater video images that were disclosed together with the photos, the NRA cannot confirm any significant damage to the fuel storage racks and fuel assemblies.

Photo① View of the lower part of the refueling equipment and the fuel storage racks

Photo② View of the fuel storage racks (photographed from above)

Photo③ Deposits on the fuel storage racks

Photo④ View of the refueling equipment corridor

Photo⑤ Refueling equipment bridge

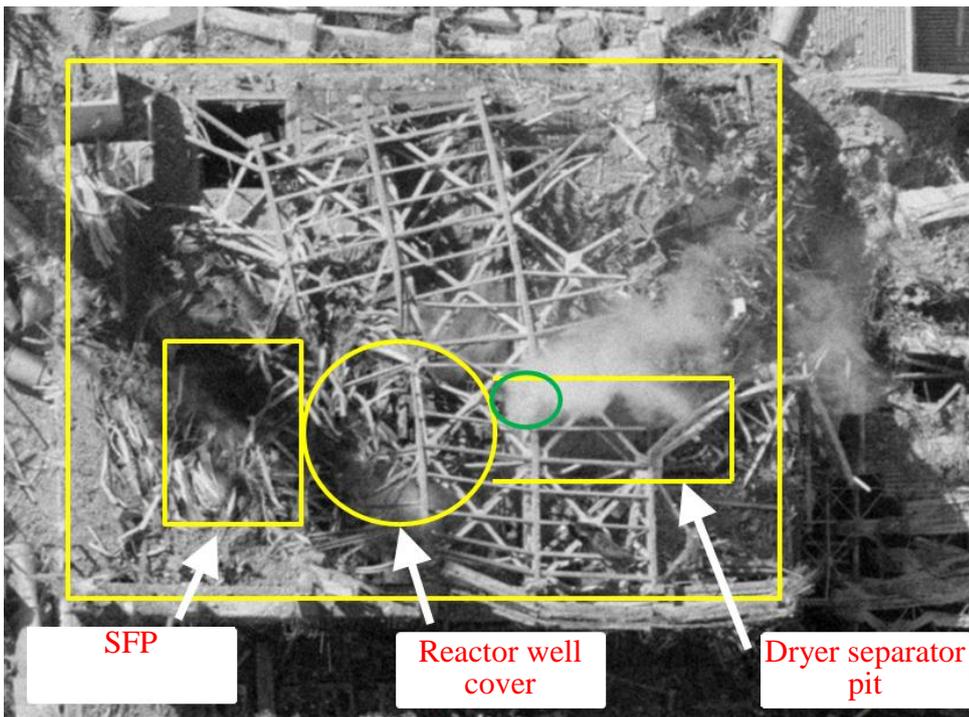
Figure 6.2 Location of White Steam rising from the Reactor Building of Unit 3

The NRA estimated the location of the white smoke from above the reactor building, by precisely overlapping a simplified 5th floor plan of the reactor building of Unit 3 on the smoke-showing aerial photos taken by the Ministry of Defense (see Fig. 6.2). Through such image overlapping, the NRA estimated roughly location of the white smoke shown in the photo quoted by the National Diet Investigation Commission (in Fig. 6.3) came from the adjacent area of the dryer separator pit and reactor well cover, where opposite side to the SFP across the reactor.

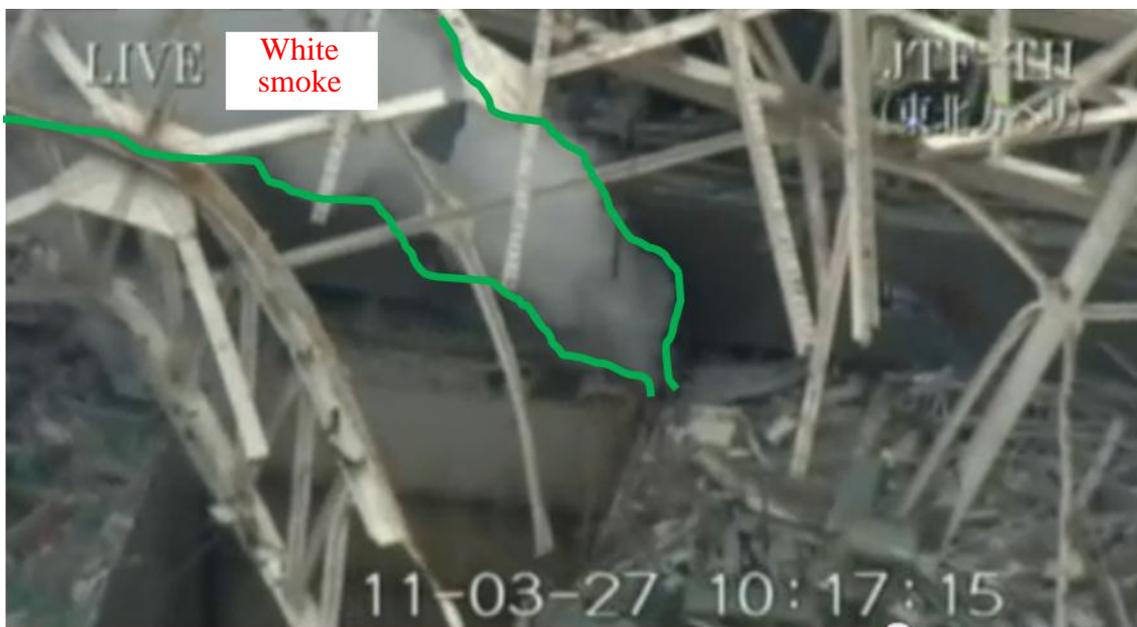
Figure 6.4 White Smoke rising from the Reactor Building of Unit 3 (site 2)

The NRA also confirmed from another image (in Fig. 6.4) taken by the Ministry of Defense that showed white smoke coming from the adjacent area of the dryer separator pit and reactor well cover, where opposite side to the SFP across the reactor.

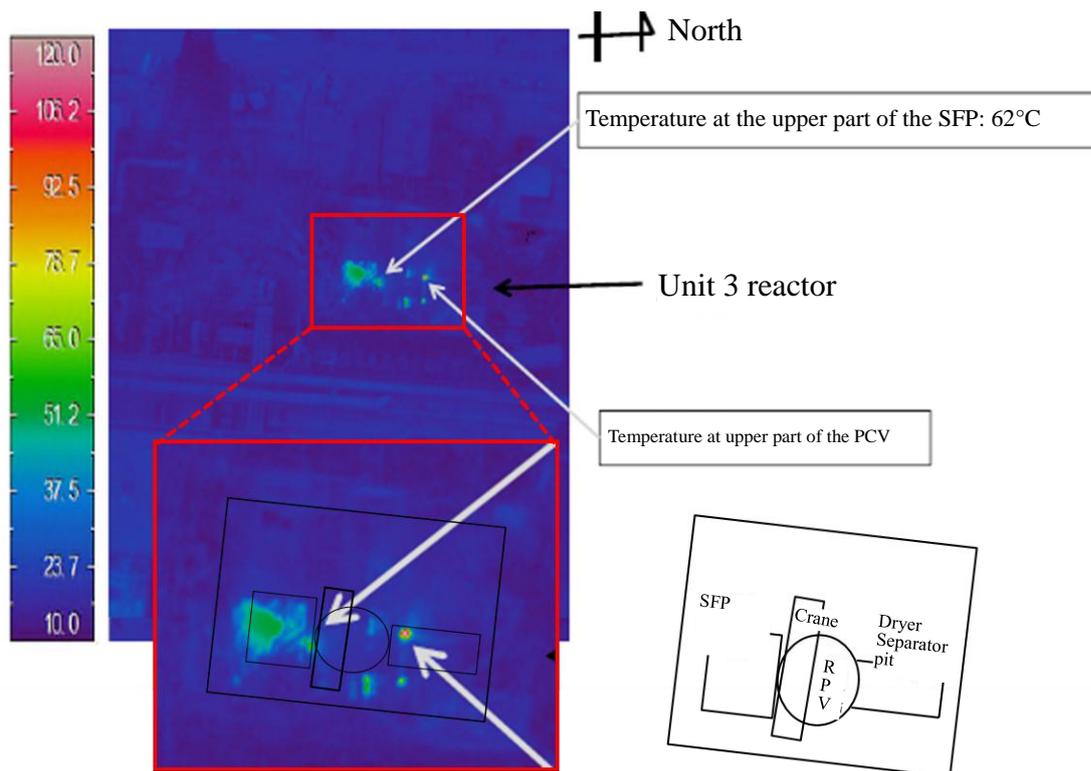
Figure 6.5 Measurement Results of Temperature Distribution in the Reactor Building of Unit 3

By overlapping a simplified floor plan of the 5th floor in Unit 3 with a thermal image made by the Ministry of Defense on March 20, 2011, the NRA confirmed that the temperature of the SFP was about 60°C, which is not so high as to cause white smoke (i.e., plenty of steam). In contrast, the adjacent area of the dryer separator pit and reactor well cover, where opposite side to the SFP across the reactor, was over 100°C, which showed possibility that the white smoke (plenty of steam) generated (see Fig. 6.5).

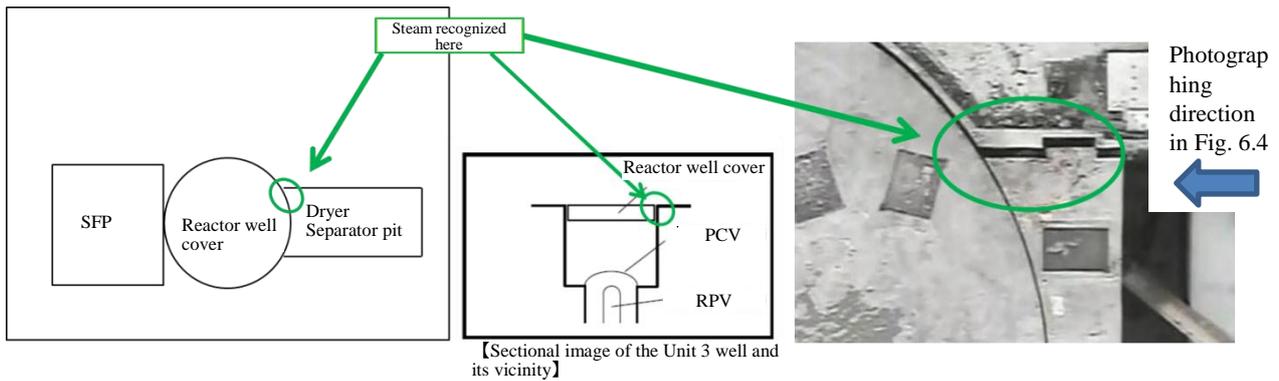
Figure 6.6 Equipment Layout on the Top of the Reactor Building of Unit 3

From Items 1) and 2), the NRA estimated that the white smoke came from the adjacent area of the dryer separator pit and reactor well cover, where opposite side to the SFP across the reactor (see Fig. 6.6).

The NRA can hardly presume that the white smoke (steam) came from such a location even if the SFP generated white smoke. In case the SFP was not a smoke generation source, the NRA estimated that the possible cause of heat generation was the steam coming from inside the reactor through sealed portions deteriorated by heat or the water hosed out from fire engine heated at the outside walls of the PCV. Note that no rain was confirmed.

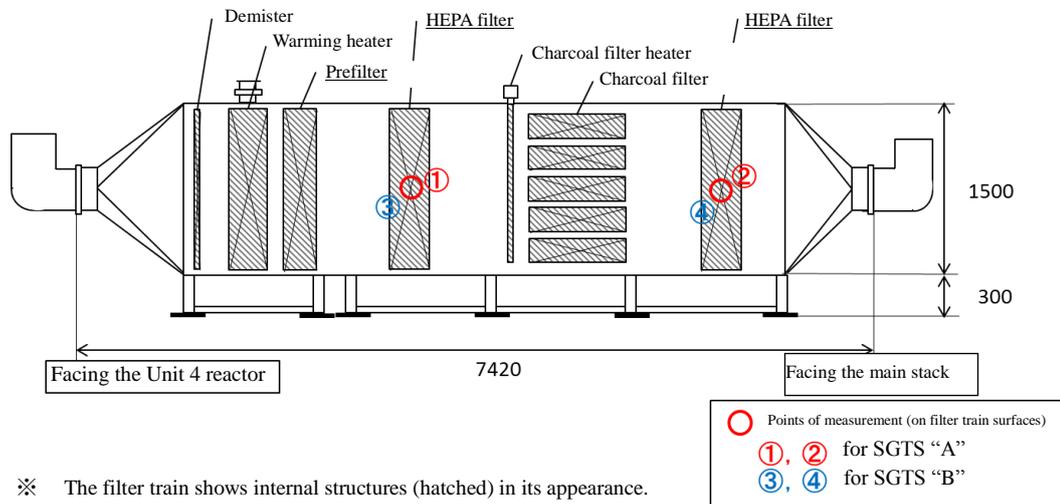
Figure 7.3 Structure of the SGTS Filter Train

To examine this possibility of hydrogen gas backflow from Unit 3, NRA measured the radiation levels of the SGTS filter trains in Unit 4 that consisted of multiple filters to remove radioactive materials, in consideration of TEPCO's site investigation problems noted above⁷⁵(see Fig. 7.3).

Upstream side (facing the Unit 4 reactor building)	Downstream side (facing the main stack)
System "A"	16.7 $\mu\text{Sv/h}$ (Fig. 7.3①)	1500 $\mu\text{Sv/h}$ (Fig. 7.3②)
System "B"	38.0 $\mu\text{Sv/h}$ (Fig. 7.3③)	1220 $\mu\text{Sv/h}$ (Fig. 7.3④)

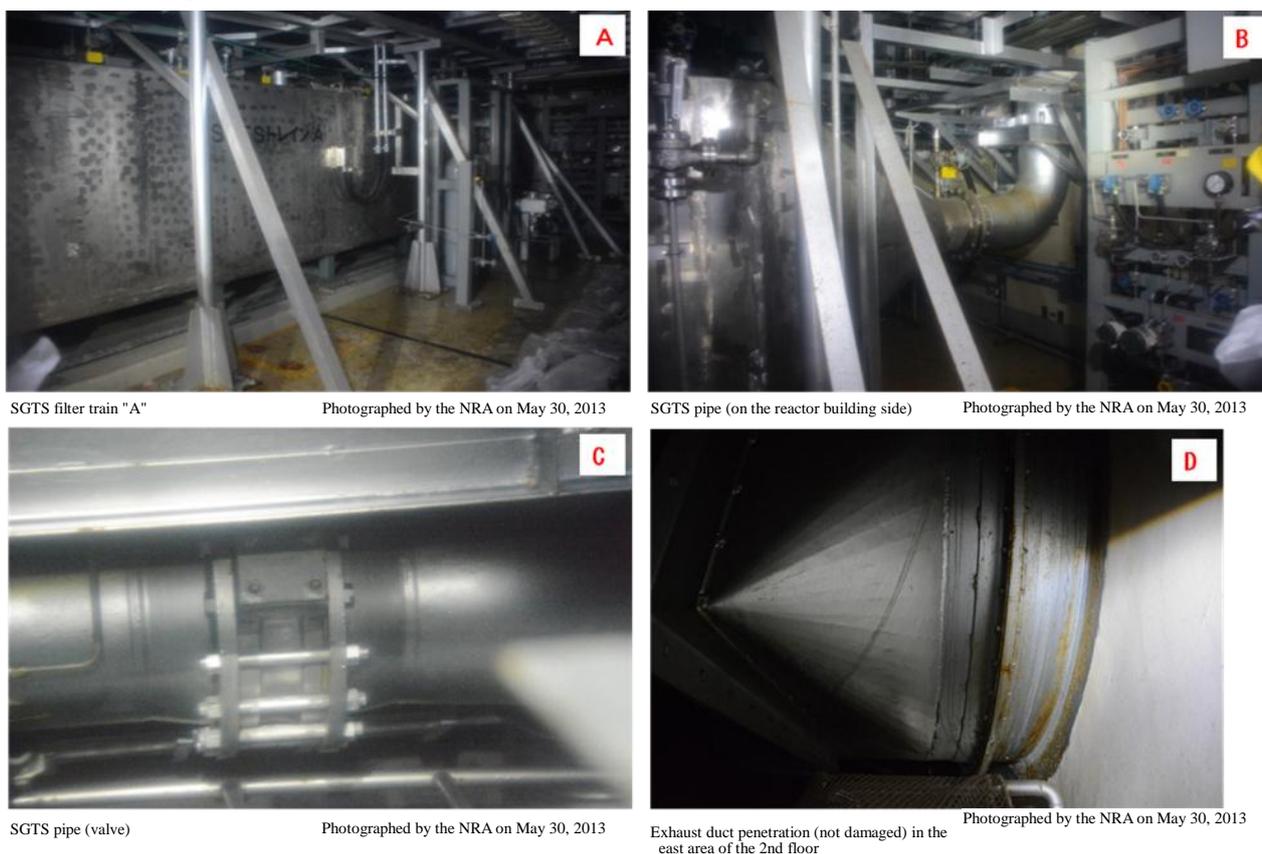
Figure 7.6 Situations of SGTS Filter Trains, Pipes, and Exhaust Duct Penetrations

- No remarkable damage was confirmed in the appearance of the SGTS pipes and filter trains of Unit 4 (see Figs. 7.6 and 7.7).
- As for exhaust ducts running upstairs and downstairs in the east part of the 2nd floor of the reactor building of Unit 4, the NRA confirmed slight damage on the exhaust duct running downstairs to the 1st floor, but severe damage on the exhaust duct running upstairs to the 3rd floor (see Fig. 7.8). The NRA estimated that hydrogen gas flowed upstairs through the exhaust ducts, accumulated there, and then exploded.
