Analysis of the TEPCO Fukushima Daiichi NPS Accident

Interim Report
(Provisional Translation)

October 2014

Nuclear Regulation Authority, Japan

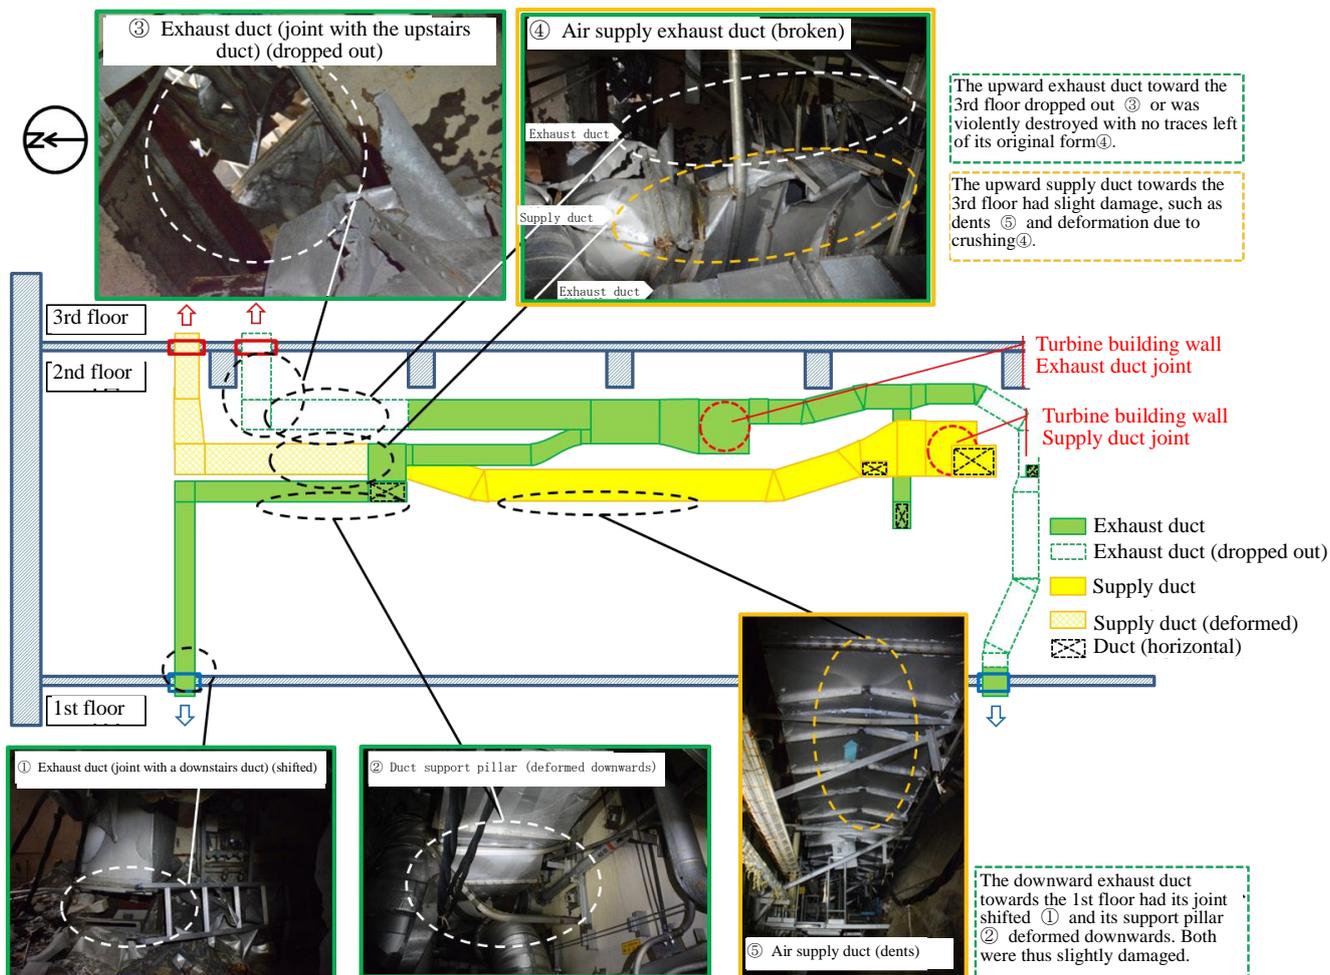
Figure 7.8 Traces of Damages on the Exhaust and Supply Ducts in the East Area of the 2nd floor of the Reactor Building

- No remarkable damage was confirmed in the appearance of the SGTS pipes and filter trains of Unit 4 (see Figs. 7.6 and 7.7).
- As for exhaust ducts running upstairs and downstairs in the east part of the 2nd floor of the reactor building of Unit 4, the NRA confirmed slight damage on the exhaust duct running downstairs to the 1st floor, but severe damage on the exhaust duct running upstairs to the 3rd floor (see Fig. 7.8). The NRA estimated that hydrogen gas flowed upstairs through the exhaust ducts, accumulated there, and then exploded.

- Although the NRA confirmed less damage to the supply ducts than to the exhaust ducts, some parts of the upward supply duct line (towards the 3rd floor) were crushed (see Fig. 7.8). The NRA estimated that the explosion in a nearby exhaust duct caused such crushing damage.

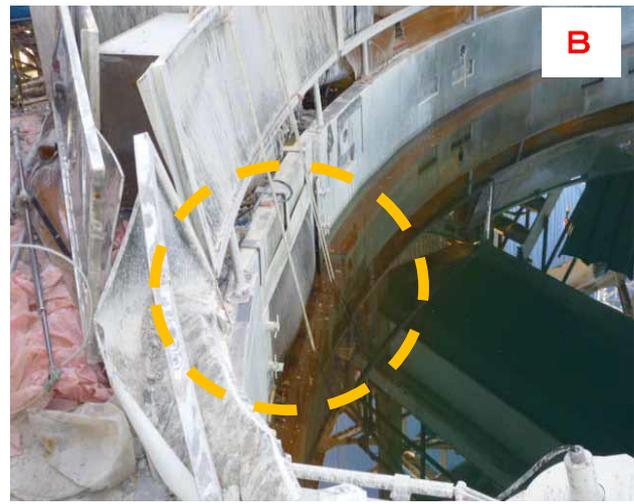
Figure 7.9 Deformed Exhaust Port Net of the Exhaust Ducts

- The NRA confirmed that steel net was deformed outward, which was provided to cover the exhaust ports of exhaust ducts located above the water in the reactor well and the SFP on the 5th floor. (i.e., backward from 4th to 5th floor) (see Figs. 7.9 and 7.10). The NRA estimated that this deformation was caused by a blast burst from the 4th to 5th floors through the exhaust duct.⁷⁸

⁷⁸ Units 1, 5, and 6 closed the relevant exhaust ducts to prevent water sloshing in the SFP from leaking from the ducts. However, the exhaust duct of Unit 4 had not been closed as exhaust duct-closing measures were still being discussed (as reported by TEPCO on May 14, 2013).

Deformation of the exhaust port net of the exhaust duct above the reactor well on the 5th floor (deformed outward)
(photographed by TEPCO on November 8, 2011)

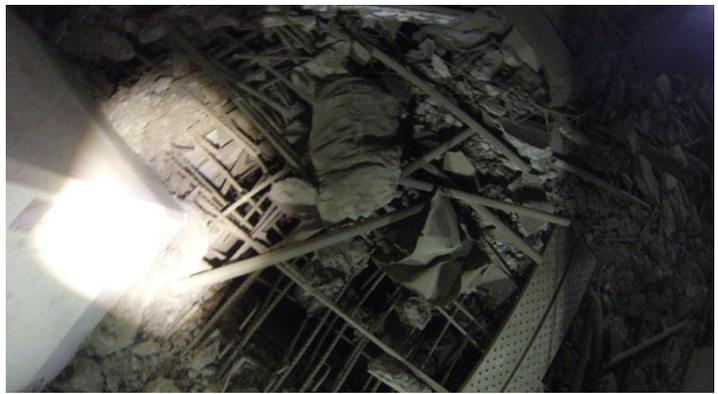
Figure 7.12 Traces of Damages on the Reactor Building (floor and ceiling in the northwest area of the 3rd floor)

Photographed by the NRA on February 6, 2014
 Close-up view (floor surface)

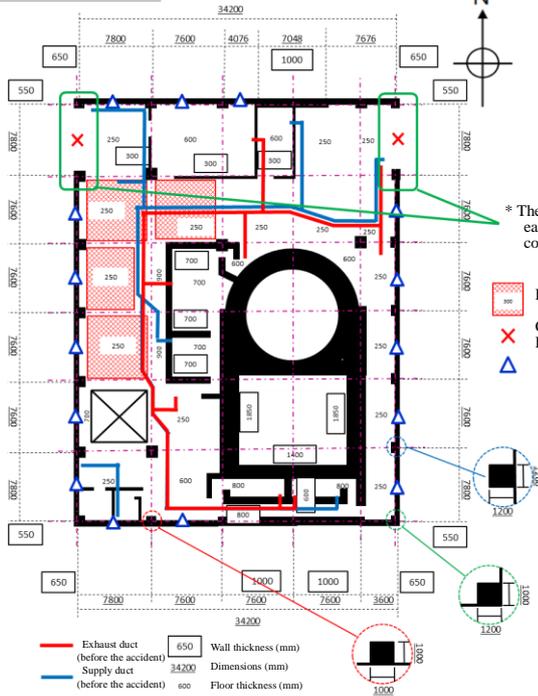
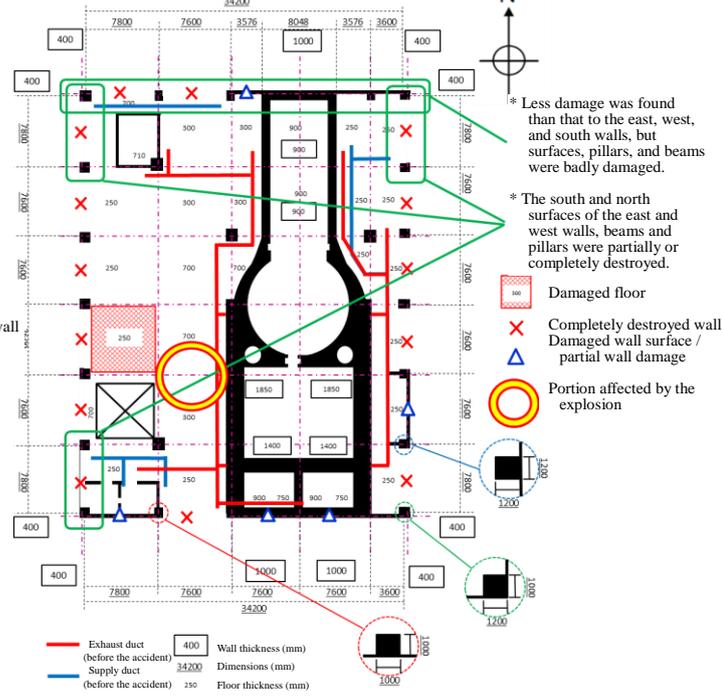
Figure 7.15 Traces of Damages on the Reactor Building (floor, ceiling, and walls)

partially destroyed, but confirmed no damage to the north and south walls (1000-mm thick). The east, west and south walls (250-mm thick) on the 5th floor (excluding the north wall) were also totally or partially destroyed. The NRA also confirmed some damage to beams and pillars near the north and south walls, and the staircase. On the 3rd floor, the NRA confirmed that the walls (550-mm thick) around the north staircase were completely destroyed (see Figs. 7.14 and 7.15).

As for the reactor building floors and ceilings, the NRA confirmed that thinner floors were severely damaged near the exhaust duct, which was severely destroyed. The NRA estimated that this destruction was caused by shock waves and blasts from the explosion of hydrogen that accumulated here via the exhaust ducts, and that particularly intense shock waves and blasts severely destroyed the thinner and structurally weaker portions of the floors.
