Evaluation of the report by Tokyo Electric Power Company regarding the leakage from piping transferring water treated at the Multi-nuclide Removal System (ALPS) at the Fukushima Daiichi Nuclear Power Station

Nuclear Regulation Authority
15 July 2015

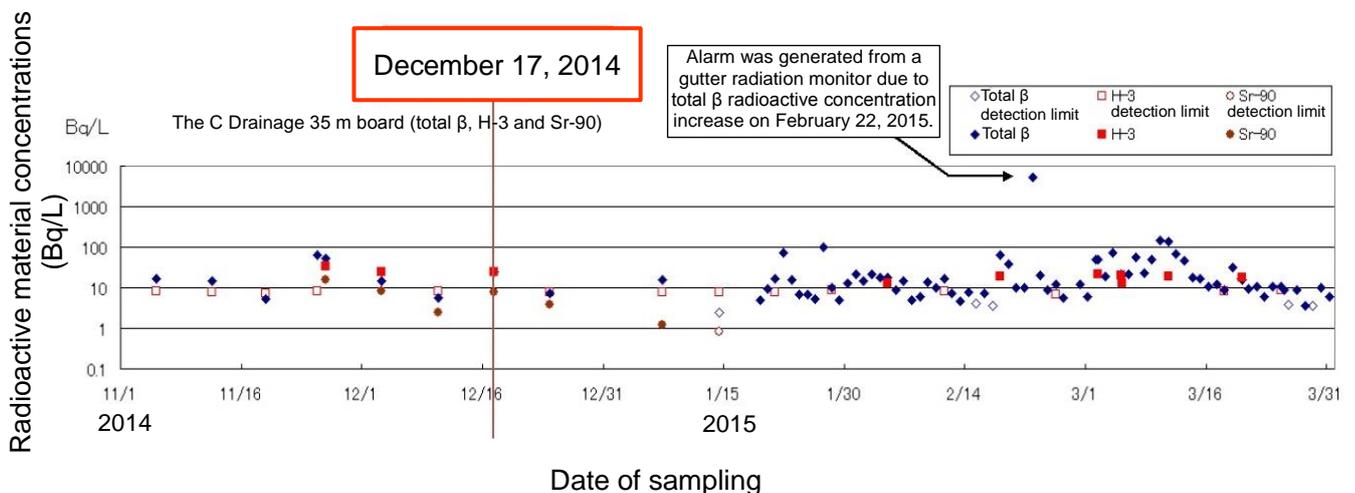
Figure 8. Concentrations of radioactive material in effluent sampled from C drainage before and after the leakage from ALPS treated-water transfer piping
