Investigation and analysis of TEPCO's Fukushima Daiichi NPS Accidents (1/9)

NRA investigation and analysis of TEPCO's Fukushima Daiichi NPS accidents

Background to investigation and analysis of TEPCO's Fukushima Daiichi NPS accidents

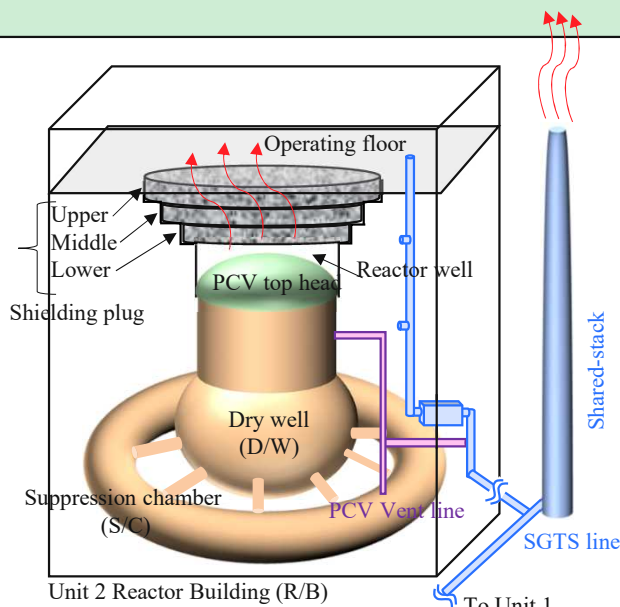
Figure. Names of sites related to the Cs-137 leakage routes

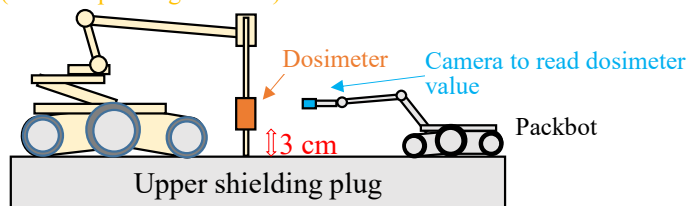
- The dose rates on the dividing line of the shielding plug (red line) and at the intersection of the dividing lines (green circle) are higher than those at the circumference, suggesting that the leakage routes of Cs-137 are not at the outer circumference of the shielding plug as previously assumed, but at the shielding plug joints.

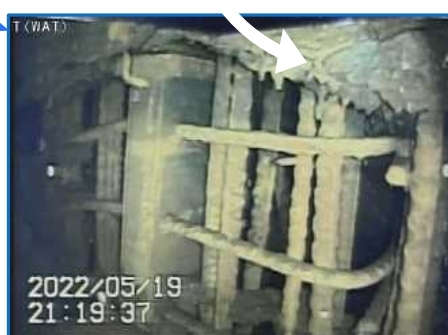
Damaged concrete of pedestal

1. Debris mound seems to exist near the pedestal opening. (not clear)
2. Loss of concrete at both sides of the opening. Rebars seems to be intact.
3. Concrete is lost only below the crust.
4. Lead net shield melted at a specific height.
5. Miscellaneous pipes are not affected severely.
