The 35th International Geological Congress, Cape Town, South Africa (Aug. 28-Sep. 2, 2016) Monday, Aug. 29, 2016, Session T8.2, "Geohazards and societal benefits: coping with reality / Risk evaluation and management in the 21st Century", Hall 4B2, 17:00-17:15, #2221. Ver. 7

Japan's Nuclear Regulation Standards against Natural Hazards after Fukushima

Akira ISHIWATARI

Commissioner of Nuclear Regulation Authority, Japan (D.Sc., Geologist) (石渡 明(原子力規制委員会委員))

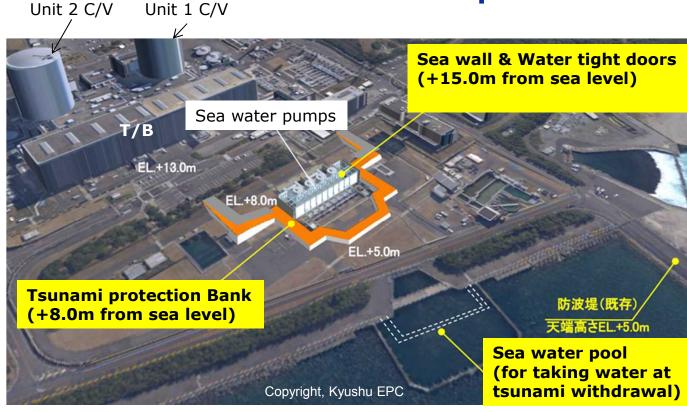
Tsunami protection

NPPs Tsunami Height		Input Tsunami	Site Elevation
Sendai	2.0m	7.0m	13m
Ikata	1.9m	8.7m	10m
Takahama	1.7m	6.7 m	3.5m

Design Basis Tsunami Height of Sendai NPPs is calculated at the point 8 km offshore and 50 m water depth.

Input Tsunami Height is the maximum at the site waterfront.

Site Elevation is the ground height where reactors are placed.
