International Workshop on Recent Advances in Seismic and Fault
Displacement Hazards Assessment for Nuclear Installations
18-21 June 2024, IAEA Headquarters, Vienna, Austria

Recent Nuclear Regulations, Re- evaluations, and Backfits in Japan to Cope with Natural Hazards

Akira Ishiwatari, Commissioner
Nuclear Regulation Authority (NRA), Japan

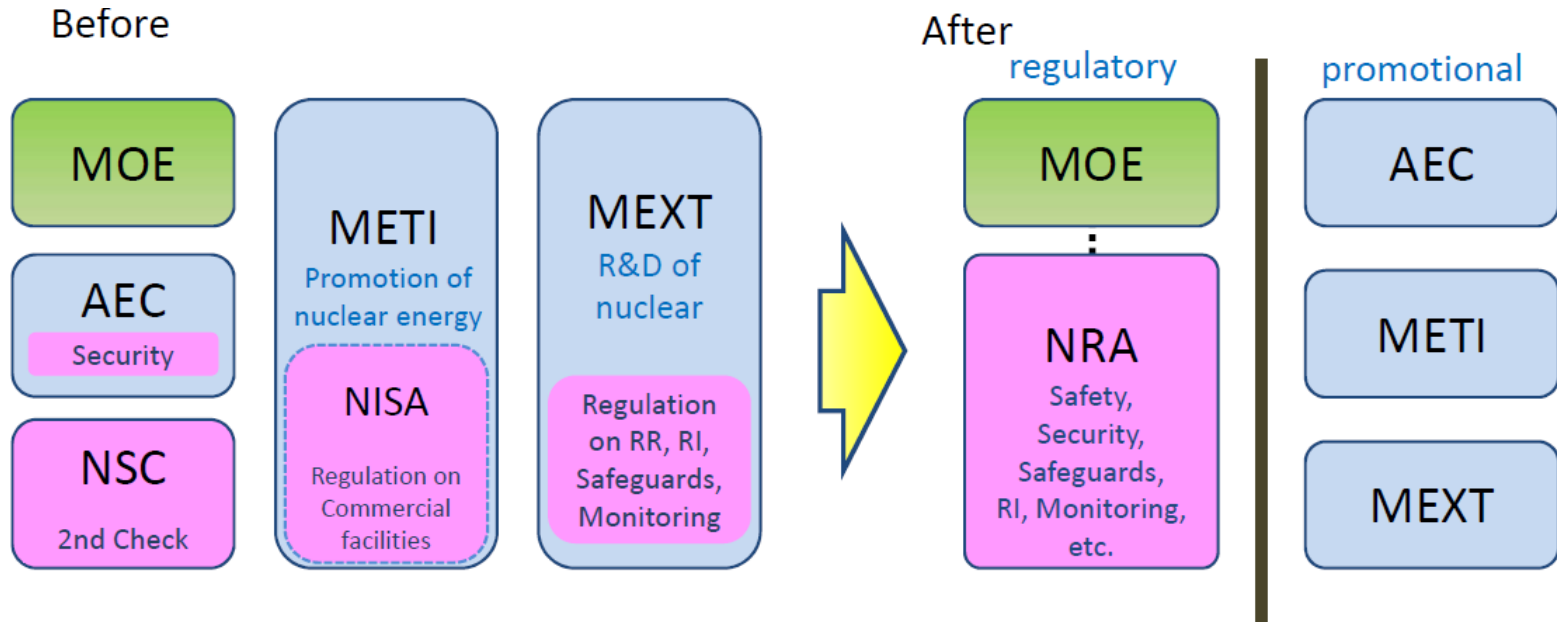
NRA as an independent regulator

To reflect lessons learned from the TEPCO's Fukushima Daiichi NPS accident, relevant authorities were integrated as an independent commission (Nuclear Regulation Authority) in September of 2012.

- AEC : Atomic Energy Commission
- METI : Ministry of Economy, Trade and Industry
- MEXT : Ministry of Education, Culture, Sports, Science and Technology
- MOE : Ministry of the Environment
- NISA : Nuclear and Industrial Safety Agency (abolished)
- NSC : Nuclear Safety Commission (abolished)

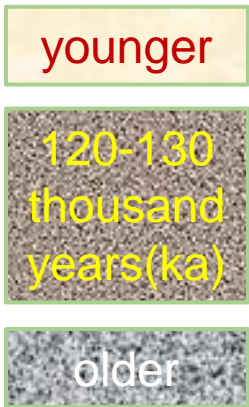
1. Covering Bed Method

Geological age of bed

Judge: Capable Fault

“Capable fault” is the official term for “active fault” that is defined in IAEA Safety Standards Series No. SSG-9 “Seismic hazards in site evaluation for nuclear installations”. The “120-130 ka” is the base age of Upper Pleistocene.

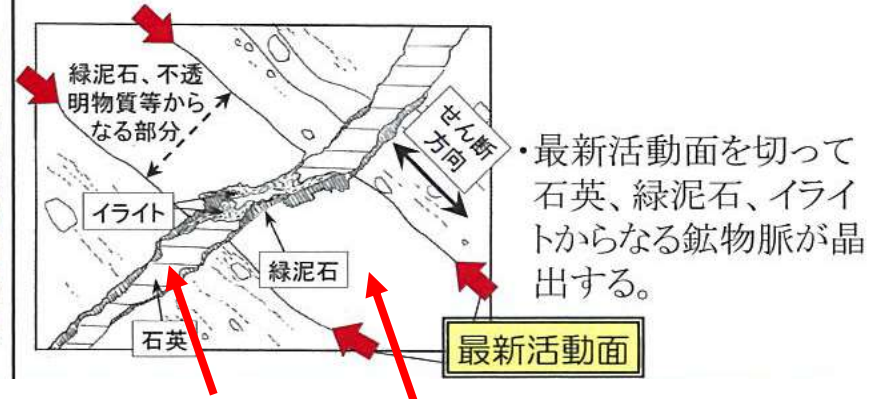
Mineral veins cutting fault zones (Sendai NPPs)

D-45 fault zone is cut by a quartz vein (p.109)

Polarizing microscope views of about 1 mm width

Mineral veins are of 1 to 3 million years age.

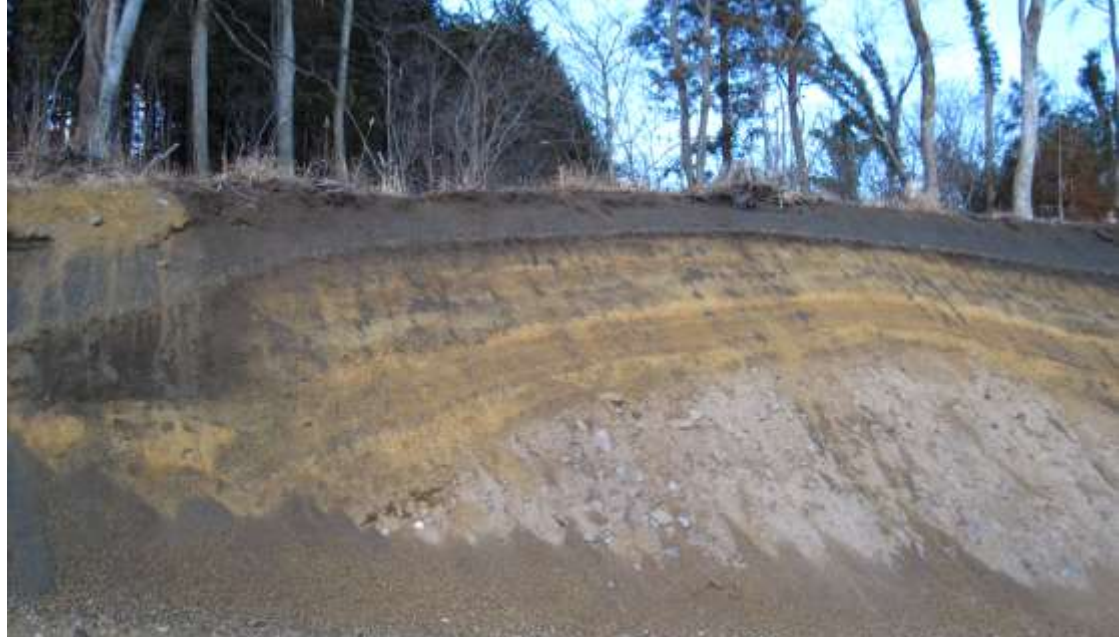
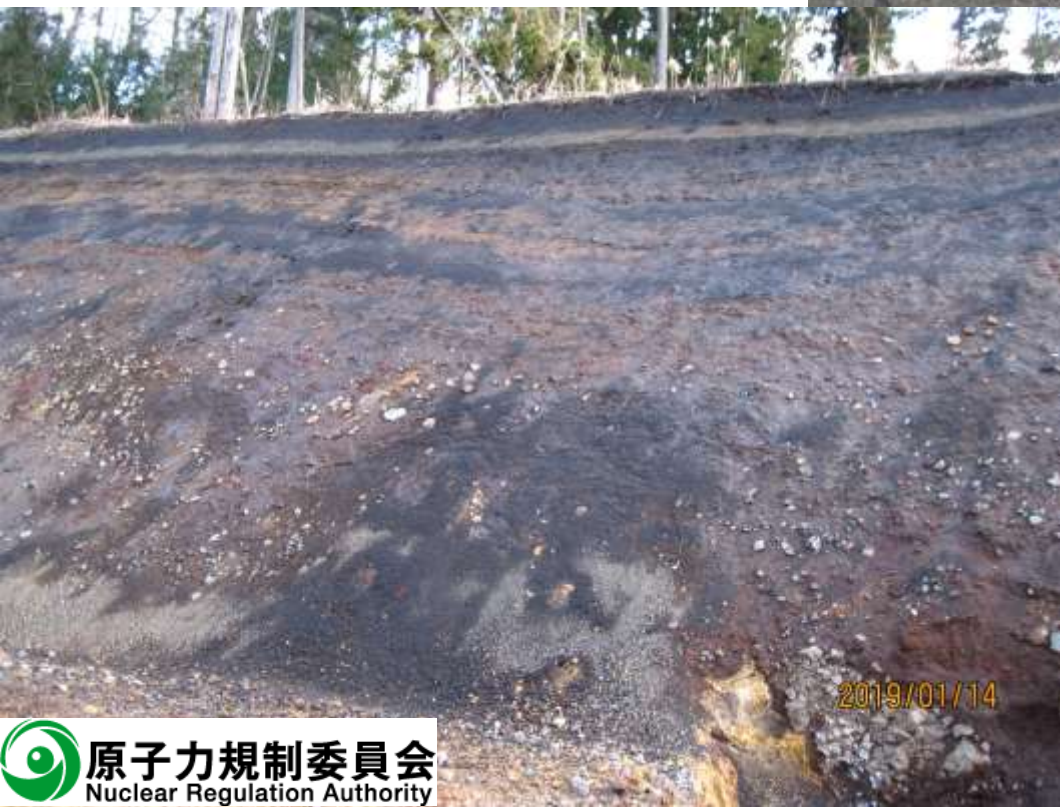
The 1707 Hoei volcanic ash layer (top >1 m) that covers eastern foothills of Mt. Fuji (Midono, Gotemba City)

In the 1707 eruption, white ash came first, and thick black ash followed. This suggests magmatic evolution in the deep magma chamber, and similar explosive eruption is expected for the next time. 25

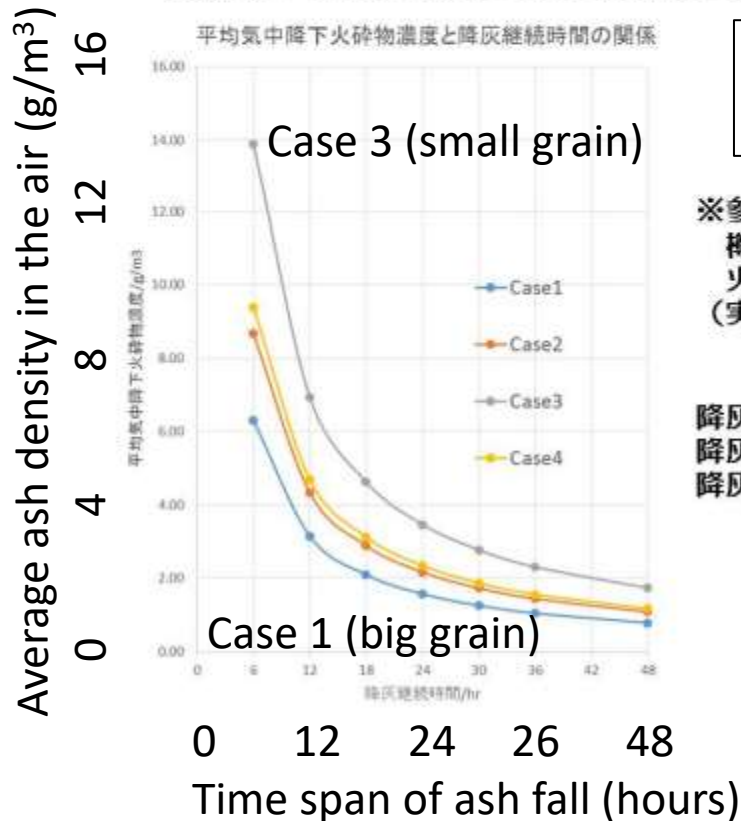
Calculation of volcanic ash density in the air: an example

- 堆積量：15cm
- 粒径分布（以下の4つのCase）
 - Case1：0.070cm（100%）、Case2：0.050cm（100%）、Case3：0.025cm（100%）
 - Case4：0.070cm（25%）、0.050cm（50%）、0.025cm（25%）
- 終端速度：1.1m/s（0.070cm）、0.8m/s（0.050cm）、0.5m/s（0.025cm）

Deposited volcanic ash thickness: 15 cm

Ash size distribution (4 cases):

Report of the NRA examination team for assessment of volcanic ash fall (June 22, 2017).

降灰継続時間を12~24時間と考え、
降灰継続時間が12時間の場合の平均濃度は、**3~7g/m³**
降灰継続時間が24時間の場合の平均濃度は、**2~4g/m³**

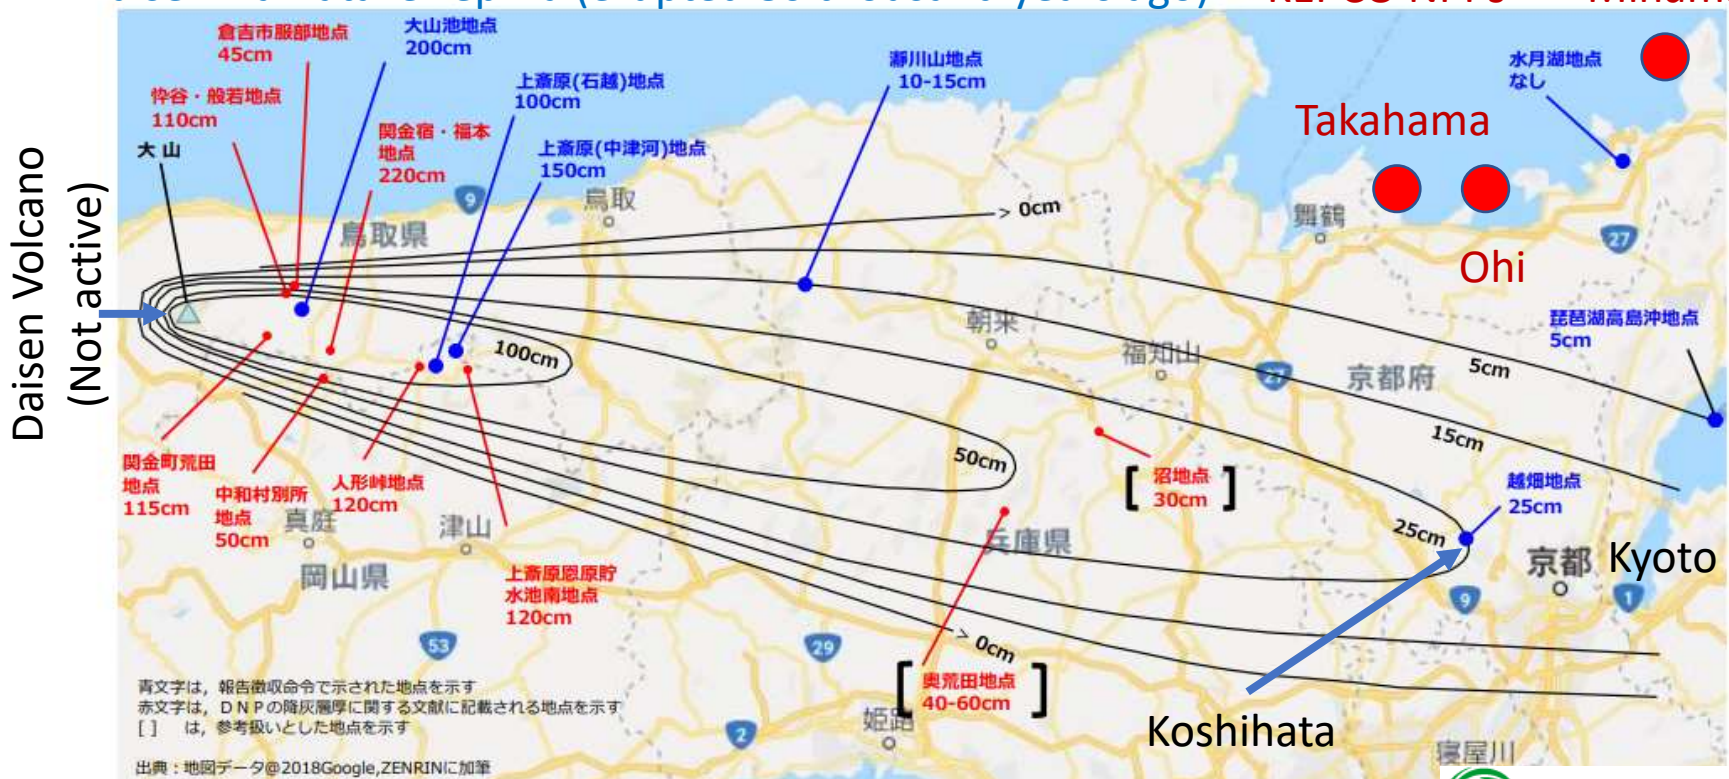
Volcanic ash thickness evaluated for KEPCO's Takahama, Ohi and Mihama NPPs was 10 cm when these NPPs passed re-evaluation in 2015-2017. NRA-funded study of AIST revealed that the Namatake ash bed of the Daisen Volcano is as thick as 30 cm in Koshihata to the west of Kyoto. The ash thickness to cope with is 27 cm for Takahama, 25cm for Ohi and 22 cm for Mihama as fixed in 2021.

Daisen Namatake Tephra (erupted 80 thousand years ago) KEPCO NPPs Mihama

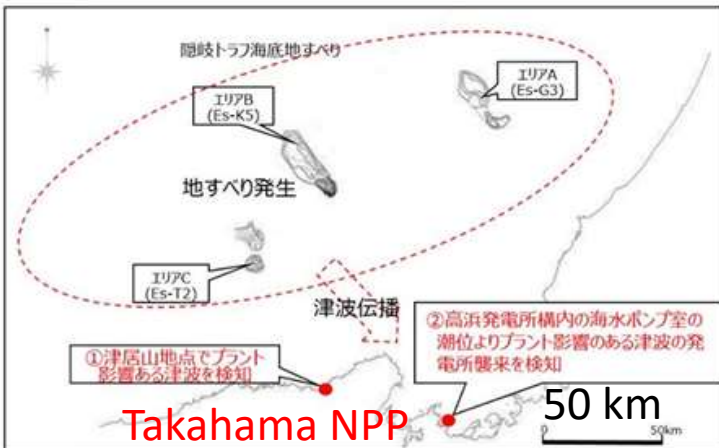
図7 4プラント運転時における取水路防潮ゲートの状況 (正面図) 28

Water Gate

Possible submarine landslides in Japan Sea to cause tsunamis

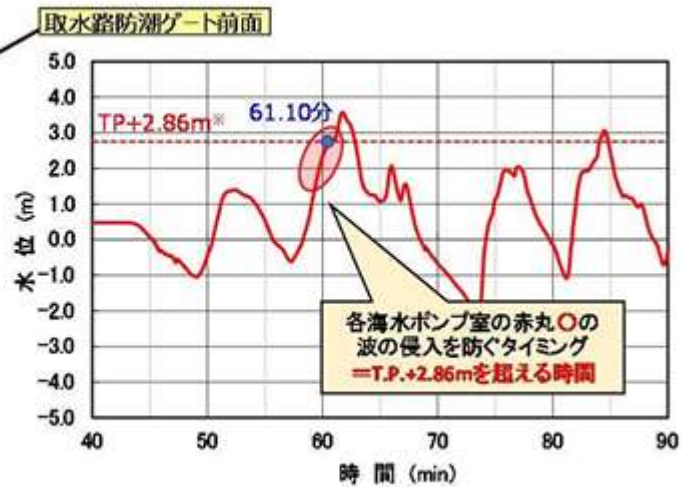
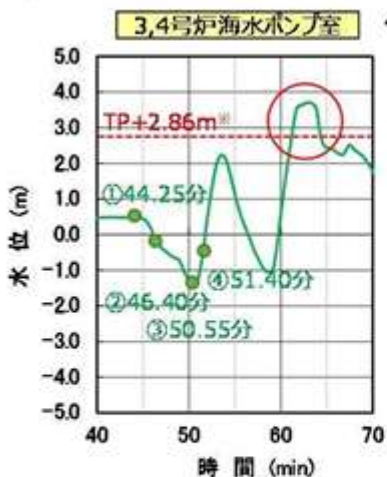
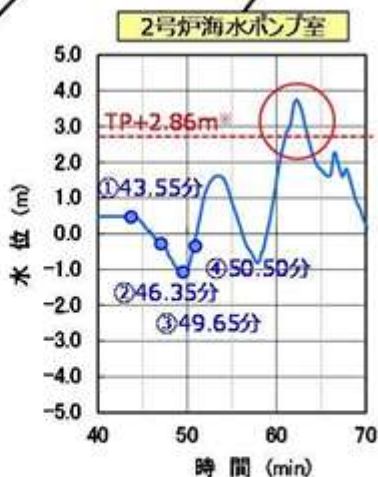
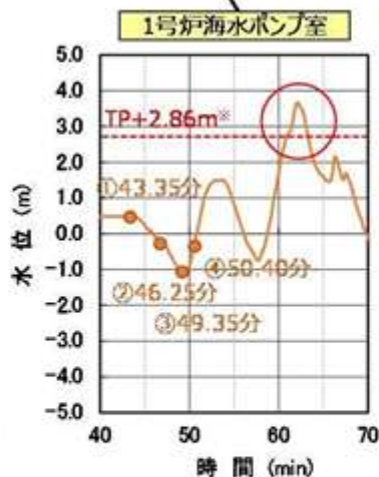
Backfit (3): Tsunami coming without warning 2

1号炉 SWP	2号炉 SWP	3,4号炉 SWP	取水路防潮ゲート
①	43.35分	43.55分	44.25分	-
②	46.25分	46.35分	46.40分	-
③	49.35分	49.65分	50.55分	-
④	50.40分	50.50分	51.40分	-
取水路防潮ゲートの閉止 (④+1分)				52.40分
取水路防潮ゲートでの水位が TP+2.86mを超える時間				61.10分

※：潮位のばらつきと高潮余裕度を考慮した場合に敷地高さを超える高さ
 $T.P.+2.86m = \text{敷地レベル} T.P.+3.5m - \text{潮位のばらつき} 0.15m - \text{高潮余裕度} 0.49m$

①：変動開始時間、②：-0.6m水位変動、③：第1波目最低水位
 ④：+0.6m水位変動

Sea level change of more than 50 cm within 10 minutes is identified as tsunami arrival and the water gate should be immediately closed.

On Dec. 22, 2018, Anak Krakatau Volcano of Indonesia erupted and large tsunami attacked coastal areas, caused >400 deaths. This tsunami came without warning. Takahama NPP was not prepared for such tsunami coming without warning, and NRA ordered backfit in 2019.

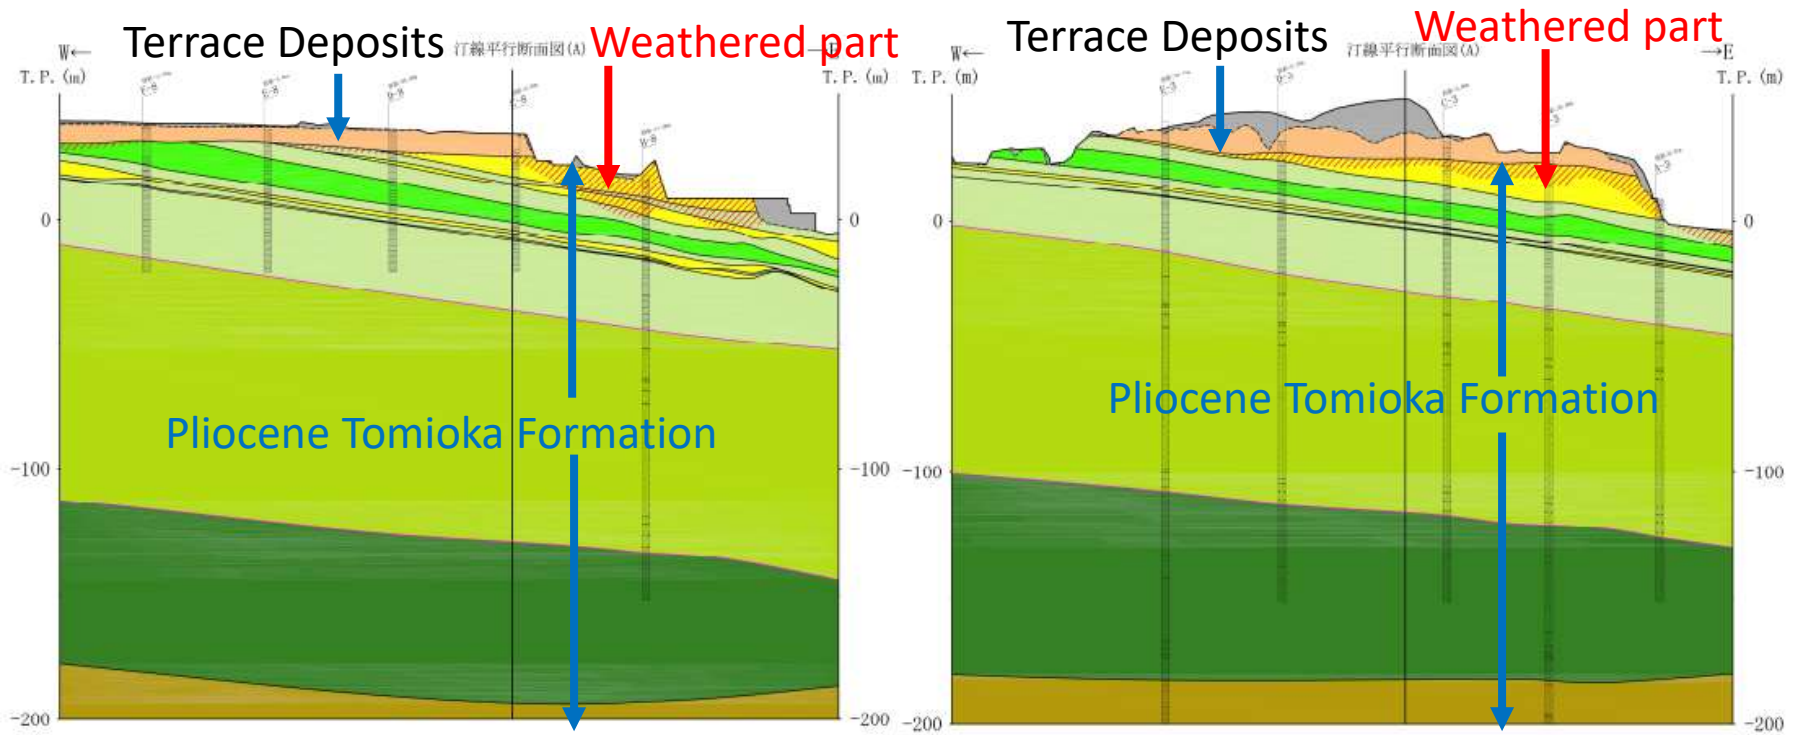
(East-West Sections)

敷地内の富岡層風化部の分布状況

埋戻土	埋戻土	風化部
粘土-シルト	段丘堆積層	
砂	富岡層T3部層砂岩	
礫	富岡層T3部層泥質部	
泥岩	富岡層T3部層互層部	
砂岩	富岡層T2部層	
凝灰岩	富岡層T1部層	
軽石	先富岡層	
	凝灰岩鍵層

※ 各ボーリング孔は断面線に投影

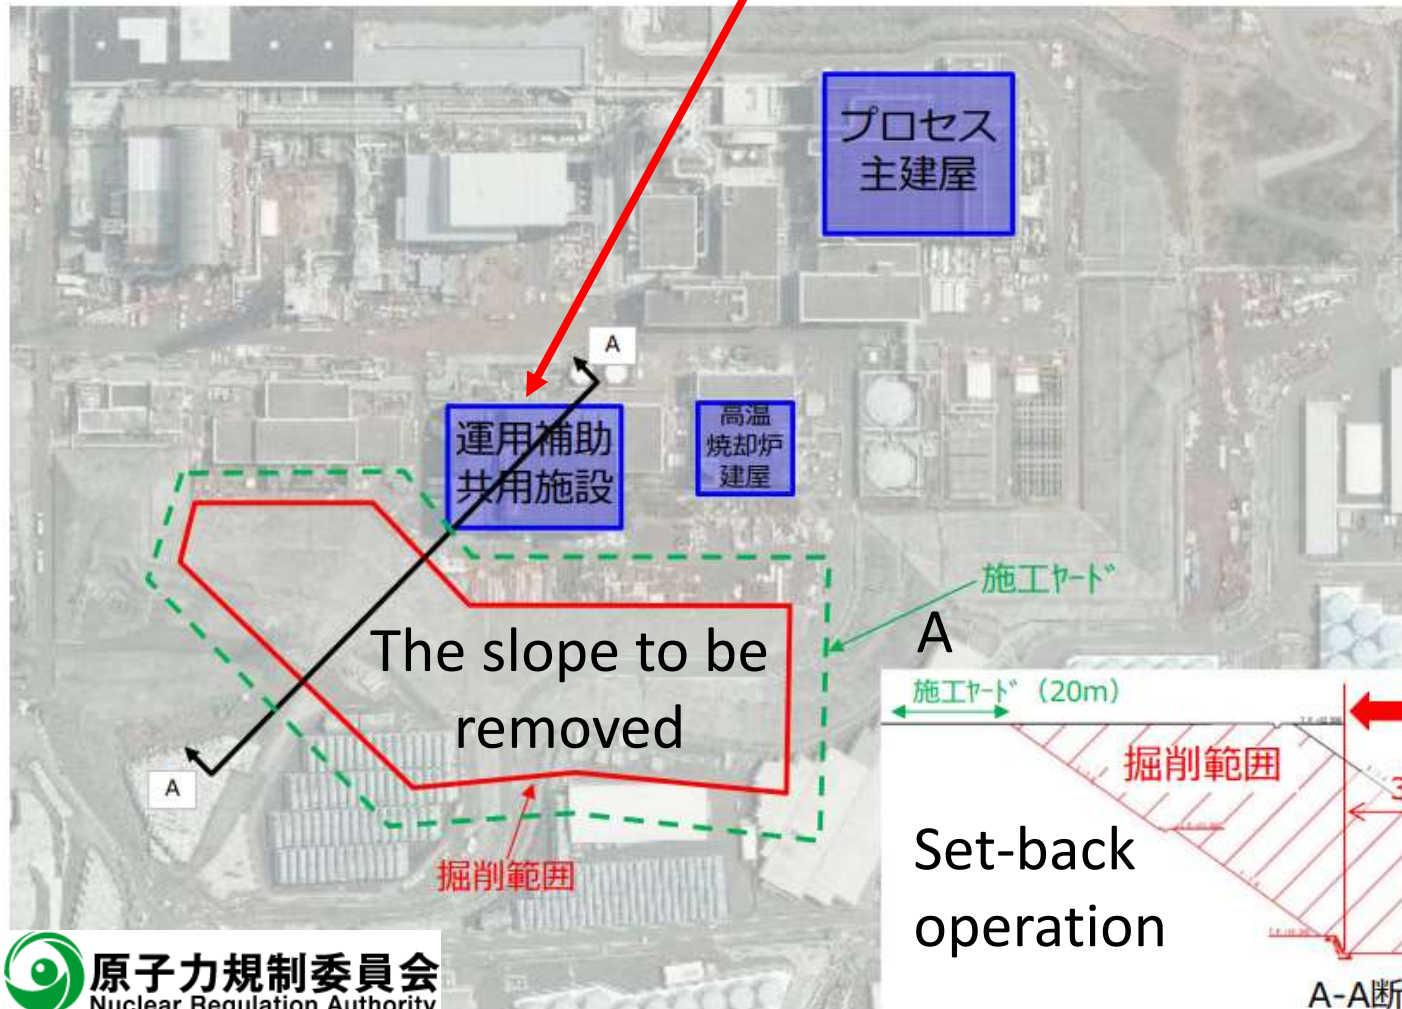
斜面セットバック工事の概要

Used-fuel storage pool facility

The slope to be removed
