# Japan's experience on improving nuclear installation safety challenged by external events; the Noto Peninsula earthquake

Koshun Yamaoka

Commissioner, Nuclear Regulation Authority, Japan

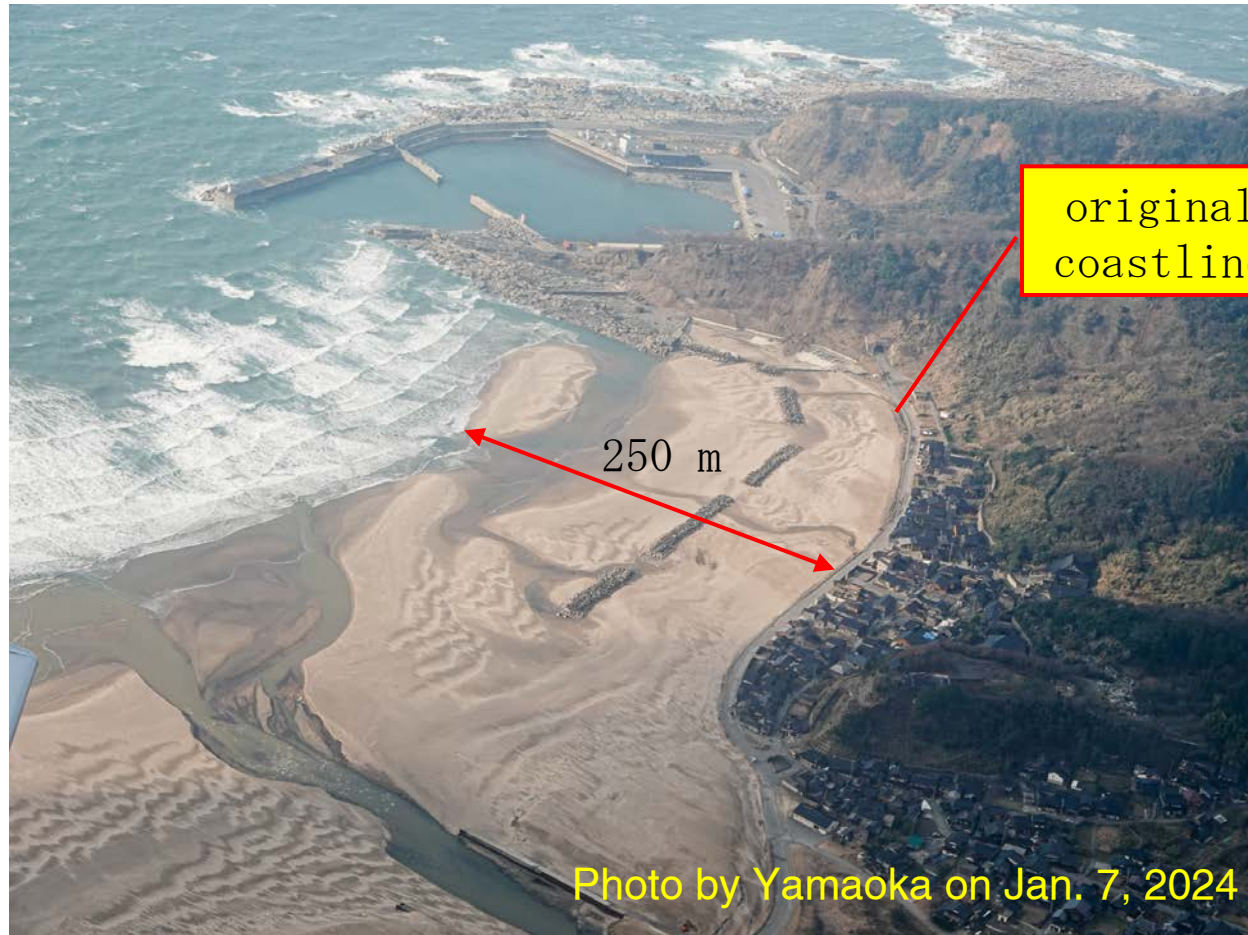
- Crustal deformation by InSAR with ALOS-2 observation (GSI,JAXA)
- Maximum uplift is **4m** at the NW coast.
- Land area increased by **4.74 km<sup>2</sup>** (GSI, 2025)

Vertical movement by InSAR  
( Analysis by GSI from ALOS-2 data of JAXA)

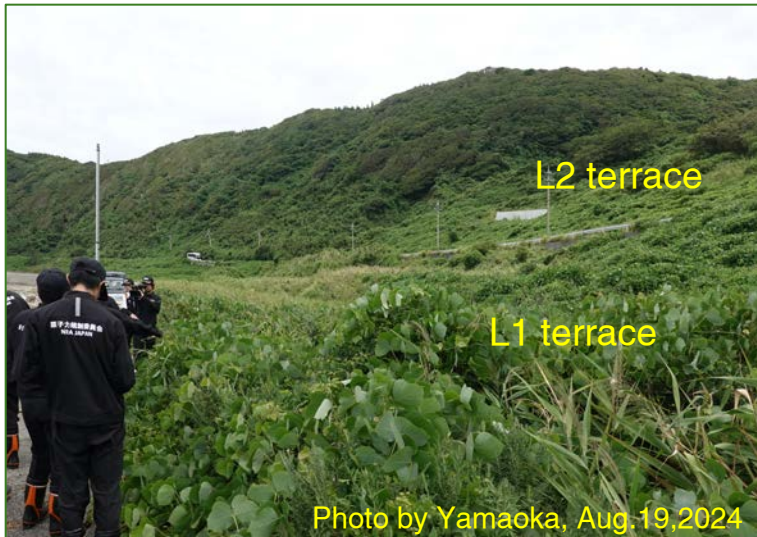
Three major marine terraces were identified (Shishikura et al. 2020) along the north coast.

- Each terrace represents the uplift corresponding to a past earthquake which was multi-segment rupturing like the 2024 earthquake.
- A smaller uplift corresponds to the earthquake of AD1729 (Hamada et al. 2015).
- The multi-segment rupture occurred every 900–1400 years, with some smaller events in between.

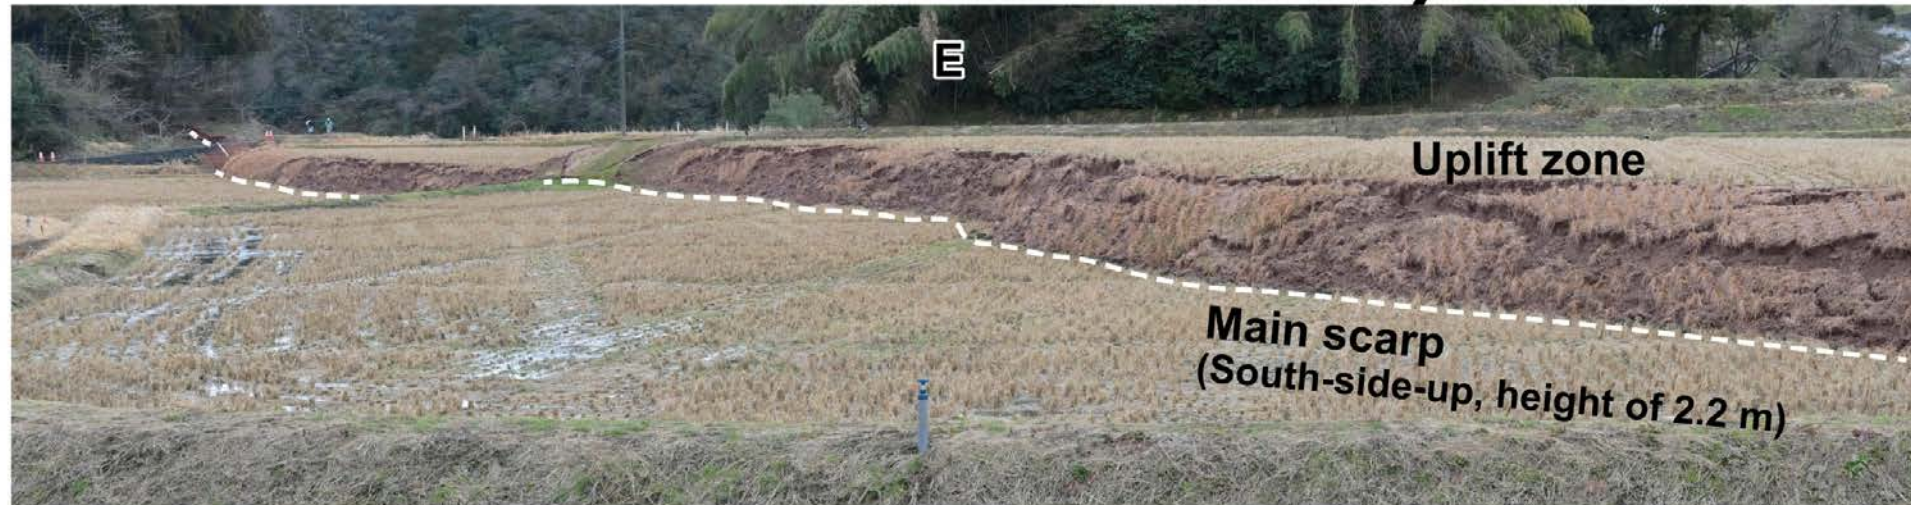
Location of 'Accompanying Faulting'

Faulting with a displacement of about 2m was found apart from the source fault of the Noto Pen. Earthquake.

- The faulting was caused by regional land slides, (Nakamura et al. 2024, Komura et al. 2025) which may be triggered by strong ground motion of the earthquake.
- Some of the faults slipped along the pre-existing fault surface.

3. Accompanying faulting was found apart from the earthquake fault.
  - Careful examination, including the evaluation of soil stability, is required.
4. The road and house damage raised the awareness of the potential threat of multi hazards by earthquakes and SA of NPP.

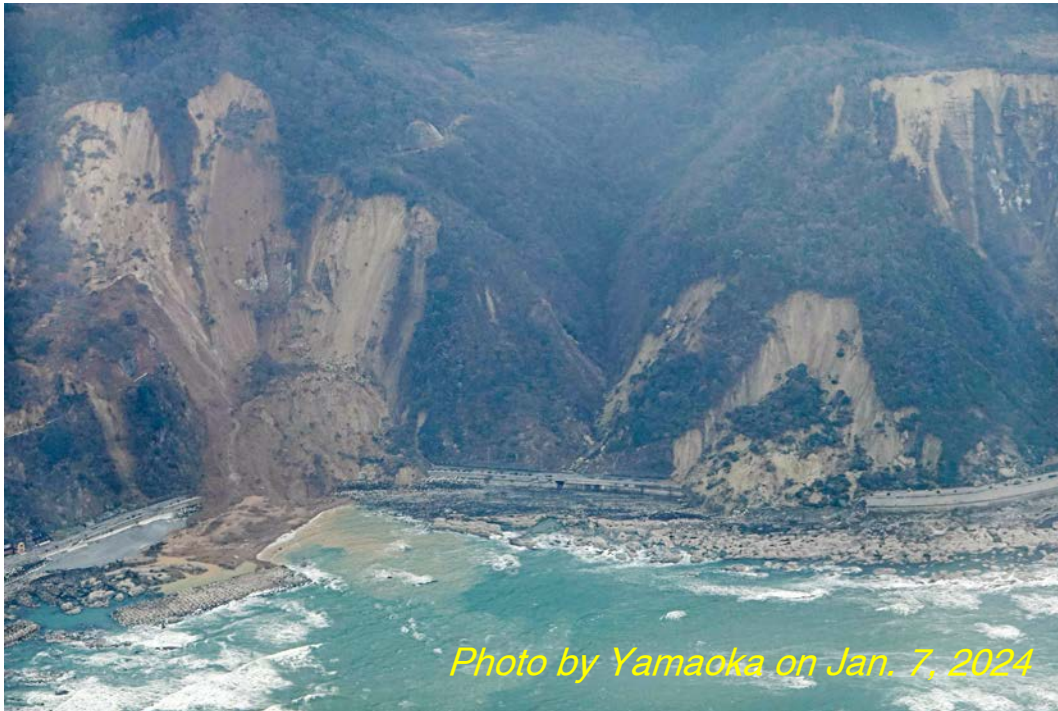
## Road Closure

- Even the high-grade road, which is a major connection route in the peninsular, was destroyed.
- Some small villages are isolated due to landslides or rockfalls on community roads.
- These damages could block the transportation of emergency supplies as well as evacuations.
